City of  
**Peterborough**

**Subject:** **Report USTR17-008**  
**River Road South / Bensfort Road Traffic Operational Review**

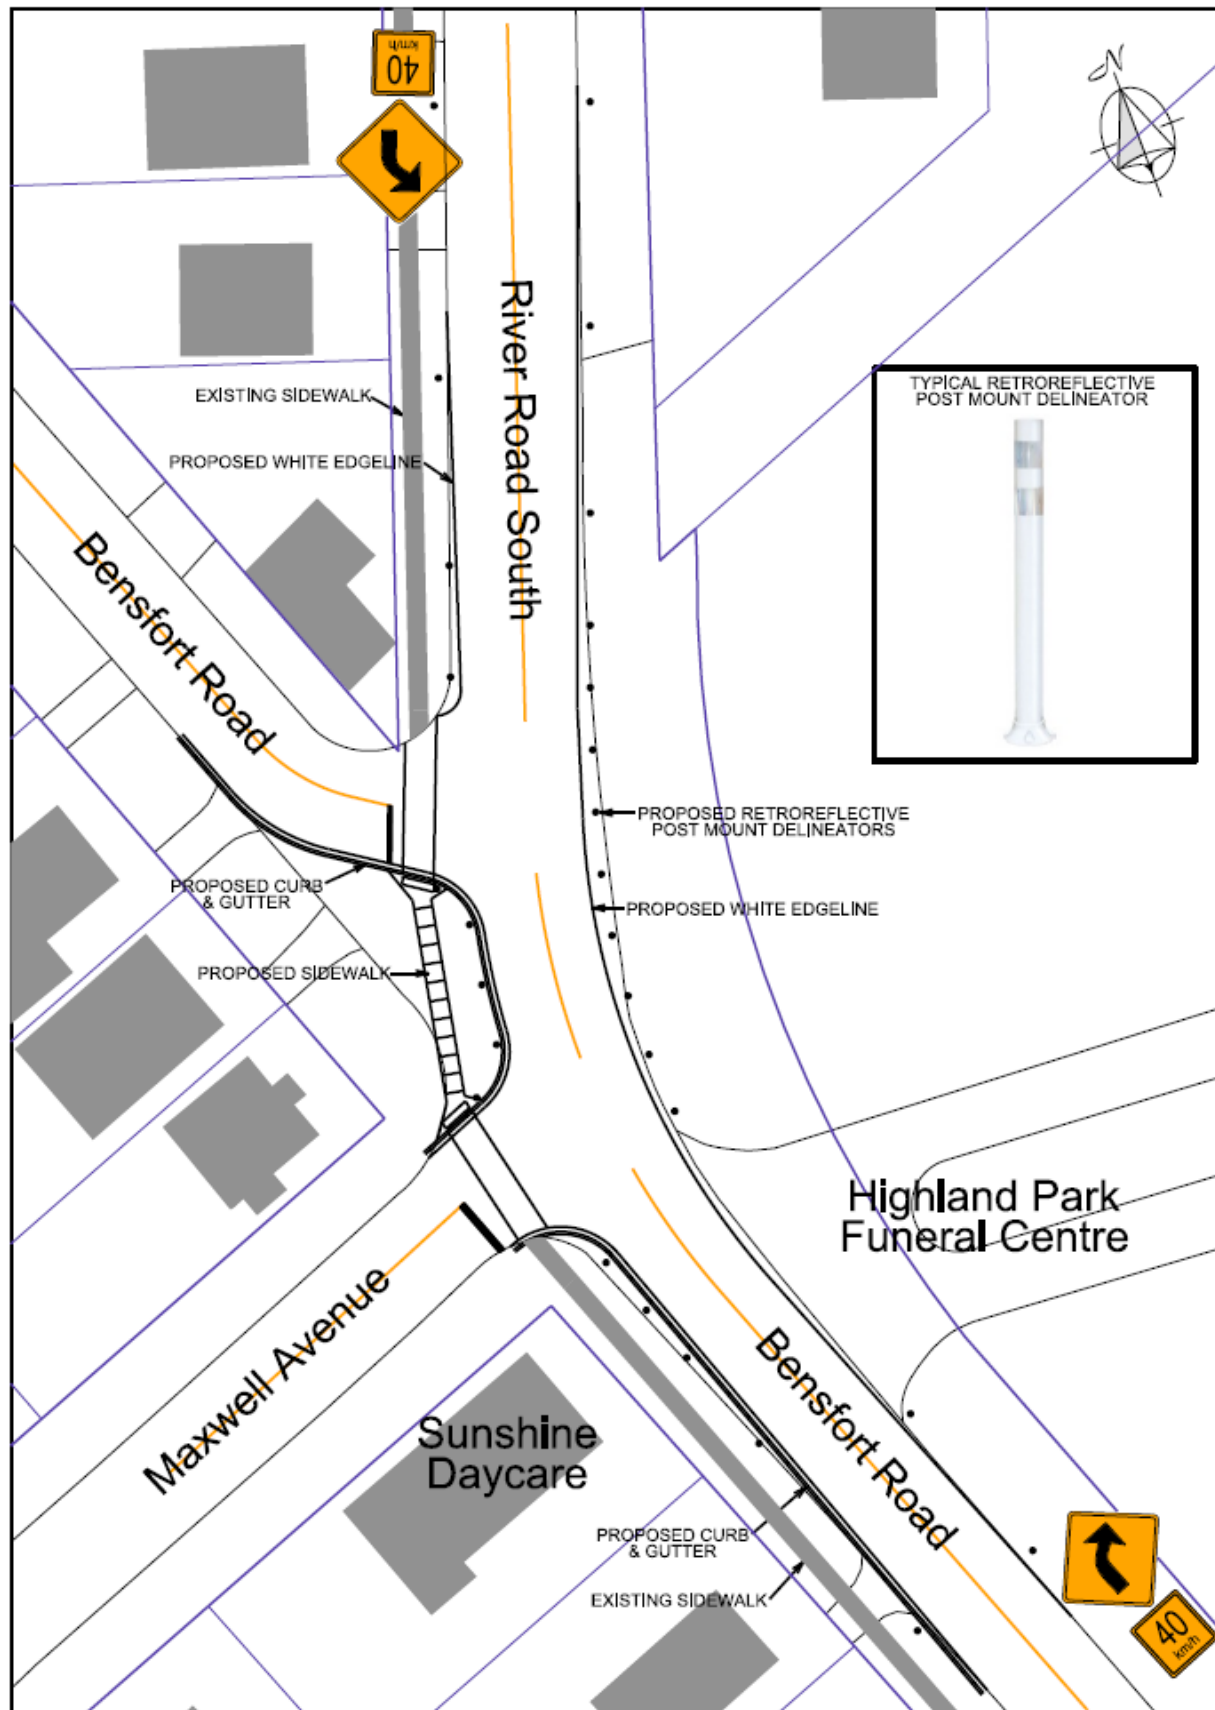
Appendix B – Intersection Improvements Concept Plan

The implementation of the concrete barrier curb on the outside of the curve will also narrow the pavement width, encouraging slower speeds and improving the guidance for southbound and northbound vehicles traversing the curve. The addition of this curb treatment will also allow for a partial realignment of the Bensfort Road (north leg) connection and will allow the stop line and crosswalk on Maxwell Avenue to be moved further east, which will improve sightlines at both locations and create a small boulevard area to allow for installation of the missing link of sidewalk between these side roads.

- oversized curve warning signs with 40km/h advisory speed tabs will be installed;
- additional yellow centre dividing line markings through the curve will be painted;
- white edge line pavement markings will be painted; and
- retro-reflective, post mounted delineators will be installed throughout the curve on both sides of the road.

A sketch of the concept improvements are shown as Appendix B.
