RE: WASTE MANAGEMENT FACILITY FLARE RECOMMENDATION

Subject: City of Peterborough Flare System Condition Assessment and Recommendation of Upgrade for Prolonged Operation

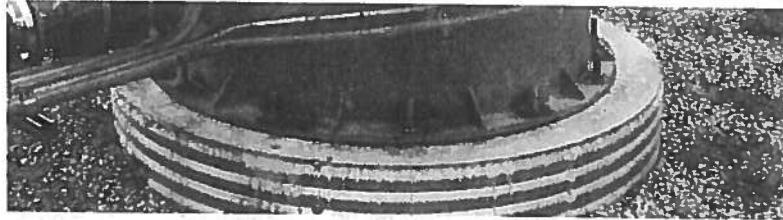
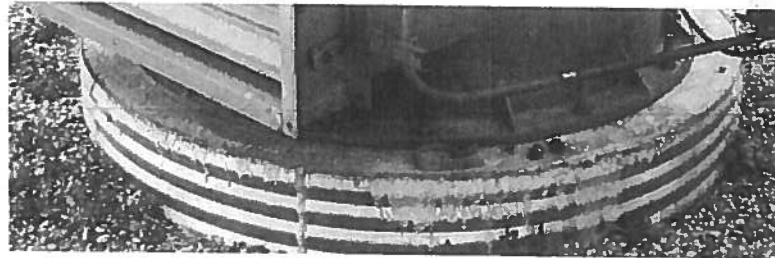
4.1. The Base Ring

There is no obvious corrosion either on bolting or weld between the shell and the base ring. It's deemed structurally sound.

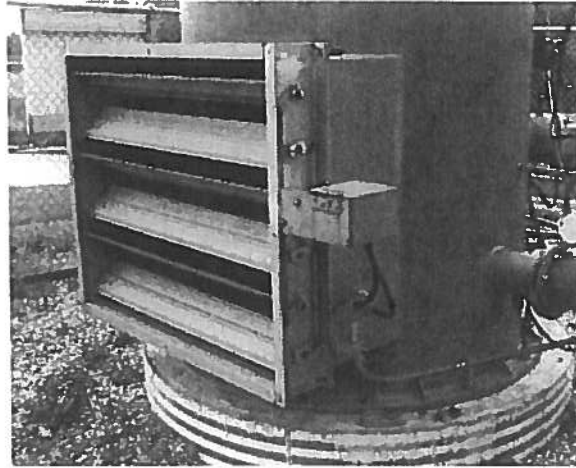
4.2. The Damper

It deemed structurally sound to serve its continuing operation. Applying light grease spray on pivoting points of shaft and linkage will free the drive from binding.

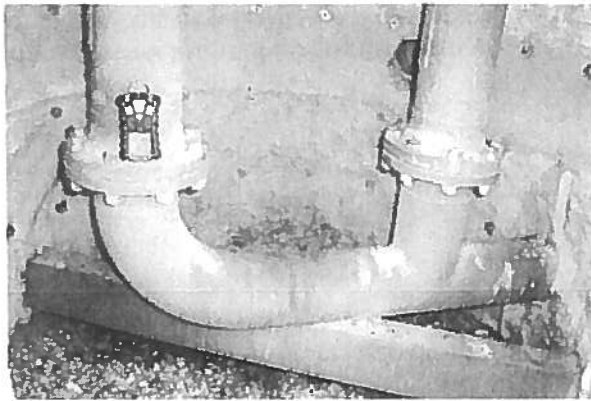
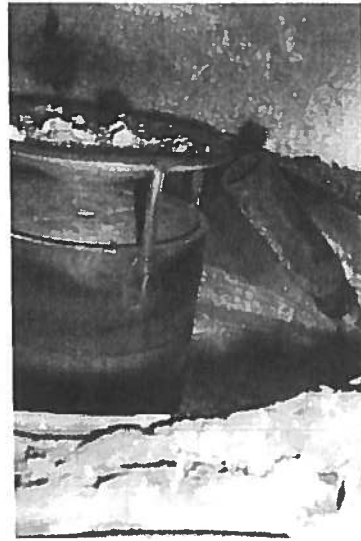
4.3. The Burner Manifold and Burner Tips

The burner manifold and burner tips are deemed sound enough for much lesser frequency of operation in the future.

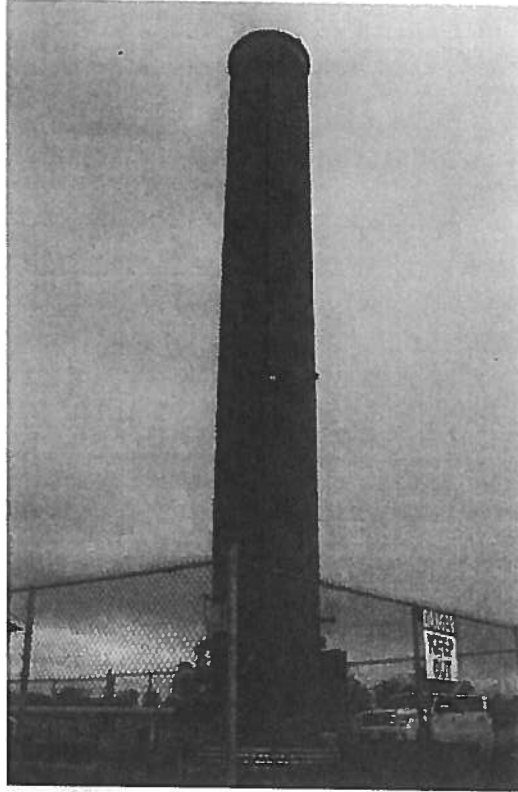
4.4.1. Exterior Surface:

The steel shell appeared to be in good condition. The ultrasonic thickness testing proved this to be an accurate assessment. Measurement of wall thickness within three feet section above table, which is directly exposed to flame, has been taken and showed no signed of change of thickness at multiple points of sampling.

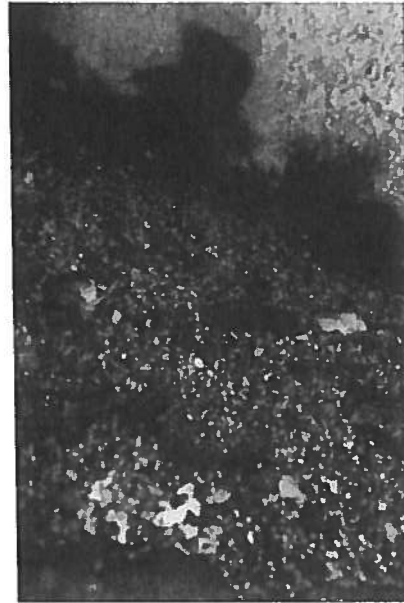
4.5. The Burner Table

Burner table is deteriorating. Obvious crevice corrosion is taking place at the junction of table top and enclosing ring of burner with significant signs of rust. There is no structural damage of the substrate and no imminent necessities for replacement. Refractory lining on top of table is deteriorating and shall be replaced.

- 1) Overall steel structure is deemed substantially sound and should have no issue in supporting extended operation except the burner table is deteriorating. Although there is no imminent necessity for replacement of the burner table, we can't foresee it's going to last long enough to cover the expected 20 plus years of operation. For future replacement, we propose to replace the table with a standalone one covered with refractory on top for better protection of manifold and dampers down below. For ease of installation, the new table will come in segments. The burner table will be floor mounted on pedestals and then be bolted together for rigidity. To install it, gravels at the bottom of the flare need to be cleared out so pedestal supports can be anchored. The gravel will then be put back.

To supply and install burner table on site in one day:

Our Price: \$5,815.05 plus applicable tax.

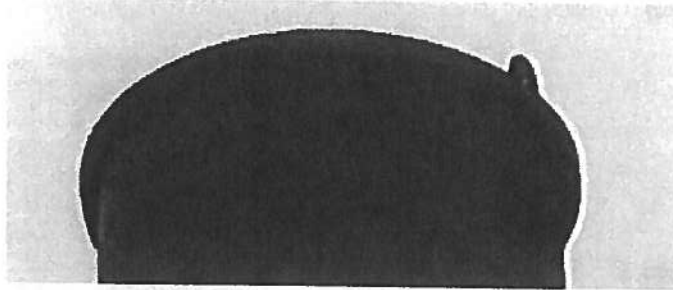
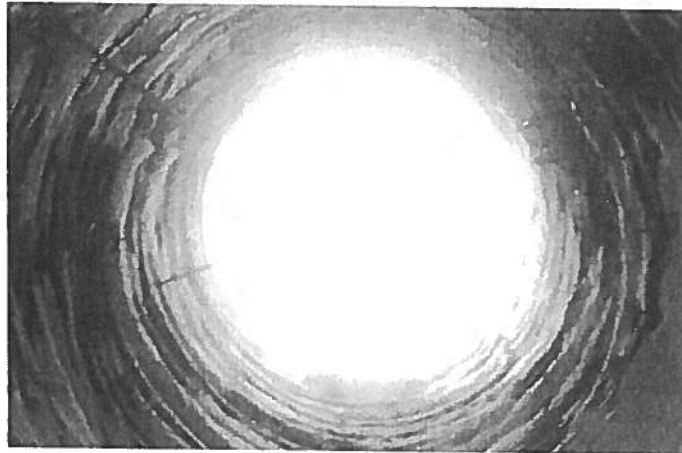
4.6. The Rain Cap

The rain cap shows no obvious damage from corrosion. No obvious sign at top section of refractory lining from losing of protection of rain cap appears. Due to its inaccessibility, no close and direct observation of rain cap condition has been conducted.

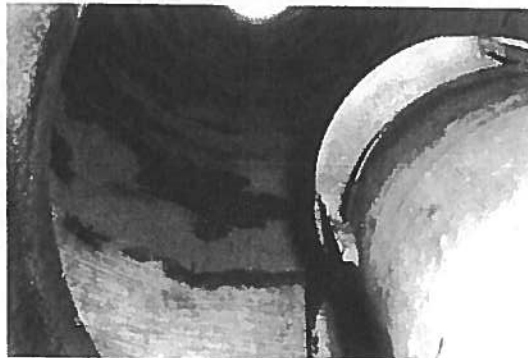
4.7. The Refractories

The refractory ceramic fibre is showing signs of crystallization deterioration, would most likely be caused from a combination the methane gas impurities and outside contaminants, rain, snow leaving deposits of iron on the refractory surface and age.

Some of anchors were corroded and the tips broke off with the removal of the washers, where others were still in good condition.

- 2) Refractory blanket shall be replaced for extended operation. We propose to replace refractory on site on spot including removing the existing ceramic fiber lining from inside the flare; install new 601 Inconel twist lock studs; the flare would be lined 1" of Cerablanket 8# density ceramic fiber, backed up with 1" of Cerablanket 6# density ceramic fiber; table top and self to be lined with 3" Cerablanket c/w twist lock studs and washers; the hot face blanket would be overlapped 20% and installed vertically secured in place with 601 Inconel twist lock washers; All anchoring to be 601 Inconel twist lock studs and washers.

Our Price: \$49,573.50 plus applicable tax.

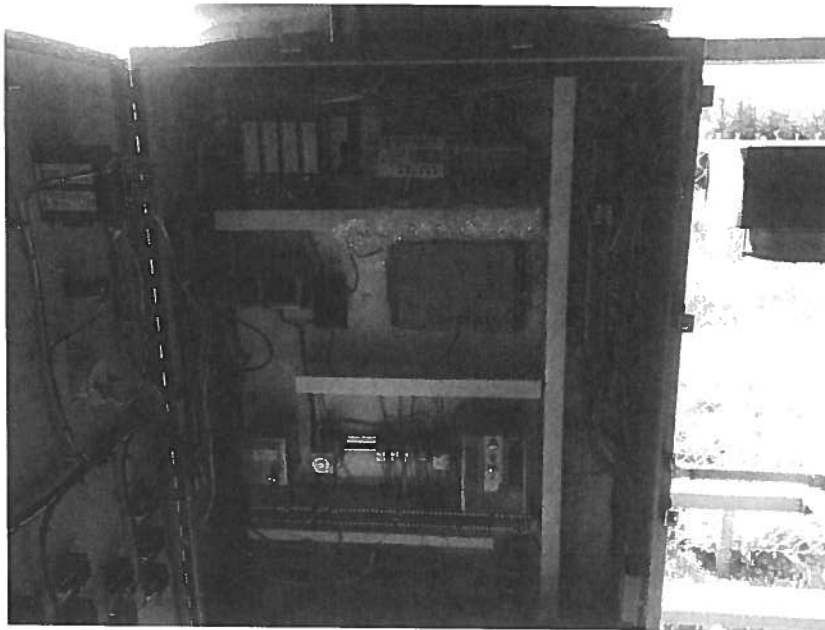
System Control Panel

The current PLC is a GE Fanuc Series 90-30 unit with 120VAC digital input and output cards. This series of PLC is still available but this particular system is now 15 years old. The documented program for this PLC is not available and only print copies of the simplified electrical drawings for this panel are available.

As a general comment, it is apparent that this system has been modified over the years but few, if any, of the modifications have been captured in the current drawing set.

As part of the TSSA upgrade, a significant portion of this panel will need to be rewired and reorganized in order to integrate the required Burner Management System (BMS) into the controls and the PLC program will need to be significantly revised. As part of the current TSSA upgrade proposal, we have included modifying these existing drawings as required and adding a page for the new BMS controller.

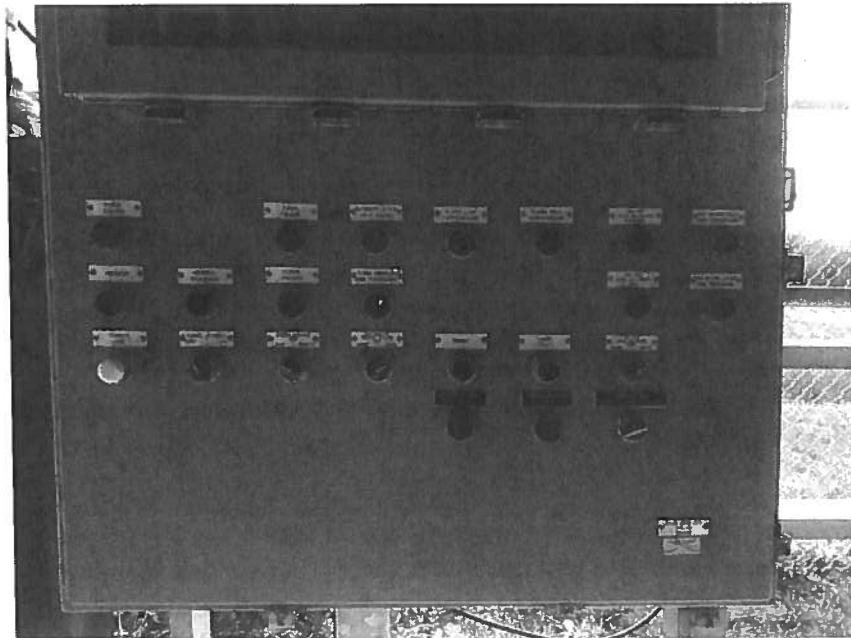
Control Panel Door

As part of integrating the BMS into the controls, a number of current functions will be eliminated which will include:
