PEER REVIEW REPORT

**PETERBOROUGH MEMORIAL CENTRE  
STRUCTURAL REVIEW**

C018.2148

FOR: CITY OF PETERBOROUGH | DATE: NOVEMBER 9, 2018

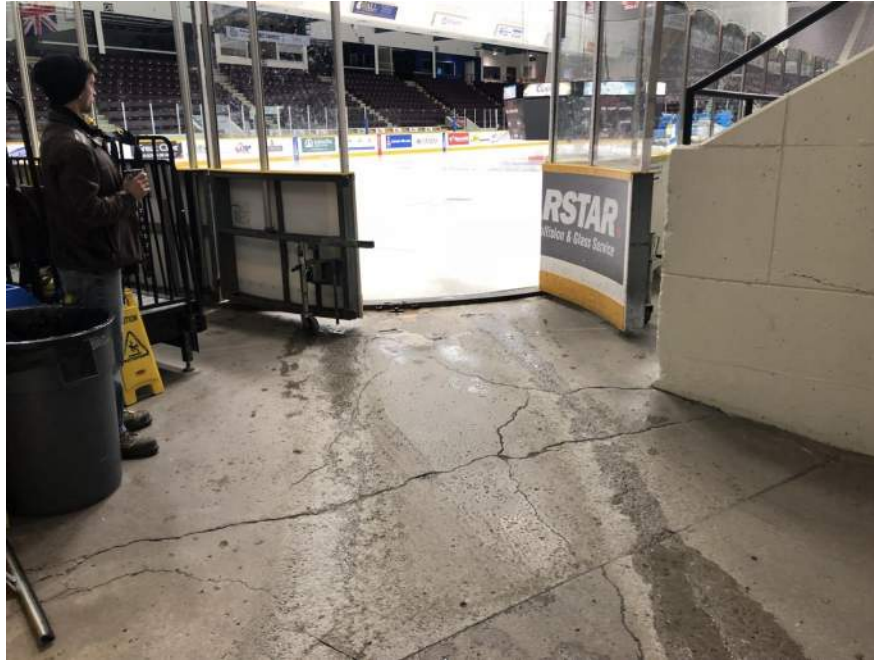
1. Wide cracks were observed on the east side of the ice rink and along the ice resurfacer path at the southeast corner of the rink. The most extensive cracking was observed within the ice resurfacer path. See photograph 1.

Photograph 1 | Cracking of Existing Concrete Slab along the Ice Resurfacer Path

1. Based on our visual observations, where accessible, the condition of the rink slab generally appeared to be in fair condition. Cracks observed should continue to be monitored for growth and deterioration.

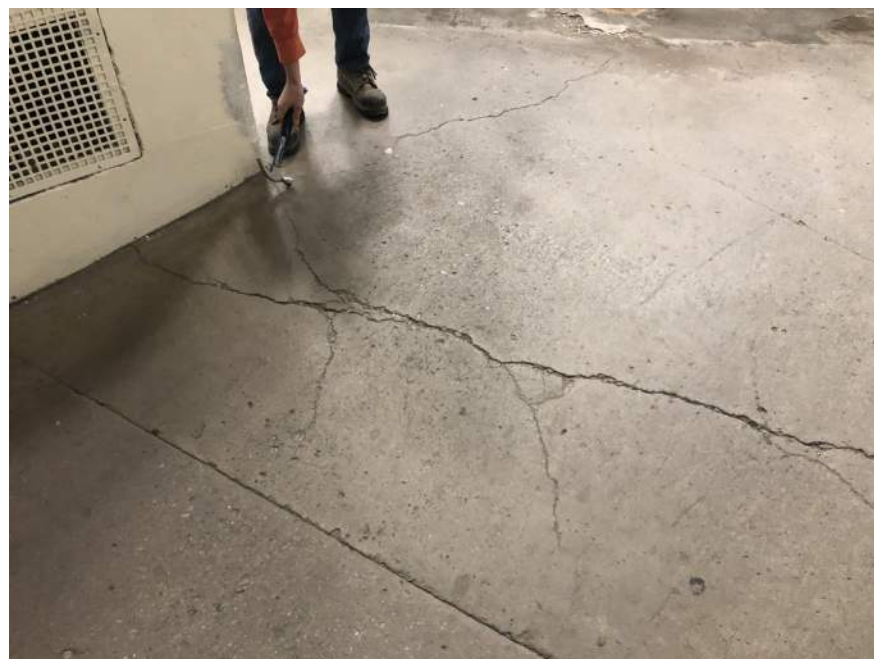
Photograph 2 | Cracking of Existing Concrete Slab along the Southwest Corner of the Ice Rink

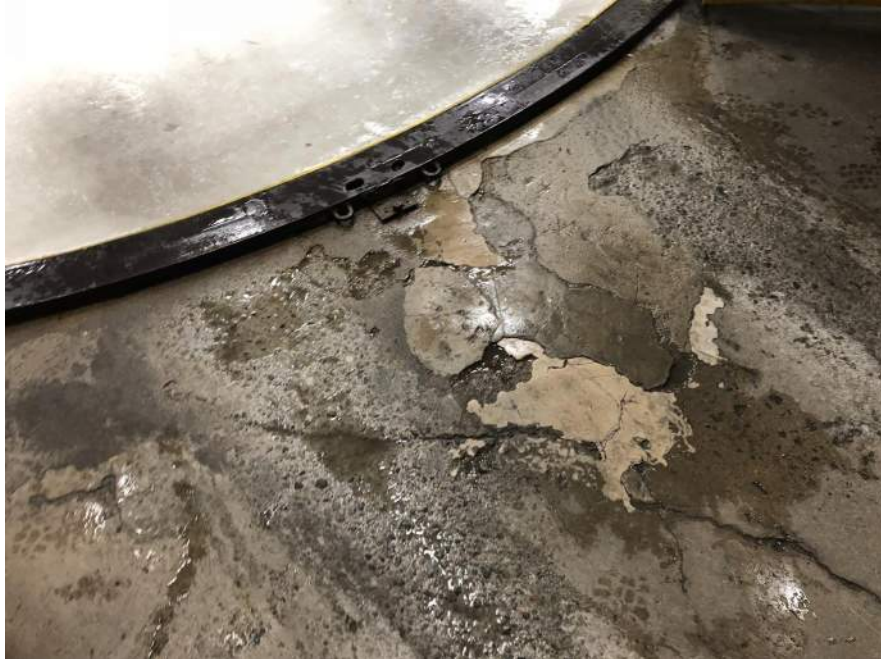
**Photograph 3 | Cracking and Delaminating Concrete adjacent to the Dasher Boards along the Ice Resurfacer Path (Southeast Corner of the Ice Rink)**

1. Based on our visual observations, the condition of the topping slab generally appeared to be in fair condition, with minor localized cracking and delamination. Deteriorated areas of the topping slab warrant localized repairs to mitigate further deterioration. Localized repairs to the topping slab will provide longevity to the topping slab and to original rink slab beneath. We recommend that localized repairs be performed within 3 to 4 years.

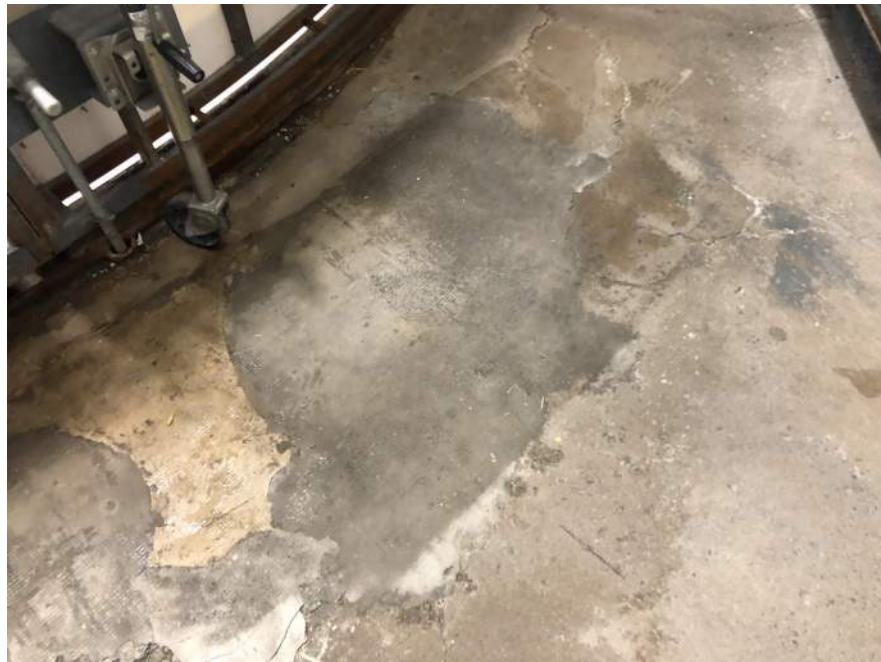
**Photograph 4 | Cracking and Delaminating Concrete adjacent to the Dasher Boards at the Alternate Ice Resurfacer Doors (Southwest Corner of the Ice Rink)**

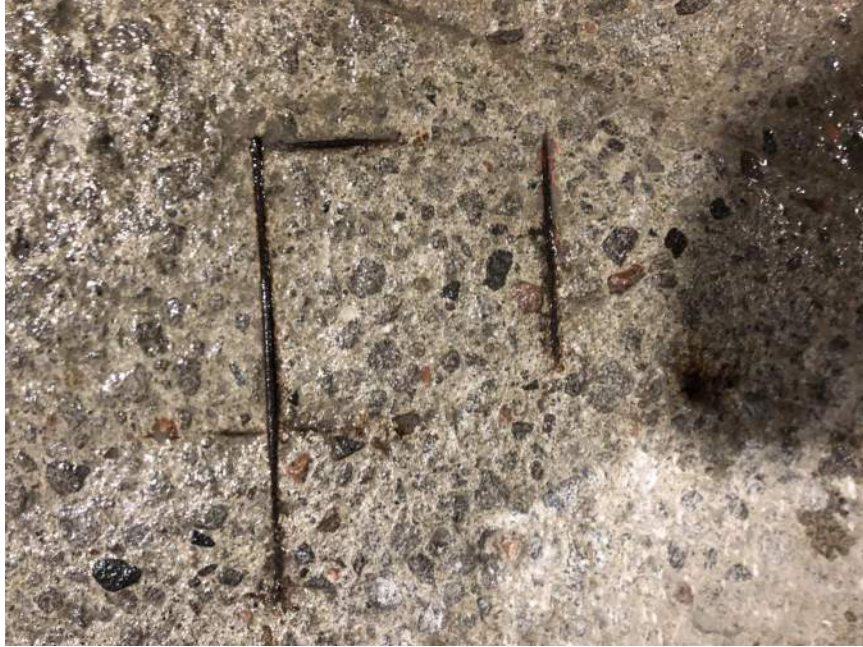
Photograph 5 | Exposed and Corroding Wire Mesh in the Topping Slab located along the Ice Resurfacer Path

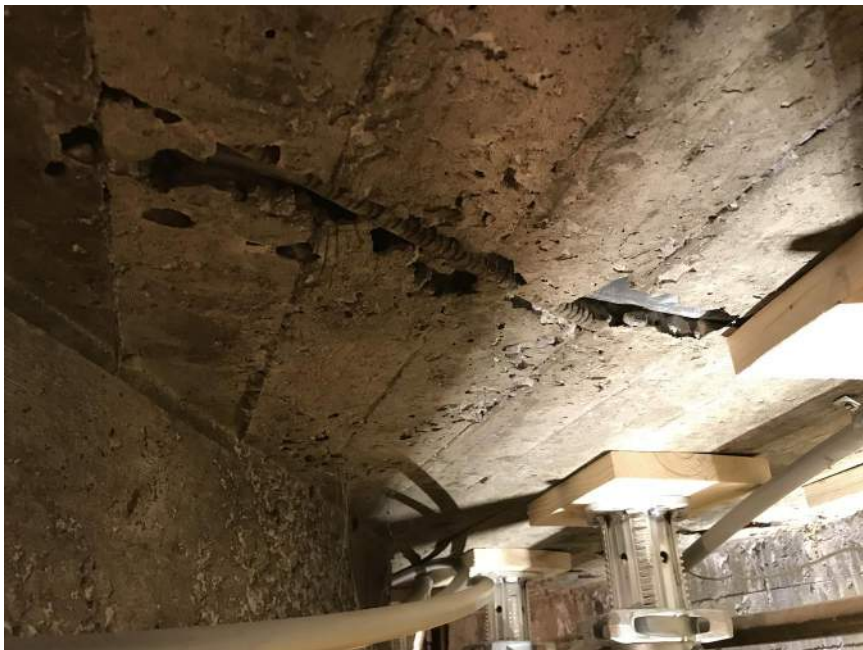
2. Extensive cracking, honeycombing, delamination and spalling was observed on the underside (soffit) of the original rink slab beneath the ice resurfacer path at the southeast corner of the ice rink. Pieces of fallen concrete and corroded reinforcing steel were observed at this location. Temporary shoring was observed at this location. See photographs 6 and 7.

Photograph 6 | Honeycombing and Exposed Conduit Pipe located on the Underside of the Existing Suspended Concrete Slab Beneath the Ice Resurfacer Path

3. Based on our visual observations and our review of the existing drawings and the investigation reports to date, the condition of the suspended concrete slab beneath the ice resurfacers path at the southeast corner of the ice rink is in poor structural condition and should be repaired. Extensive cracking, delamination and spalling of the underside (soffit) of the original 1955 rink slab was observed, and wide cracks were observed on the topside of the 1979 topping slab directly above this deteriorated area. We recommend that through slab concrete repairs be completed in this location as soon as possible. Given that this area is outside the ice rink area, the repairs can be done in the hockey offseason while still providing continued access to the rink slab during the lacrosse season. Drawing SK01 & SK02 in Appendix B indicate the area of the recommended through slab repair.

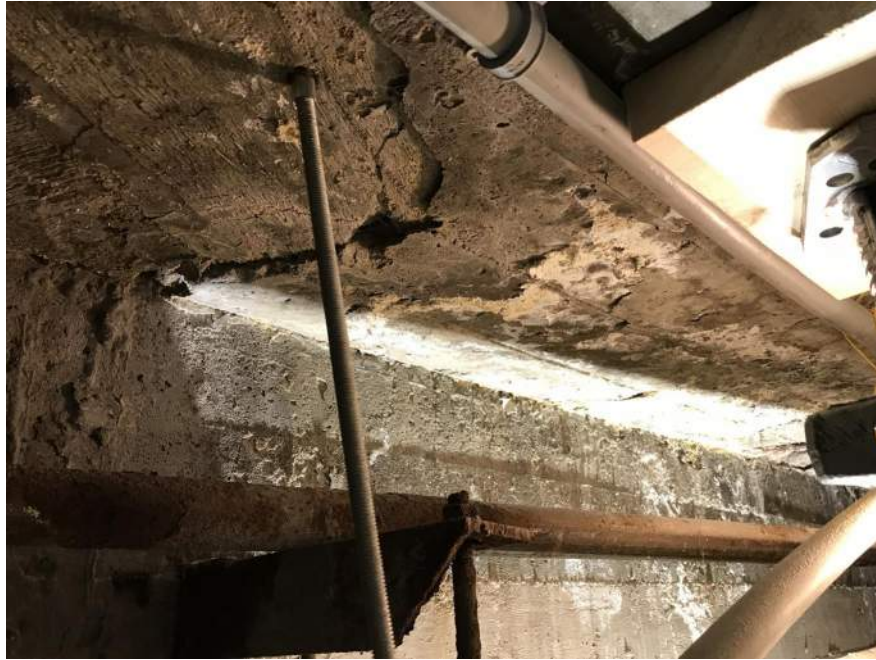
**Photograph 7 | Cracking located on the Underside of the Existing Suspended Concrete Slab Beneath the Ice Resurfacer Path**

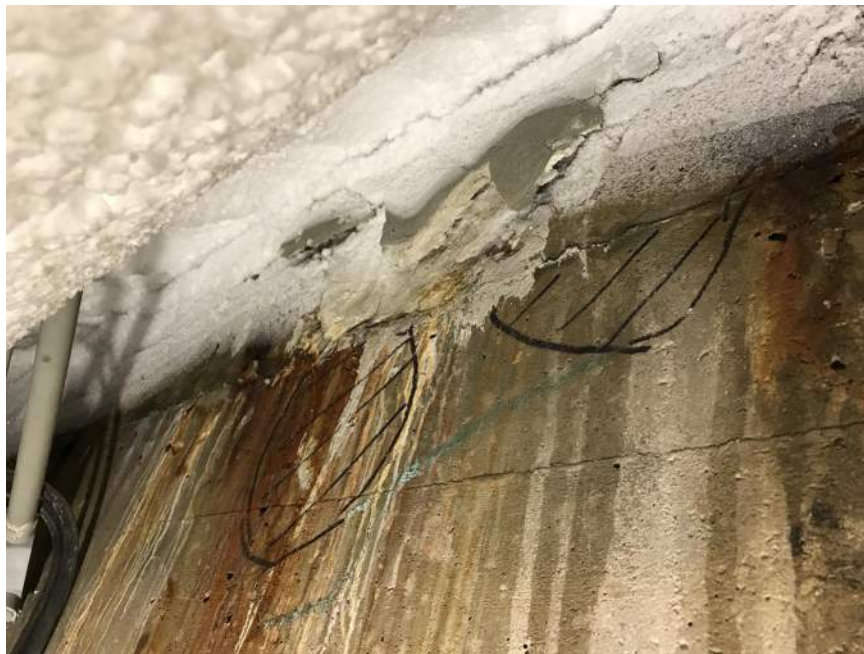
1. The north brine trench concrete foundation wall (Gridline 4x as noted on S-2 in the 2002 drawings) adjacent to the brine header pipes at the south end of the rink (beneath the dasher boards) was observed to be in poor condition. Entuitive's access at the time of review was limited to the south face of the wall since the crawlspace to the north of the wall had backfilled. Concrete deterioration was observed across the full length of the wall. Areas of cracking, freeze-thaw damage, spalling, and deteriorated concrete were observed, in addition to staining from corroding steel and water leaching. The condition of the top of the wall was not visible at the time of review due to the ice build-up around the brine header and feeder pipes. The condition of the concrete at the lower portions of the wall appeared to be sound, as was indicated in CSE's South Supporting Wall Delamination Survey Drawings SK1-01, dated July 12, 2017. See photographs 8 and 9.

1. The north concrete foundation wall beneath the dasher boards at the south of the ice rink was observed to be in poor condition and is a structural concern. Based on our field observations and our review of the existing drawings and the investigation reports we recommend that steps be taken as soon as possible to provide additional support to the original rink slab within the brine trench for the full extent of the north brine trench foundation wall.

**Photograph 8 | Spalled and Delaminated Concrete located towards the Top of the North Foundation Wall in the Brine Trench**

2. Given the extent of the wall deterioration observed and the limited accessibility to the north side of the foundation wall, it is our opinion, that the wall structure supporting the slabs cannot be effectively repaired with localized concrete wall repairs. A full replacement of the deteriorated foundation wall will come with the risk of damaging the current brine system and impacting the usefulness of the facility for both sports teams.

3. In lieu of a concrete wall repair procedure, it is our recommendation that a steel frame support system be installed to transfer the load from the slab to sound concrete at the bottom portion of the existing foundation wall and footing. A sketch detailing a proposed steel frame support system is included as drawing SK03 in Appendix B. The proposed steel framing will have to be installed during the summer months when ice buildup is not present on the brine header and feeder pipes. The existing slab will bear on steel sections that run perpendicular (north-south) to the trench foundation walls. These steel sections will have a slim profile and will be spaced to accommodate the brine headers and feeder pipes to ensure that the existing brine system is not modified during the work or after the work has been complete.

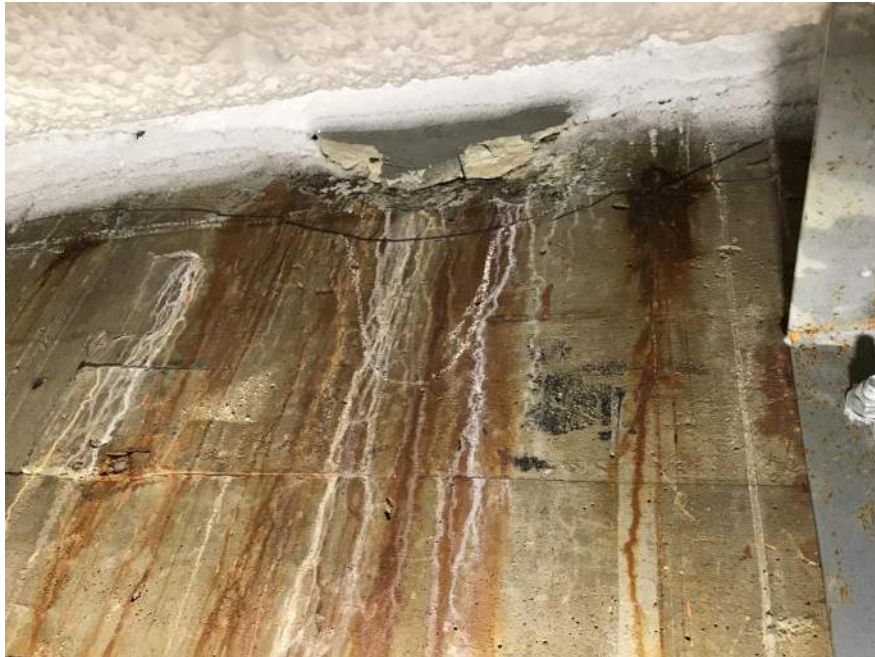
**Photograph 9 | Spalled and Delaminated Concrete located towards the Top of the North Foundation Wall in the Brine Trench**

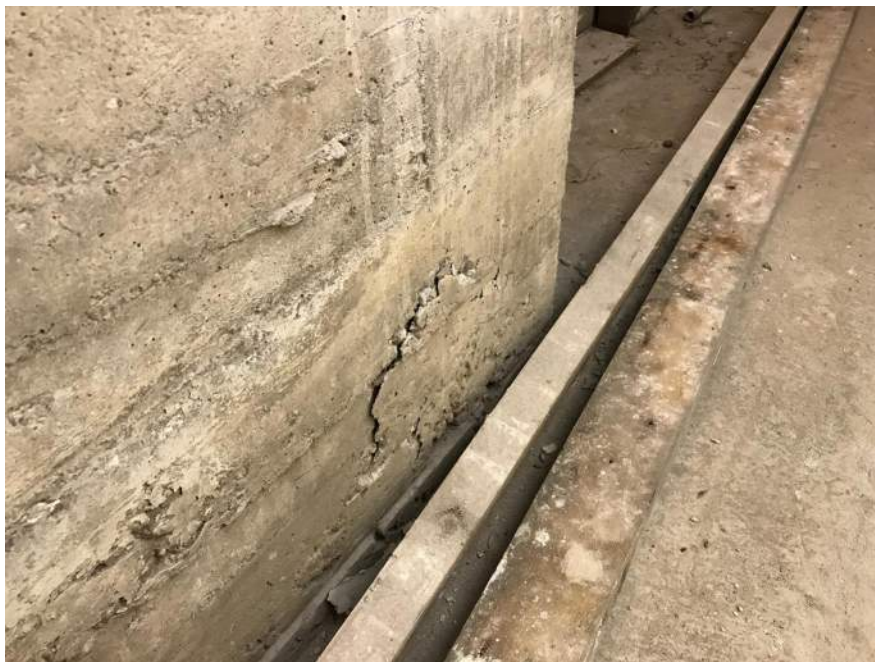
1. The north face of the south brine trench concrete foundation wall, located approximately 40 inches to the south of the north brine trench concrete foundation wall, was observed to be in fair condition. Concrete delamination and spalling at the bottom of the wall was observed. See photograph 10.

**Photograph 10 | Spalled and Delaminated Concrete located at the bottom of the South Foundation Wall in the Brine Trench**

1. Based on our visual observations and our review of the existing drawings and the investigation reports to date, the condition of the south foundation wall of the brine trench was observed to be in fair condition. Localized areas of delamination and spalling were observed along the bottom of the wall. We recommend that localized repairs be performed within 3 to 4 years.

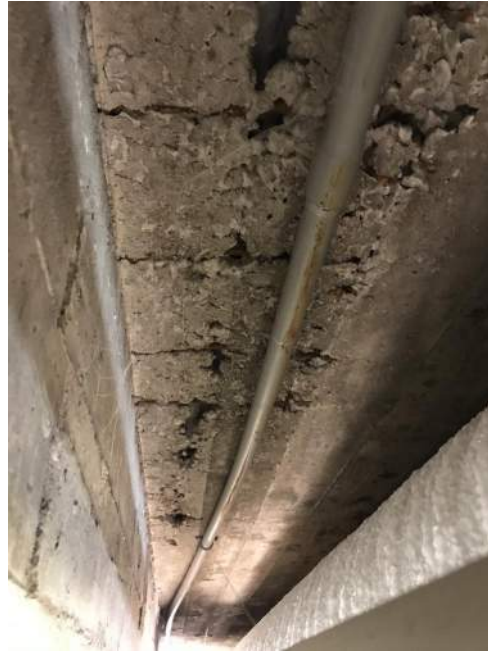
3. Extensive honeycombing was observed along the underside (soffit) of the original rink slab adjacent to the north face of the south brine trench concrete foundation wall. Exposed reinforcing bars were visible at the time of review and were observed to be lightly corroded. See photographs 11 and 12.

**Photograph 11 | Honeycombed Concrete and Exposed Reinforcing Bars along the Underside of the Existing Concrete Slab Adjacent to the South Foundation Wall in the Brine Trench**

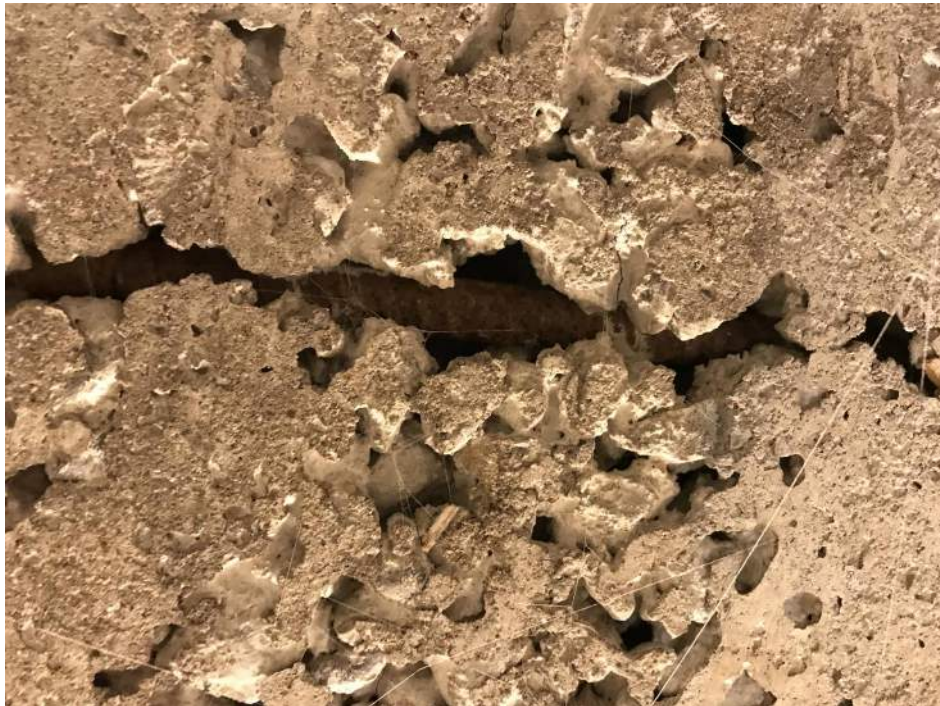
**Photograph 12 | Honeycombed Concrete and Exposed Reinforcing Bars along the Underside of the Existing Concrete Slab Adjacent to the South Foundation Wall in the Brine Trench**

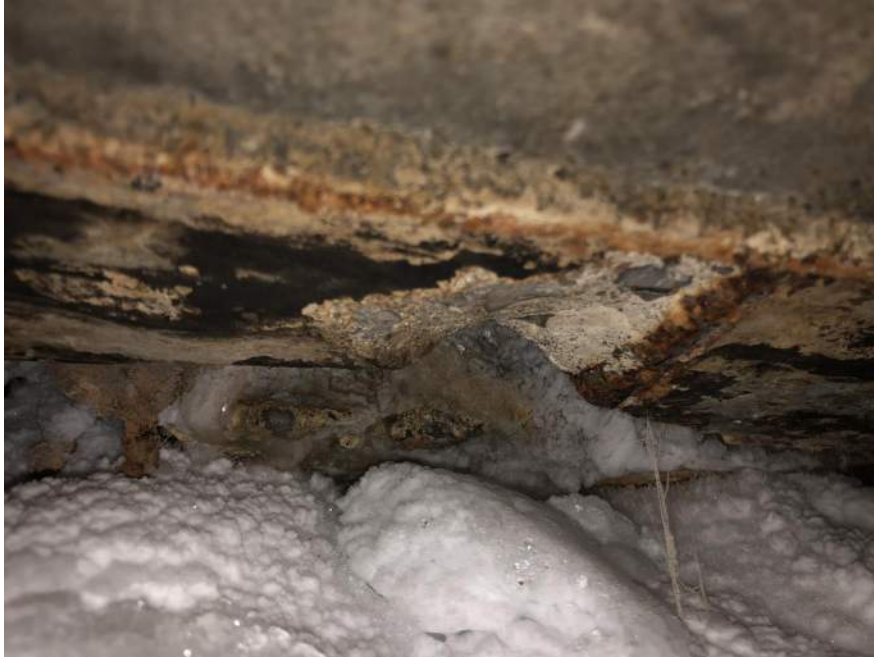
4. The condition of the underside (soffit) of the existing slab directly above the brine header and feeder pipes adjacent to the north brine trench foundation wall was not visible at the time of review. The build-up of ice around the pipes at this location made the underside (soffit) of the slab inaccessible. However, wooden formwork was observed on the underside of the slab at the locations where the feeder pipe penetrated the slab, as per CSE's structural updated report dated July 3, 2018. Where visible, the existing cast-in angle on the underside (soffit) of the suspended slab was observed to be severely

corroded. Honeycombed concrete and exposed corroded reinforcing steel were observed at these locations. See photographs 13 and 14.

**Photograph 13 | Corroded Cast-In Angle on the Underside of the Existing Suspended Slab adjacent to the North Foundation Wall in the Brine Trench**

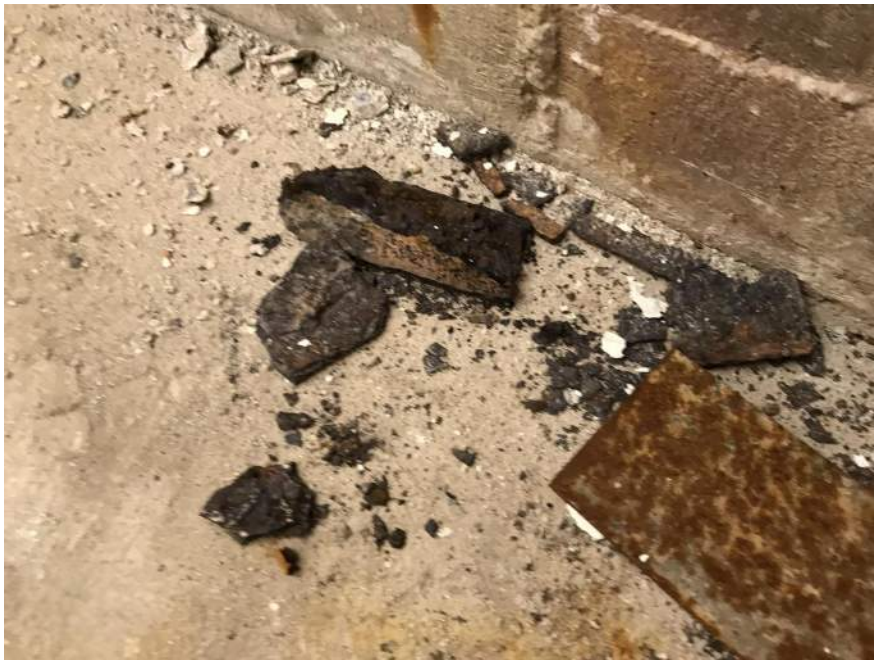
**Photograph 14 | Corroded Cast-In Angle Observed on the Crawlspace Floor below the Existing Suspended Slab adjacent to the North Foundation Wall in the Brine Trench**
