BUILDING CONDITION
ASSESSMENT REPORT

City Of Peterborough
The DelaFosse Library

Aug. 13th, 2021

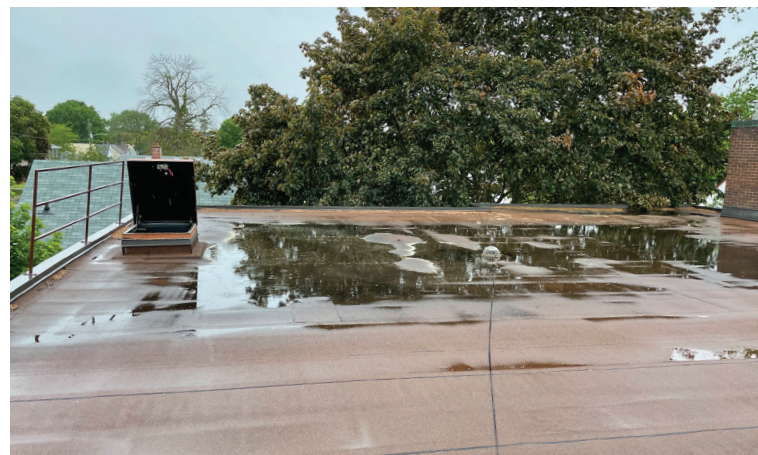
PHOTO NO. 15 /

The roof has a modified bitumen membrane which appears to be more than five years old but less than ten. It appears to have some service life remaining but is showing early signs of localized failure (a large area of insulation has lifted, for example). The amount of insulation below the roofing membrane was not determined, however there appears to be some, which would be expected based on the age of the work. The library likely has access to

these records. Regardless, reroofing with additional insulation would be the single most impactful upgrade to increase the thermal performance of the building. The roof enjoys easy access from the side parking area and the existing membrane will soon be due for replacement. There is no parapet or overhang so increasing the thermal insulation thickness, replacing the waterproof membrane, and treating the edge with prefinished metal coping is a simple and cost-effective approach to addressing thermal performance.

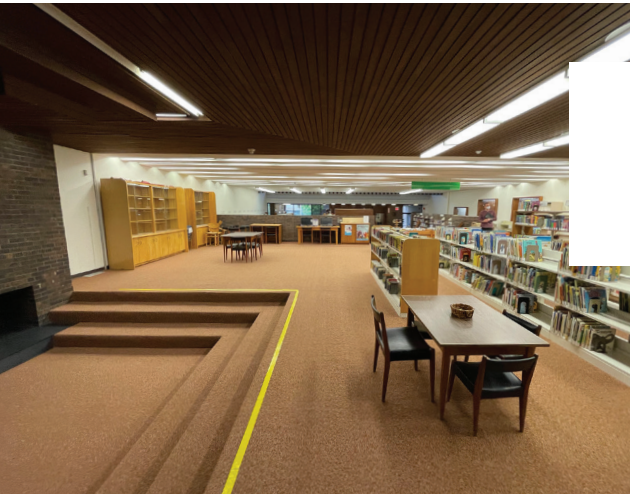
/ PHOTO NO. 05

At least a couple of details within the library share a likeness with other Zeidler buildings in Peterborough. The stepped gathering pit on the main floor is a storytelling place for children and youth. (see photo NO. 05) A similar architectural element can be found at the Cherney House on Roper Drive, also by Zeidler. The architectural motif of the cap on the book lift (see photo NO. 22) can be likened to the exterior frieze on the Beth Israel Synagogue, Weller St. (see photo NO. 24).

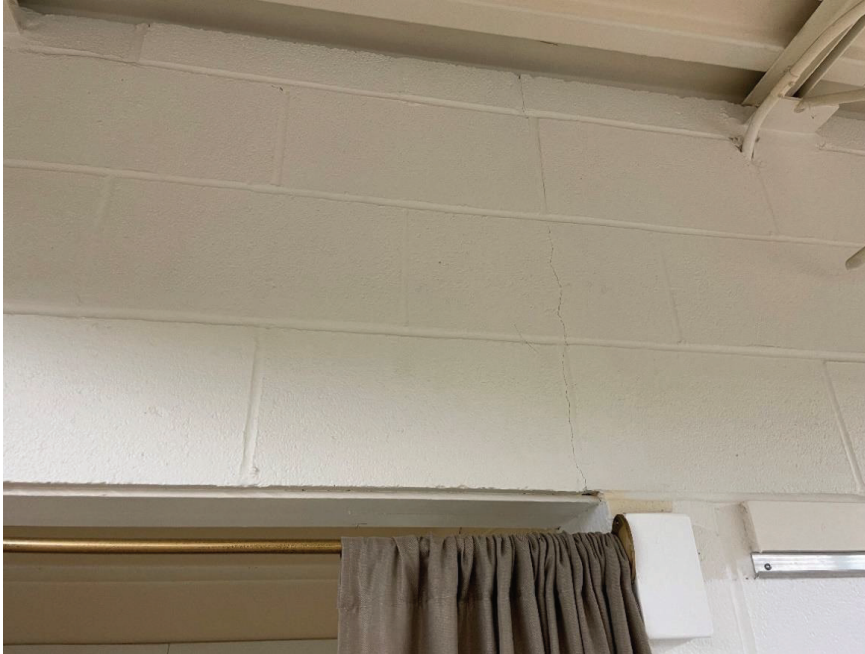
Basement walls where visible are generally in good condition. A vertical crack was noted in interior basement wall above the corner of the opening. (Photo #3)

Photo #3 – Vertical crack above corner of interior opening

2. We recommend that existing crack at the top of the opening in the basement shall be repaired by injecting grout into the voids and monitoring the area for development of any further cracks in the future. The crack appears to be stress crack and is probably due to overloading in the area.
3. Based on our visual inspection of exterior brick work mortar joints and bricks appear to be in good shape. We recommend re-pointing the localized weathered mortar joints to prevent any further deterioration. With regular inspection, the City can anticipate many more years of serviceable life from the exterior masonry.
4. We recommend that landscape retaining wall at the ramp area along with the lower section of the ramp be removed and re-constructed.

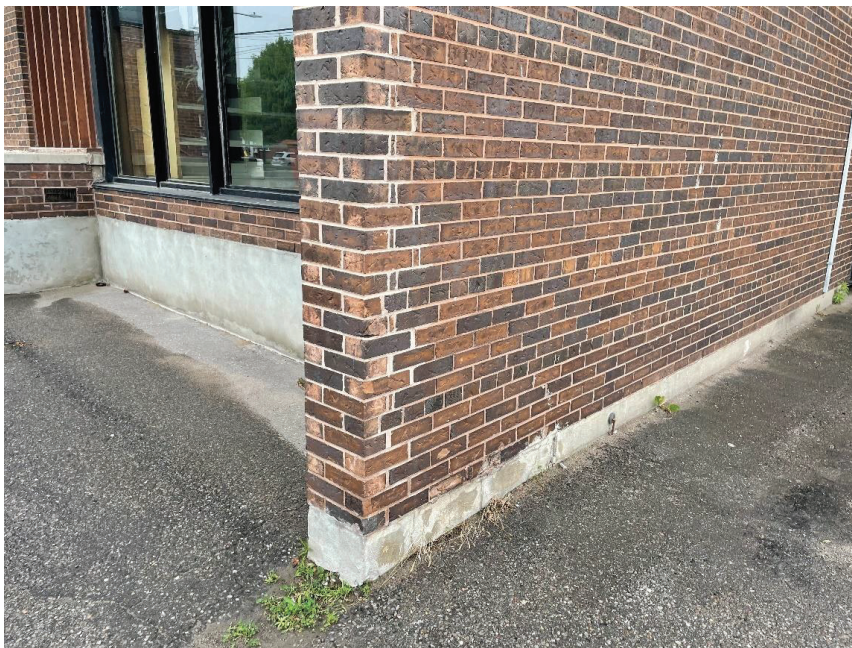
Exterior face brick (veneer) is generally in good condition. Mortar joints generally are to in good condition. (Photo #4)

Photo #4 – Brick at exterior elevation

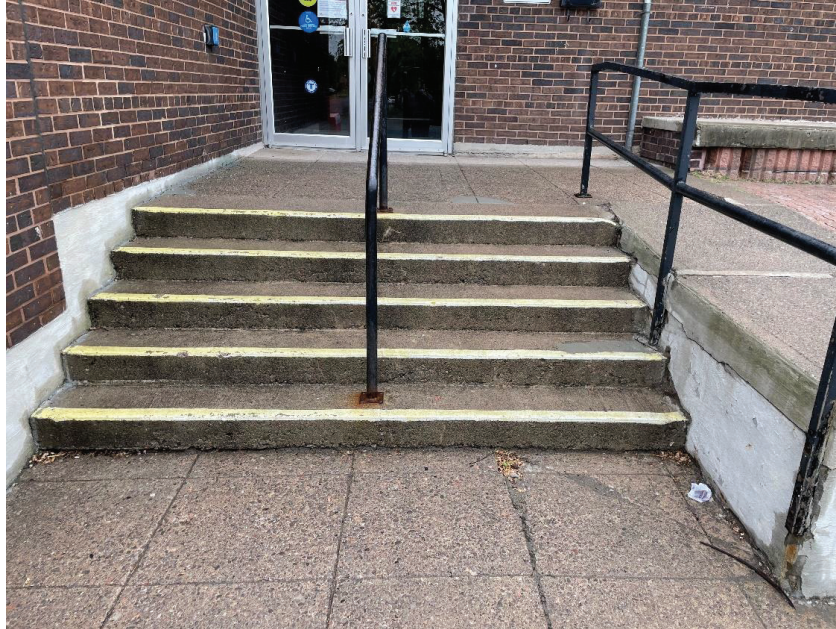
Exterior stair consists of reinforced concrete slab supported on block foundation walls. Exterior stairs are in fair condition with some minor cracking observed. It was noticed that some prior concrete patch work has been carried out at one of the steps. Some

corrosion is visible at the bottom of the metal railing located at the center of the stair and concrete has stained at few locations. (Photo #5)

Photo #5 – Exterior stair

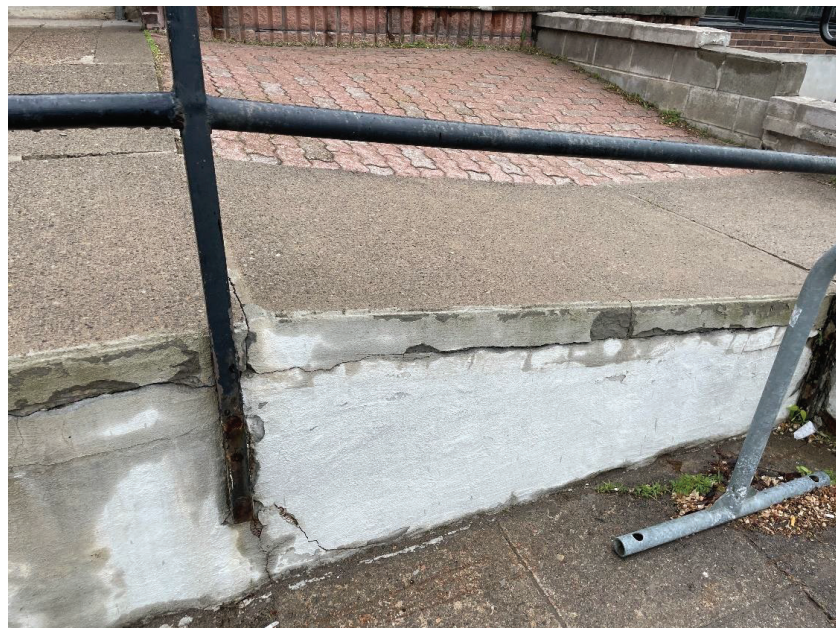
Exterior ramp slabs appear to be solid concrete panels approximately 6" thick on grade with masonry retaining walls at one end for grade difference. Some concrete panels have experienced cracking. Steel railing posts are anchored to the side of the foundation wall/slab. Generally, cracks and concrete spalling can be observed at all railing post locations. Existing retaining wall on north side of ramp has experienced extensive cracks and splitting closer to the grade level. (Photo #6-8)

Photo #6 – Exterior ramp

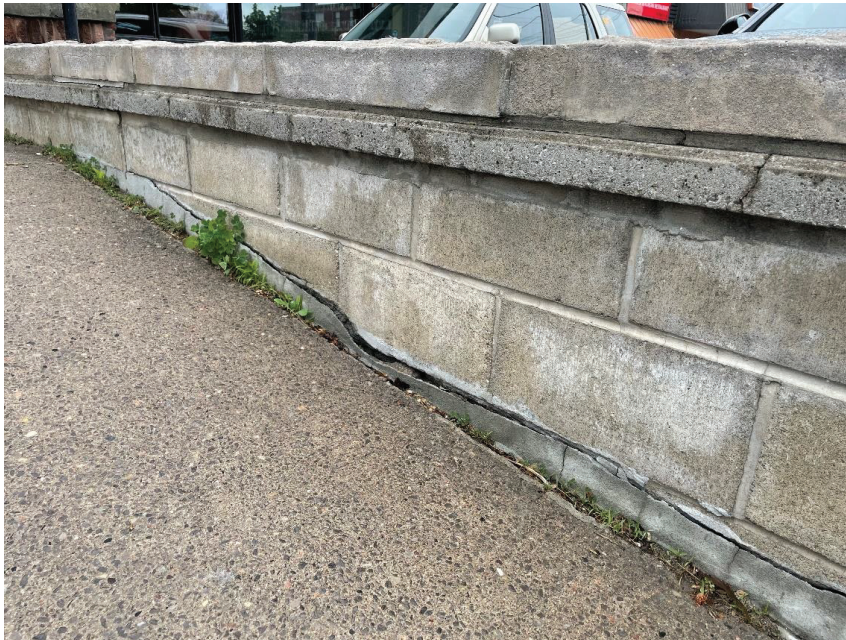
Photo #7 – Ramp retaining wall

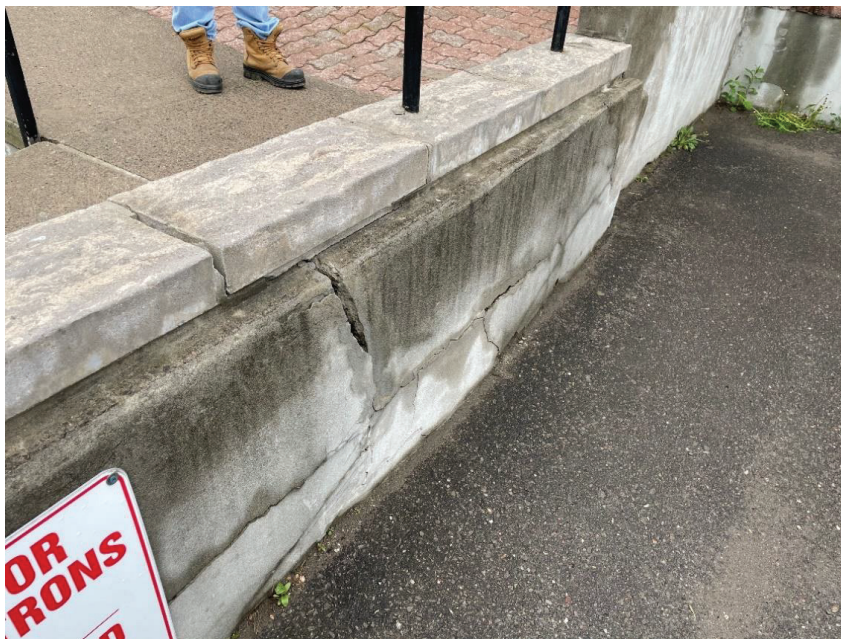
Photo #8 – Ramp retaining wall

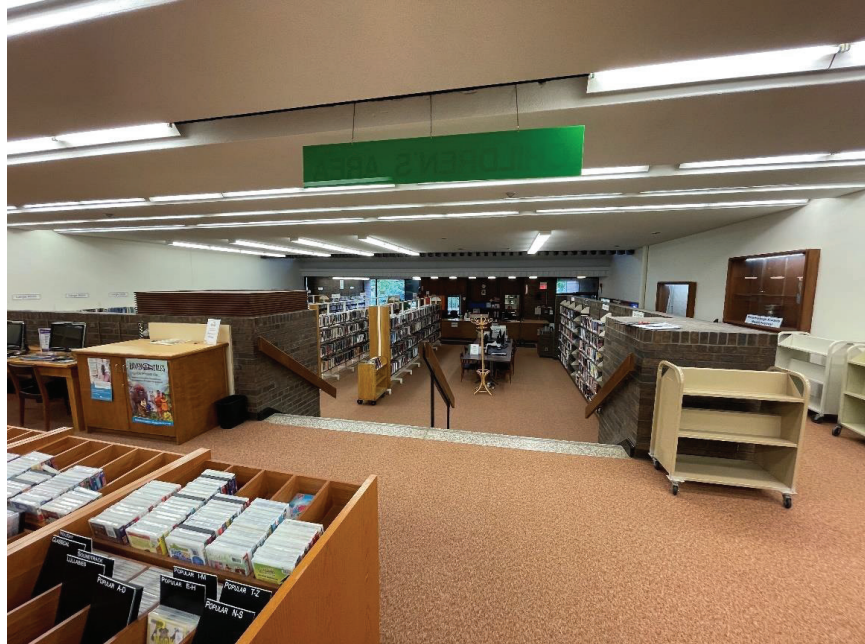
Ground floor structure appears to be in reasonably good condition although library staff has noted some vibration in the floor at the Adult library area which currently is where the book stacks are located.

Normally if the existing structure is undersized for strength, it would also be undersized to meet the serviceability requirements therefore larger than allowable deflection could be the cause of the vibration issues observed.

Photo #9 – Existing ground floor

We recommend that existing loading at the stack area be reduced immediately within the allowance of 60 psf which the floor is currently designed for.
