**SOUTH SUPPORTING WALL:
REVIEW NO.1 (JUNE 23, 2017)
BASE LINE REVIEW**

MEMORIAL CENTRE, PETERBOROUGH (ON)

**PREPARED FOR
THE CITY OF PETERBOROUGH
BY
CARVAJAL STRUCTURAL ENGINEERS INC.**

CSE PROJECT-1897a.17

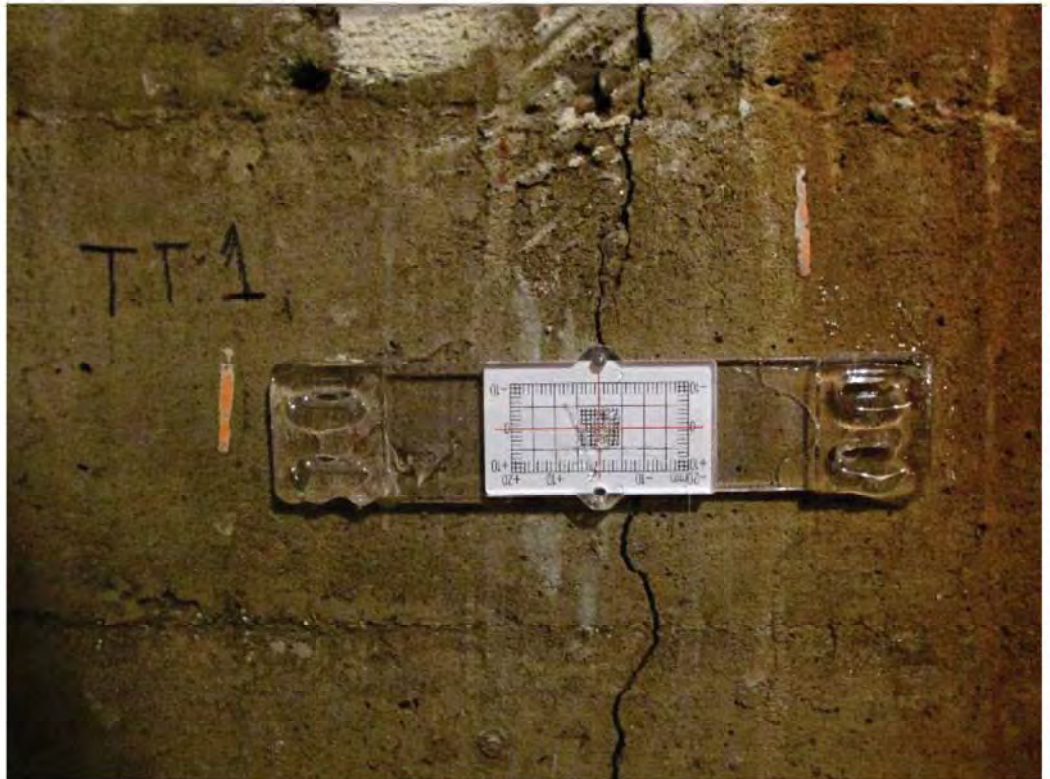
PHOTOGRAPH NO.1

- ▶ Tell-Tale Marker 1
- ▶ Location: Grid Line 10
- ▶ Comments: Crack Width is Wide.

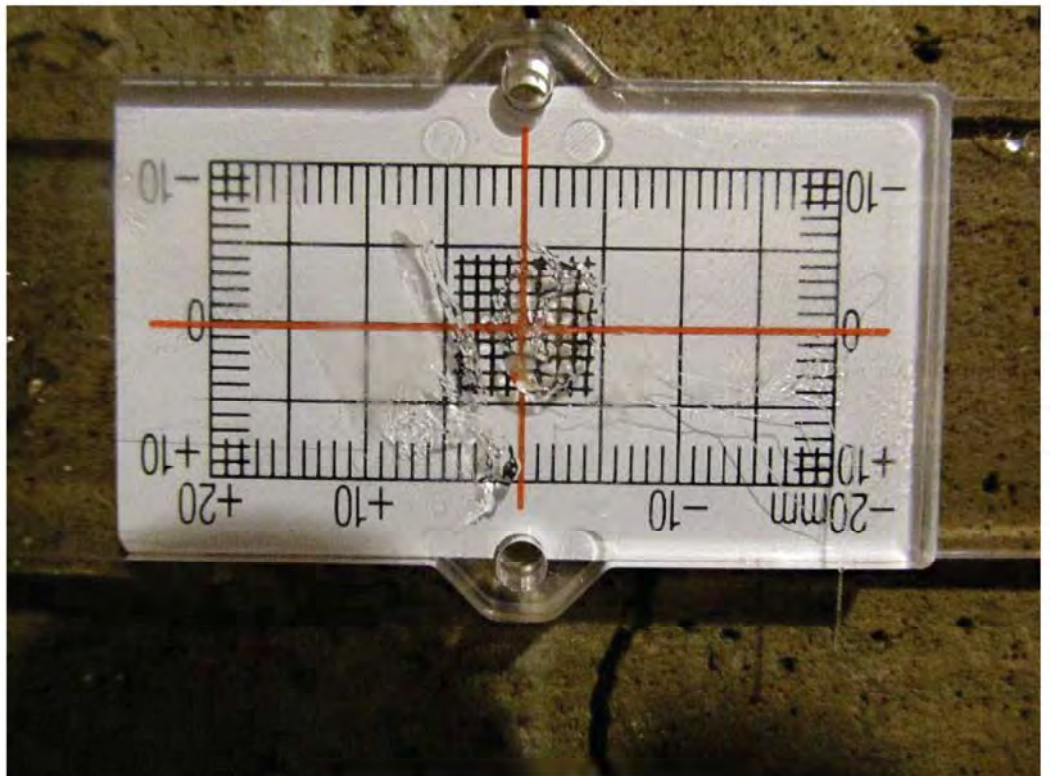
PHOTOGRAPH NO.2

- ▶ Tell-Tale Marker 1
- ▶ Location: Grid Line 10
- ▶ Comments: Initial Crack Width Reading of "0",

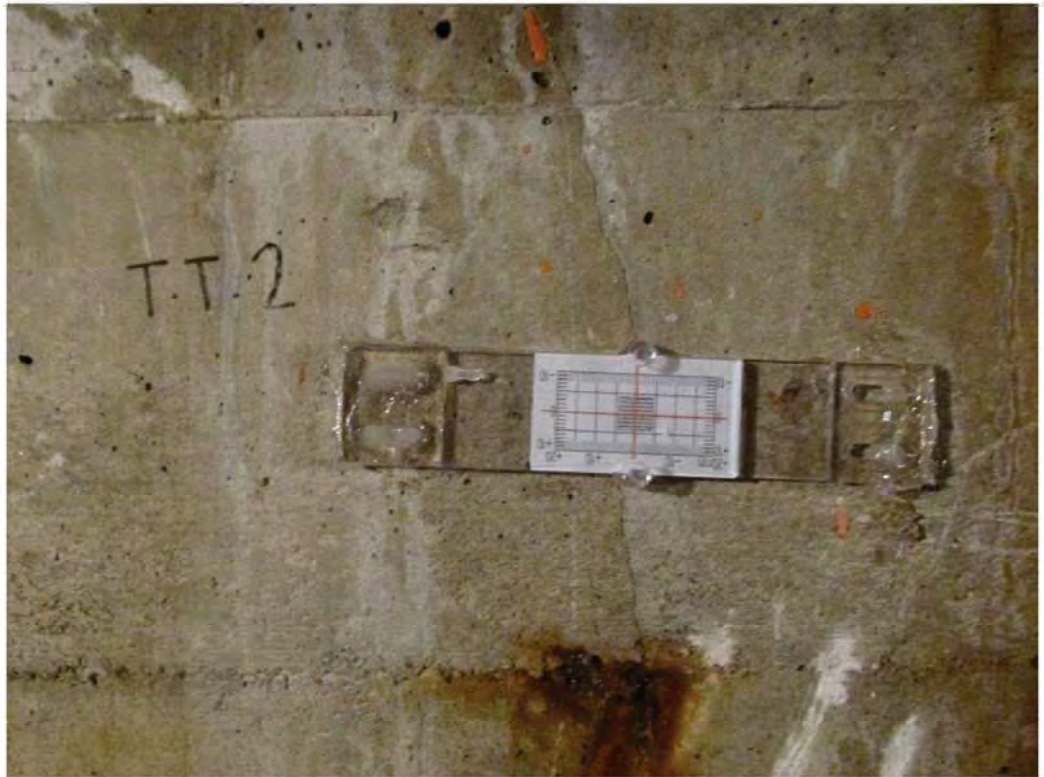
PHOTOGRAPH NO.3

- ▶ Tell-Tale Marker 2
- ▶ Location: Between Grid Line 14 & 15
- ▶ Comments: Crack Width is Medium.

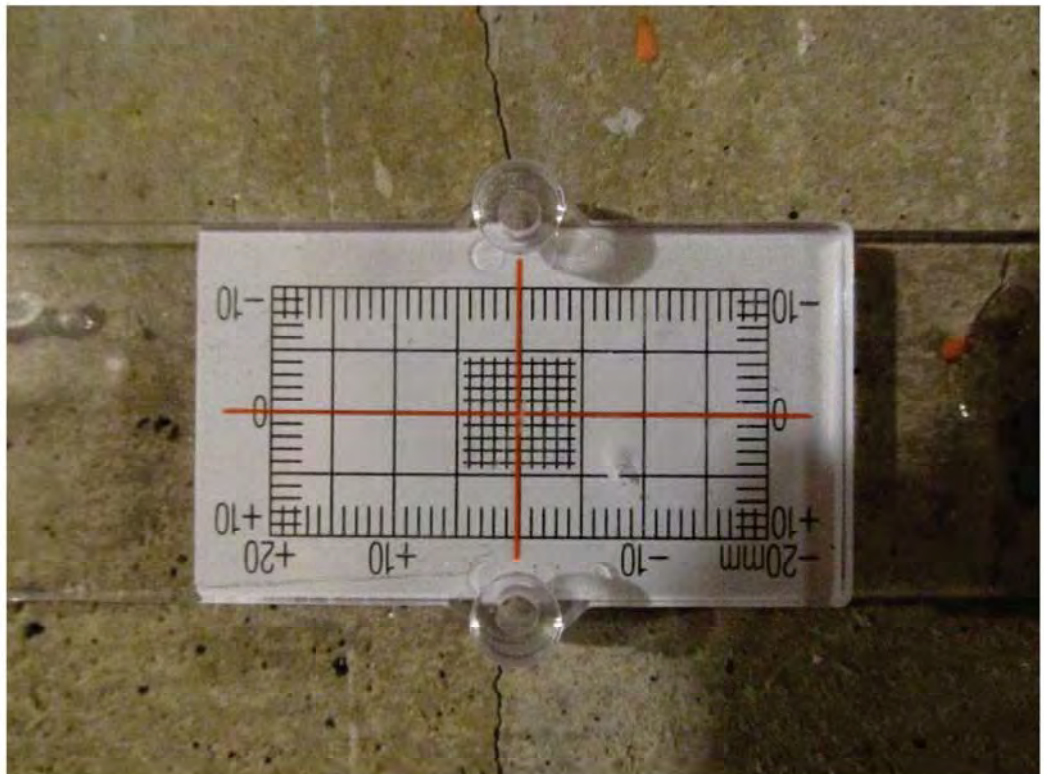
PHOTOGRAPH NO.4

- ▶ Tell-Tale Marker 2
- ▶ Location: Between Grid Line 14 & 15
- ▶ Comments: Initial Crack Width Reading of "0".

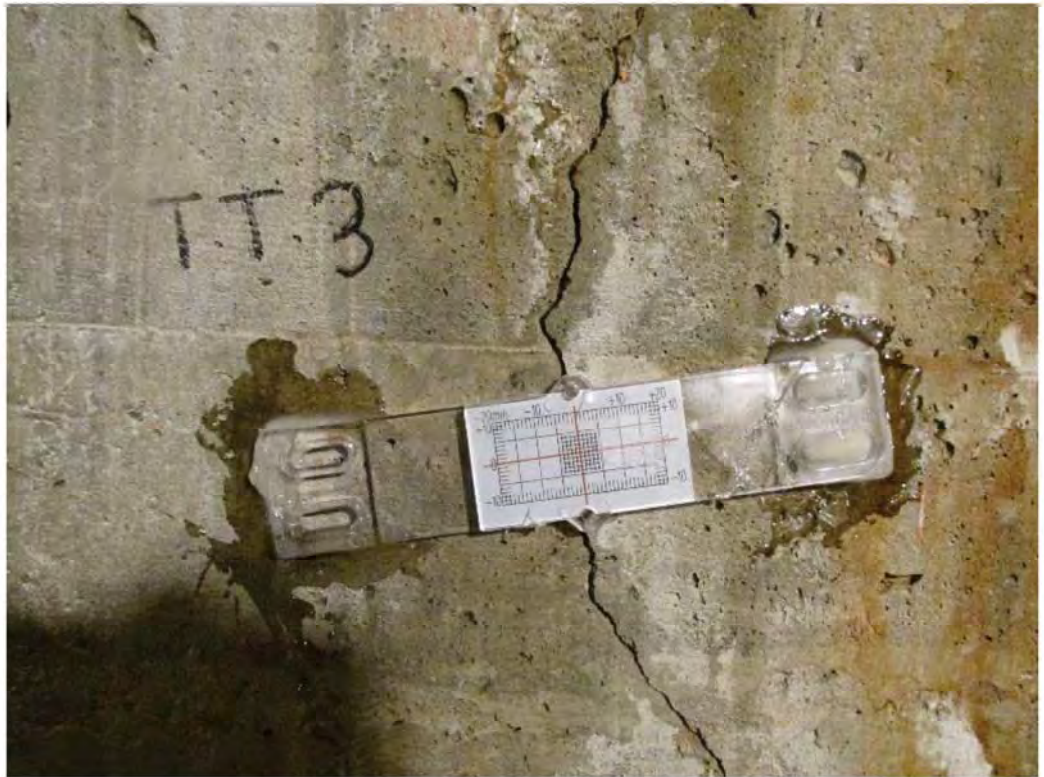
PHOTOGRAPH NO.5

- ▶ Tell-Tale Marker 3
- ▶ Location: Grid Line 19
- ▶ Comments: Crack Width is Wide.

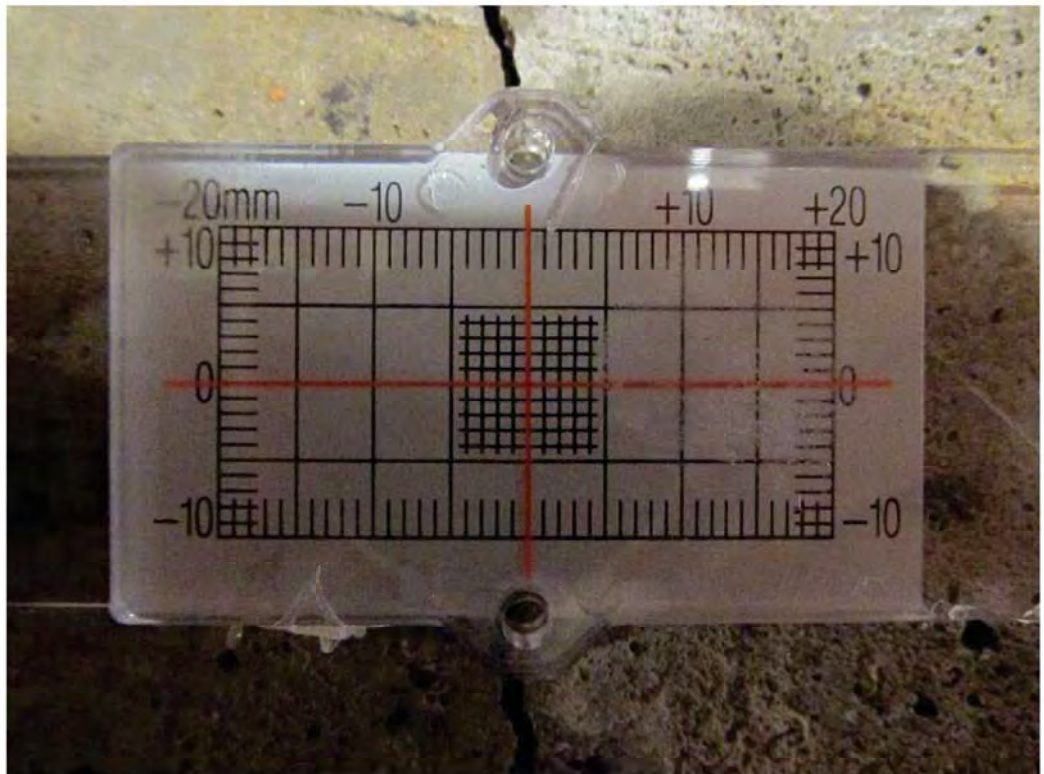
PHOTOGRAPH NO.6

- ▶ Tell-Tale Marker 3
- ▶ Location: Grid Line 19
- ▶ Comments: Initial Crack Width Reading of "0",

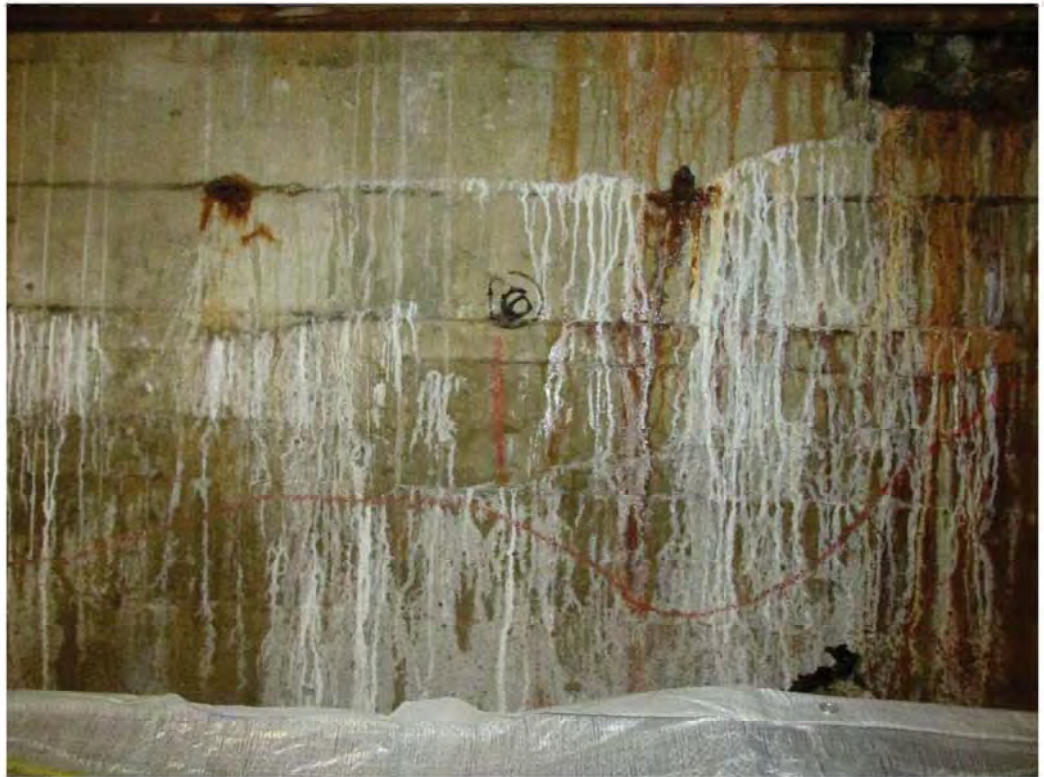
PHOTOGRAPH NO.7

As well, evidence of severe water leakage and efflorescence was typically noted along the length of the wall.

- ▶ Inside Face of Wall
(North Face)
- ▶ Location: Grid Line 6
- ▶ Comments: Typical
Condition of Severe
Efflorescence and
Medium Water Staining.

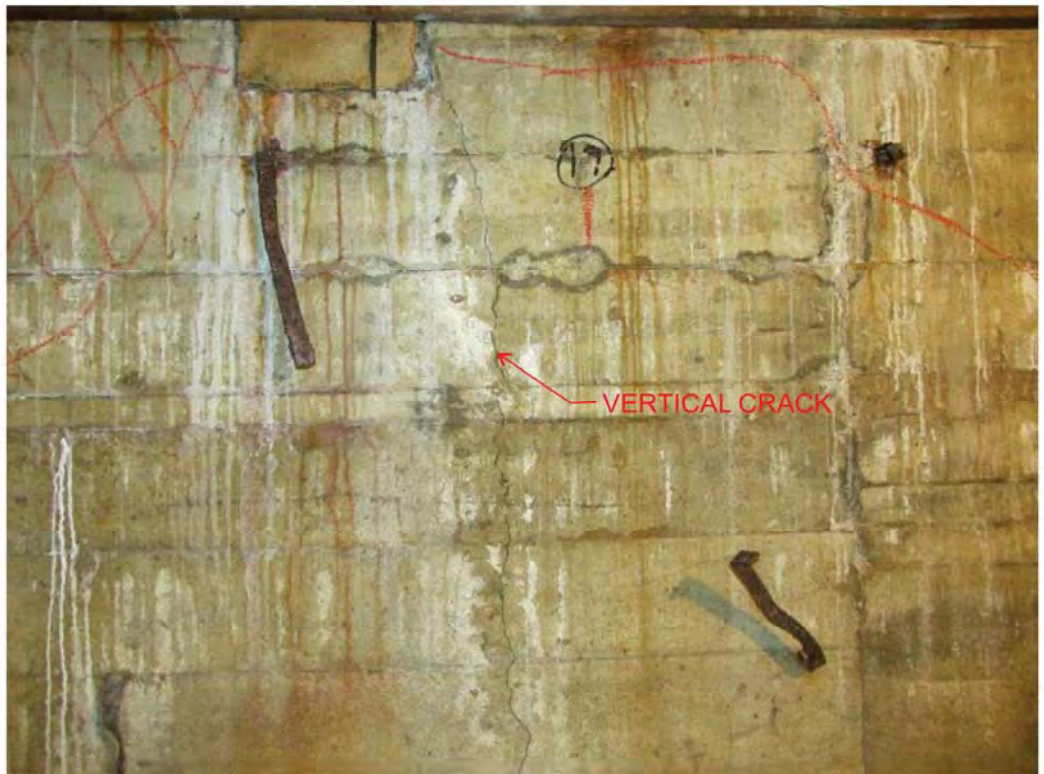
PHOTOGRAPH NO.8

- ▶ Inside Face of Wall
(North Face)
- ▶ Location: Grid Line 19
- ▶ Comments: Vertical
Crack in Wall and Typical
Water Staining &
Efflorescence.

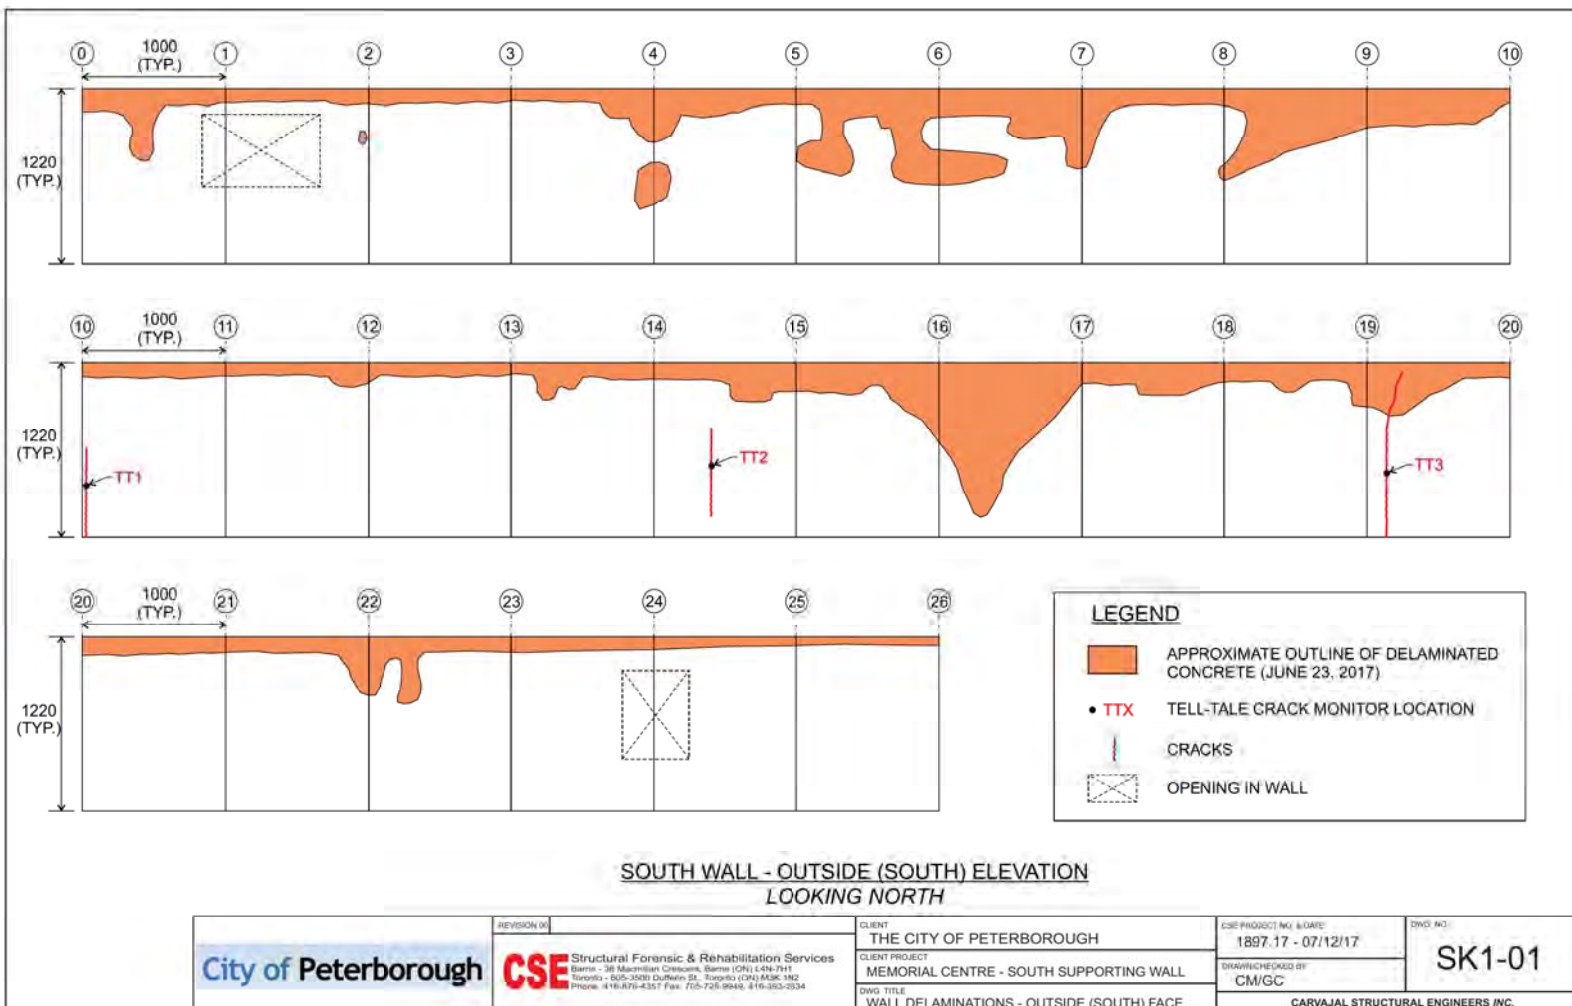
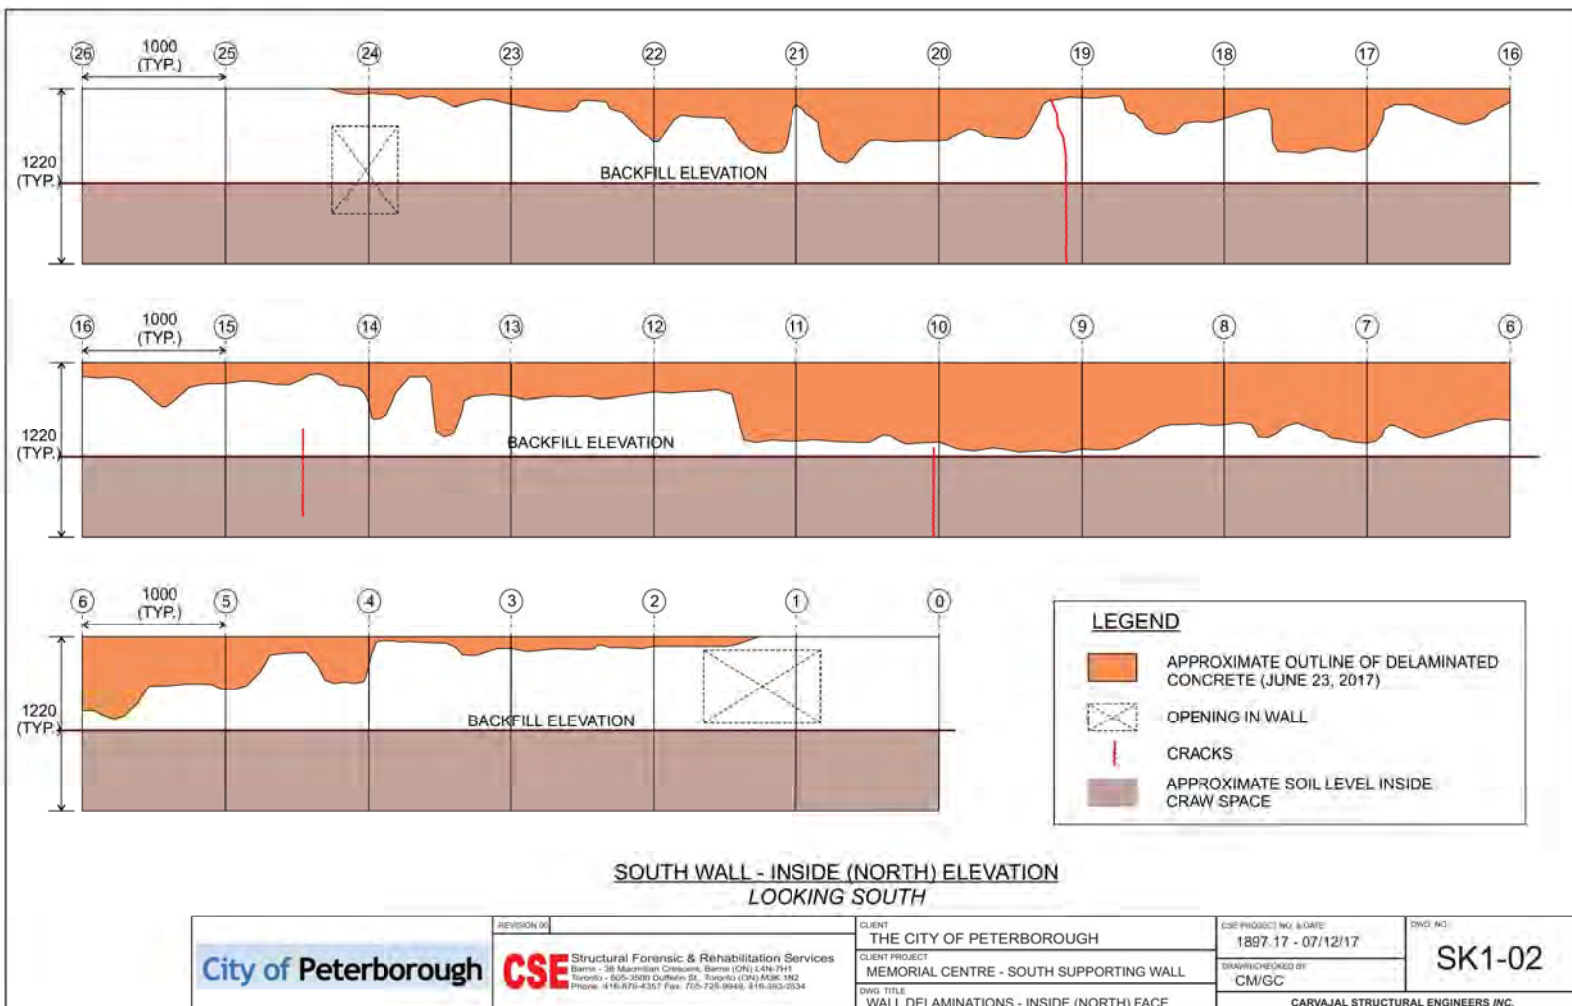
CSE BASE LINE DELAMINATION SURVEY (SK1-01 and SK1-02)

In general, a large area of hollow sounding concrete was identified along the complete length of the wall. The majority of the delaminations were found along the top portion of the wall, on both the interior and exterior faces. Typically the top 12" of the wall was found to be severely

delaminated. In many locations the area of delaminated concrete extended down towards the base of the wall.

See SK1-01 and SK1-02 in Appendix C for the locations of the delaminated areas and areas of structural concern.

The existing limits of delaminated concrete have been outlined and recorded. In the following monthly reviews a secondary hammer tap survey shall be performed around the perimeter of the noted delaminated areas to determine if the limits of the delaminated concrete are increasing.
