**STRUCTURAL UPDATED REPORT  
SOUTH SUPPORTING ICE RINK WALL  
MEMORIAL CENTRE, PETERBOROUGH (ON)**

**PREPARED FOR  
THE CITY OF PETERBOROUGH  
BY  
CARVAJAL STRUCTURAL ENGINEERS INC.**

**CSE PROJECT-2022.18**

JUNE, 2018

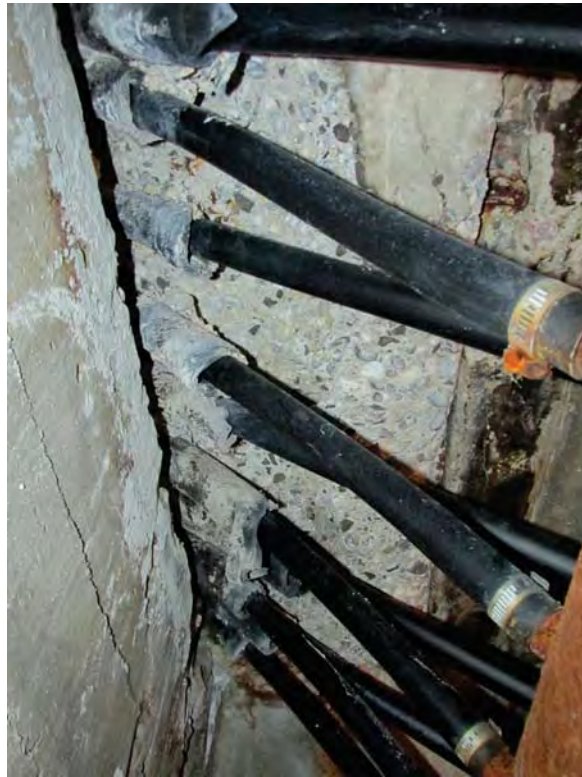
**PHOTOGRAPH NO.1**

- ▶ Test Area No.1
- ▶ Location: Between Grid Line 25-26 Outside Wall Face, Top of Wall
- ▶ Comments: No concrete removed by CSE. Concrete observed to be gravelly and crumbled easily. Depth of frost damage exceeded 80mm. Actual depth of damage not confirmed.

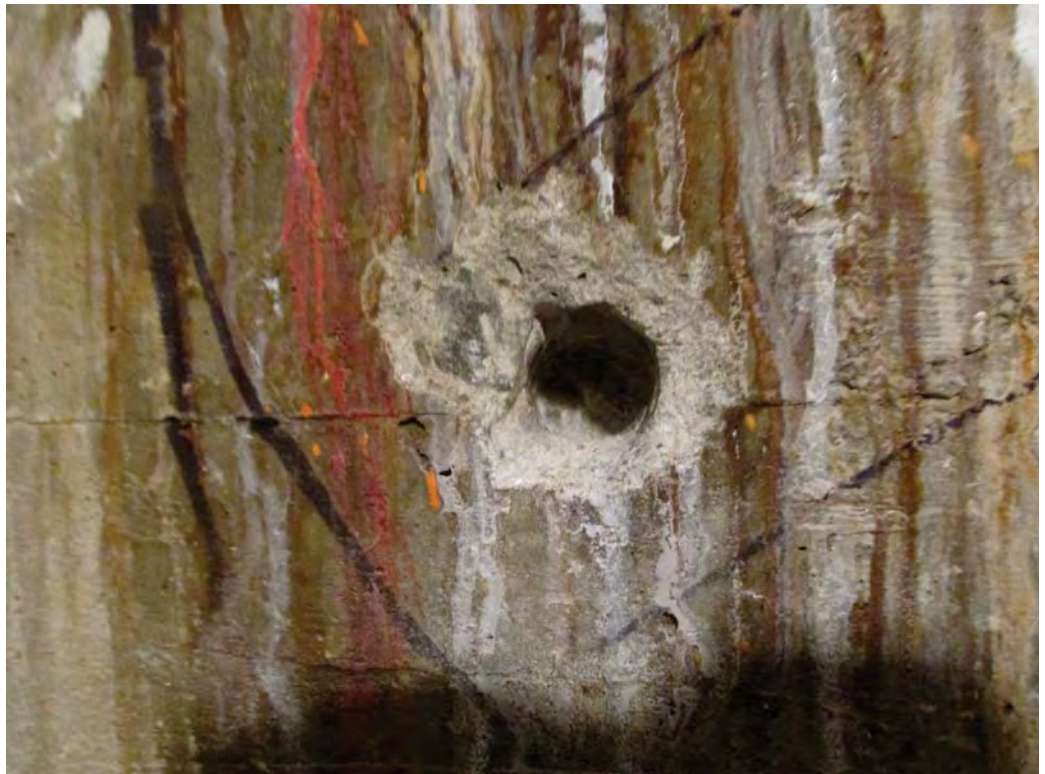
**PHOTOGRAPH NO.2**

- ▶ Test Area No.2
- ▶ Location: Grid Line 6 Outside Wall Face
- ▶ Comments: Drill used to remove damaged concrete to a level of sound concrete. Depth of damage approximately 65mm.

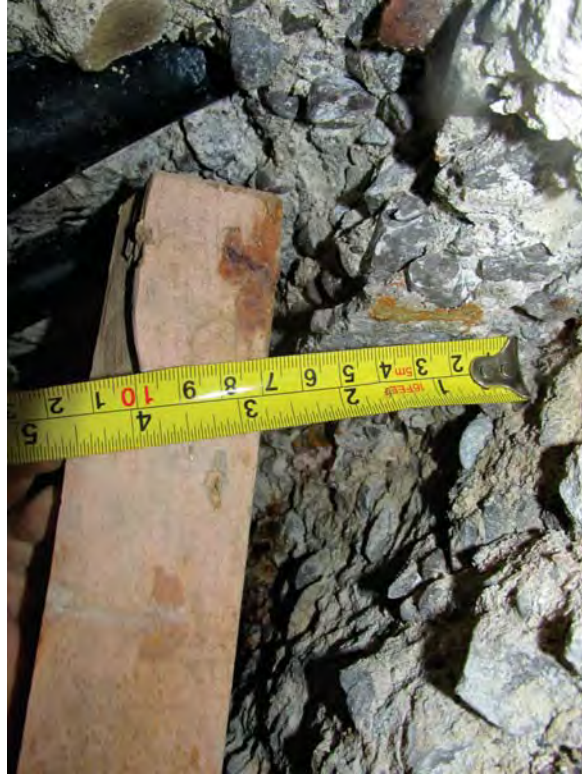
**PHOTOGRAPH NO.3**

- ▶ Test Area No.3
- ▶ Location: Grid Line 3  
Outside Wall Face, Top of Wall
- ▶ Comments: Chipping hammer used to remove loose concrete.  
Approximate depth of 70mm frost damaged concrete.

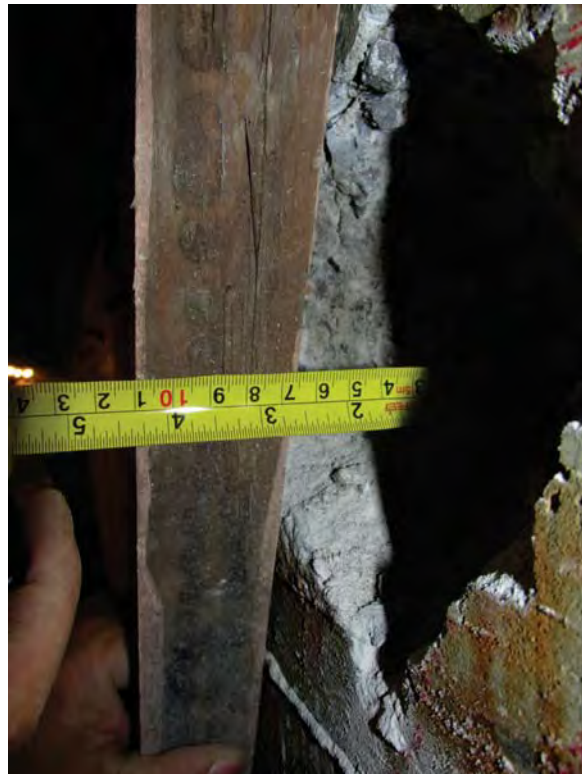
**PHOTOGRAPH NO.4**

- ▶ Test Area No.4
- ▶ Location: Between Grid Line 4-5 Inside Wall Face
- ▶ Comments: Chipping hammer used to remove damaged concrete to depth of sound concrete.  
Approximately 70mm depth to level of sound concrete.

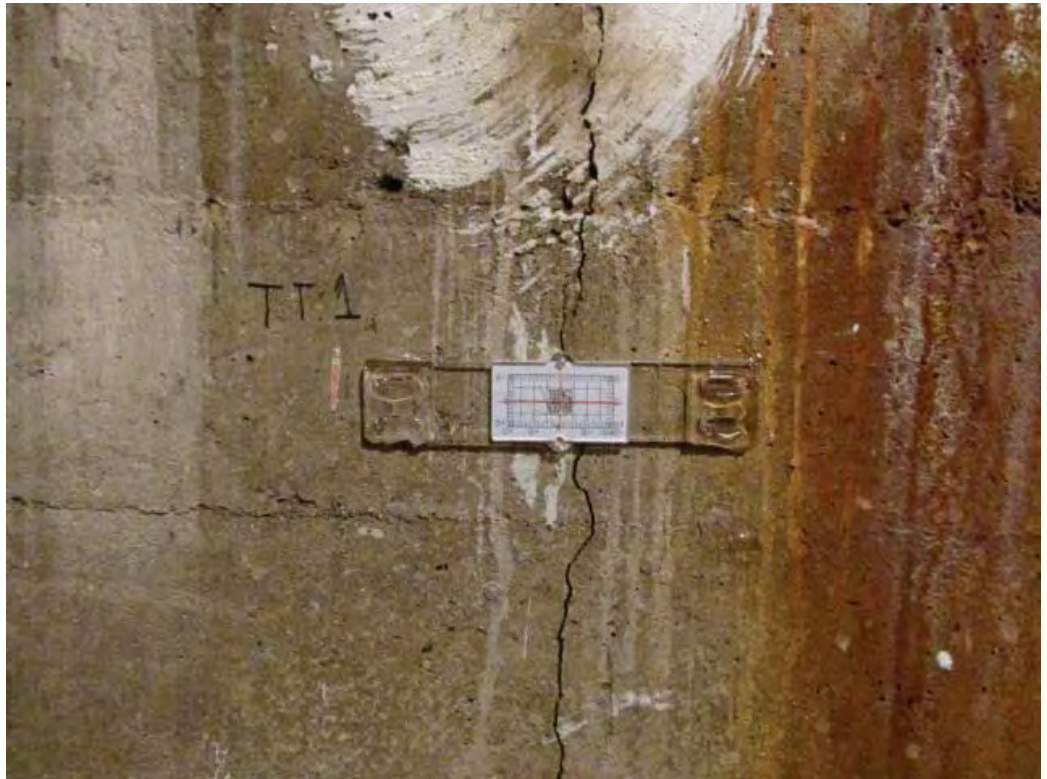
***PHOTOGRAPH NO.1***

- ▶ Tell-Tale Marker 1
- ▶ Location: Grid Line 10
- ▶ Comments: Crack Width is Wide.

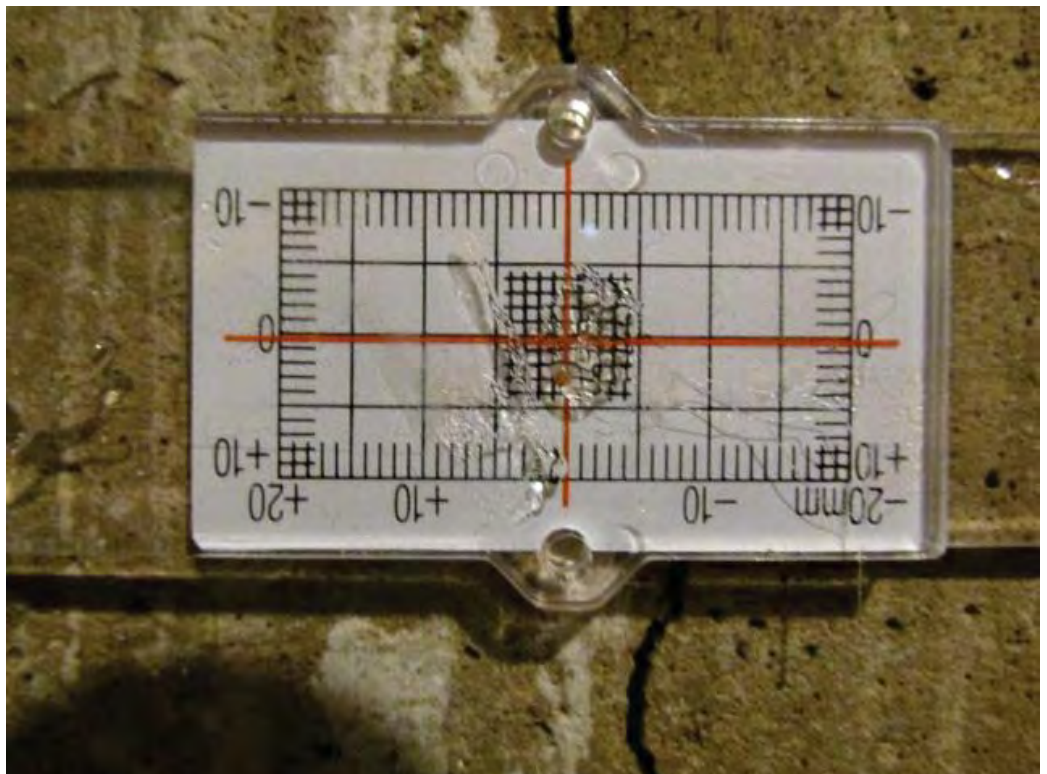
***PHOTOGRAPH NO.2***

1. The tell-tale crack monitors were reviewed to see if there has been any movement and/or crack growth. No changes were noted at Tell-Tale Markers No.2 and No.3. However, a small vertical change in the reading of Marker No.1 was observed. No concerns with this degree of movement are expressed at this time, and we will continue to monitor the crack growth at these locations at the subsequent monthly reviews. Please refer to the Photo Log for photographs of the Tell-Tale readings.

- ▶ Tell-Tale Marker 1
- ▶ Location: Grid Line 10
- ▶ Comments: Small Vertical Movement

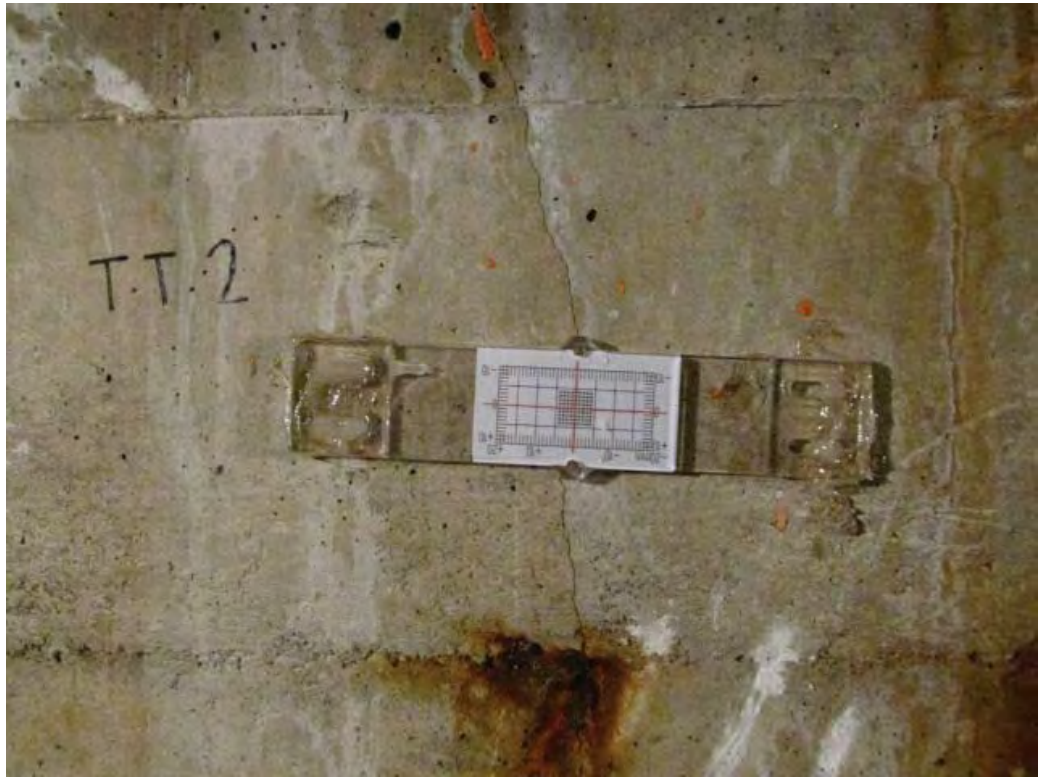
**PHOTOGRAPH NO.3**

- ▶ Tell-Tale Marker 2
- ▶ Location: Between Grid Line 14 & 15
- ▶ Comments: Crack Width is Medium.

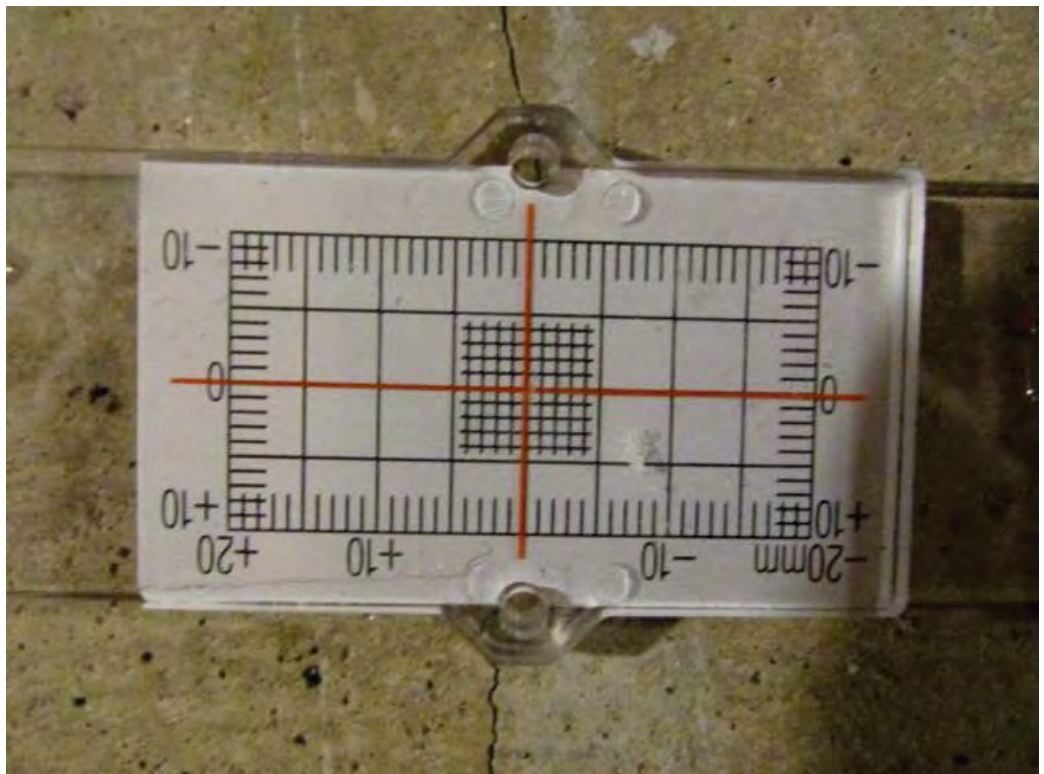
**PHOTOGRAPH NO.4**

- ▶ Tell-Tale Marker 2
- ▶ Location: Between Grid Line 14 & 15
- ▶ Comments: No Movement (Reading of 0)

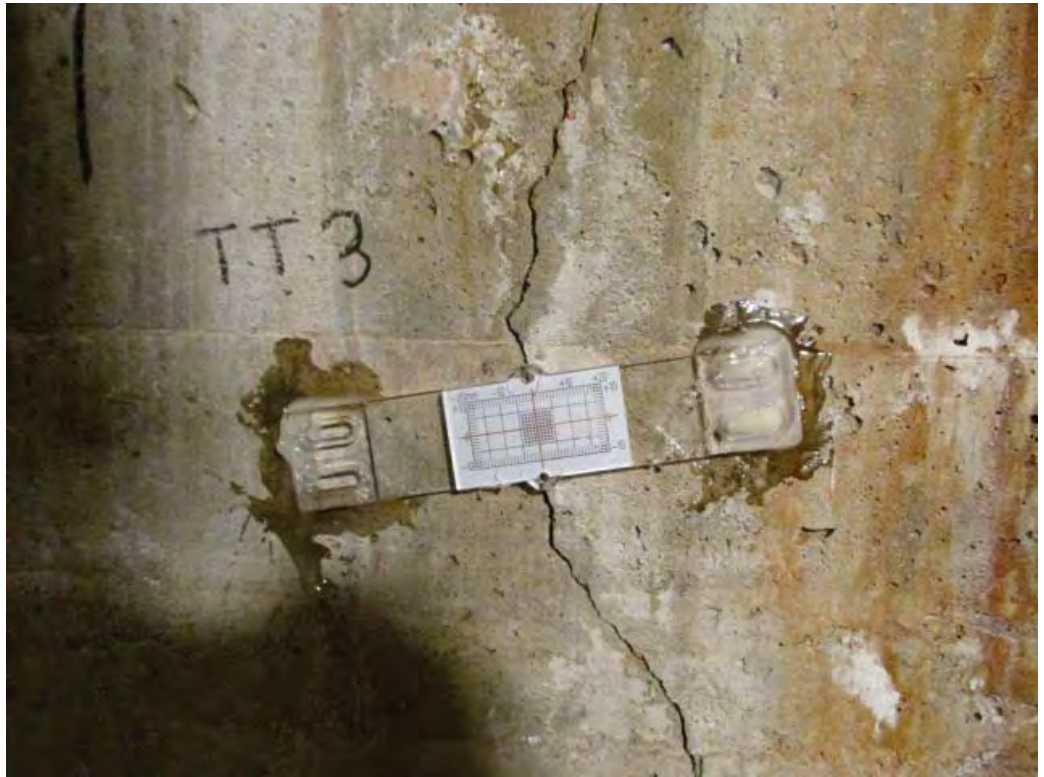
**PHOTOGRAPH NO.5**

- ▶ Tell-Tale Marker 3
- ▶ Location: Grid Line 19
- ▶ Comments: Crack Width is Wide.

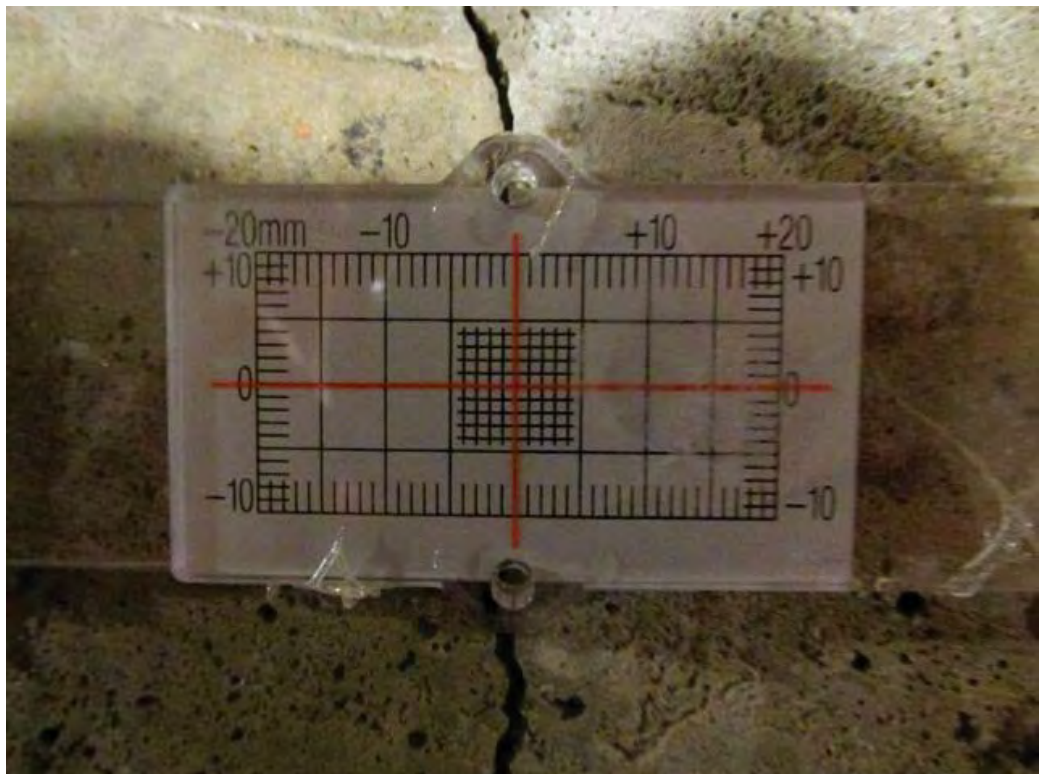
**PHOTOGRAPH NO.6**

- ▶ Tell-Tale Marker 3
- ▶ Location: Grid Line 19
- ▶ Comments: No Movement (Reading of 0)

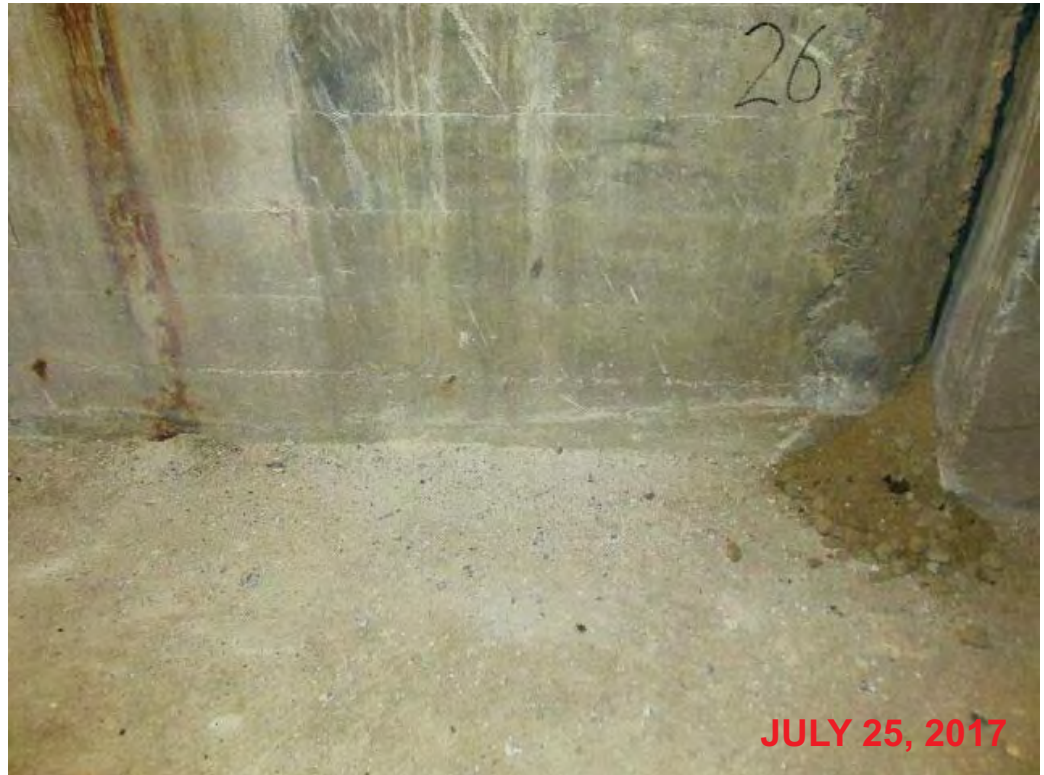
**PHOTOGRAPH NO.1**

- ▶ Debris on Floor
- ▶ Location: Between Grid Line 25 and 26
- ▶ Comments: Concrete / rubble debris on floor at July, 2017 review.

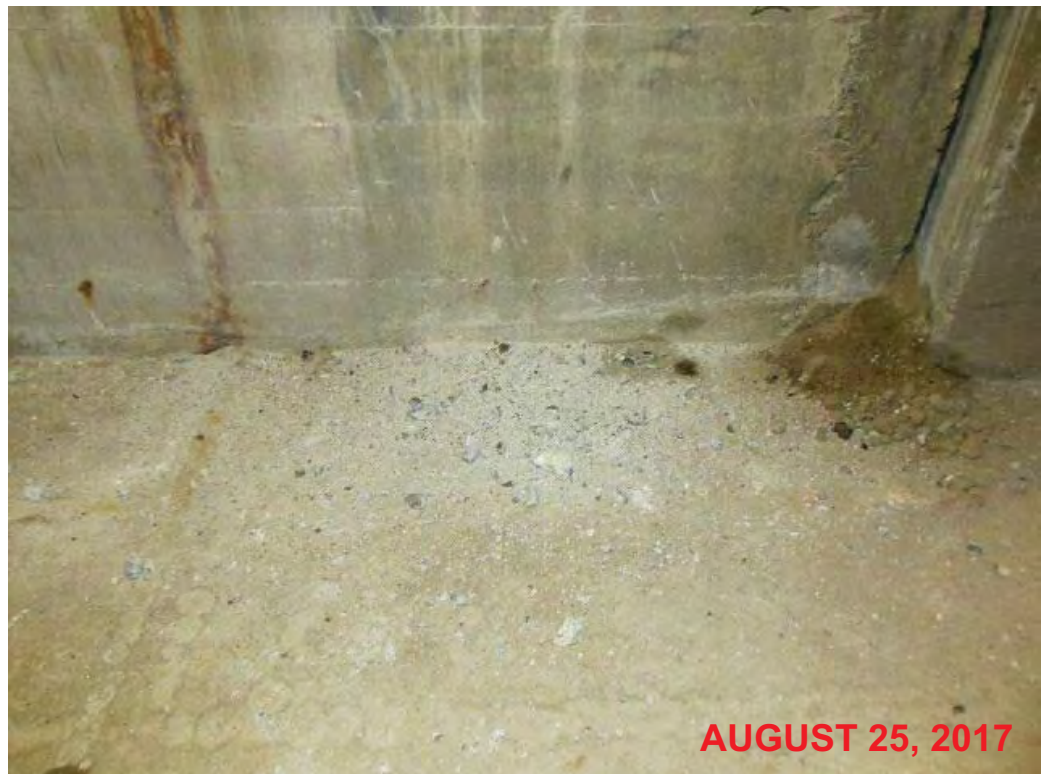
**PHOTOGRAPH NO.2**

Based on our review, there was a significant increase in the amount of debris in the header trench tunnel at the east end. This is the location of the zamboni path above. It is our understanding that the vibrations from the travelling equipment caused loose pieces of the concrete wall and/or slab to dislodge.

- ▶ Debris on Floor
- ▶ Location: Between Grid Line 25 and 26
- ▶ Comments: Concrete / rubble debris on floor at August, 2017 review. Please note the significant increase in concrete on the concrete floor.

Based on the observed concrete debris observed on the ground. We are of the opinion that some localized shoring be designed and installed along the Zamboni Path between the storage area and the Ice Rink.

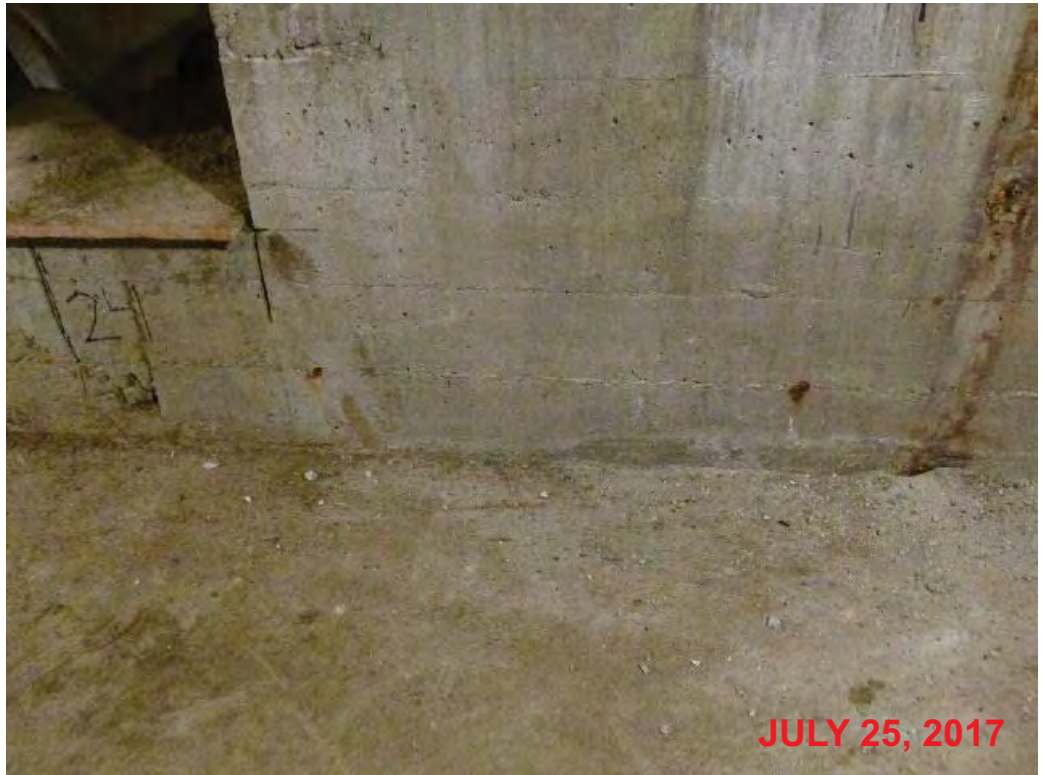
**PHOTOGRAPH NO.3**

- ▶ Debris on Floor
- ▶ Location: Between Grid Line 24 and 25
- ▶ Comments: Concrete / rubble debris on floor at July, 2017 review.

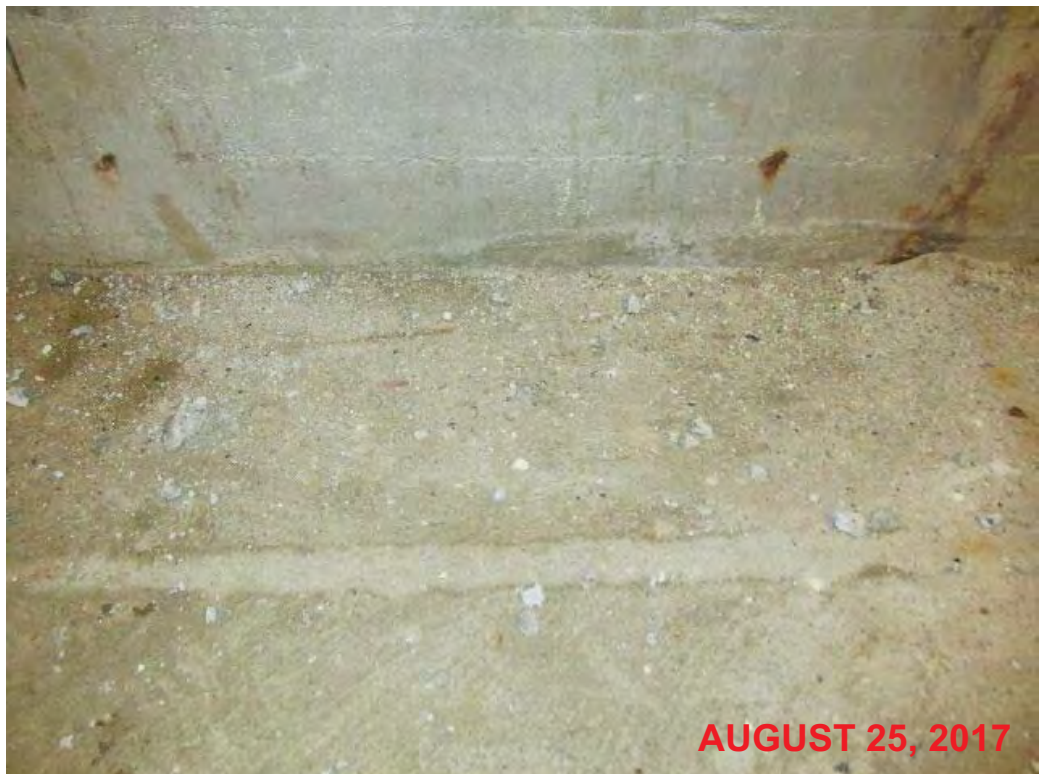
**PHOTOGRAPH NO.4**

- ▶ Debris on Floor
- ▶ Location: Between Grid Line 24 and 25
- ▶ Comments: Concrete / rubble debris on floor at August, 2017 review. Please note the significant increase in concrete on the concrete floor.

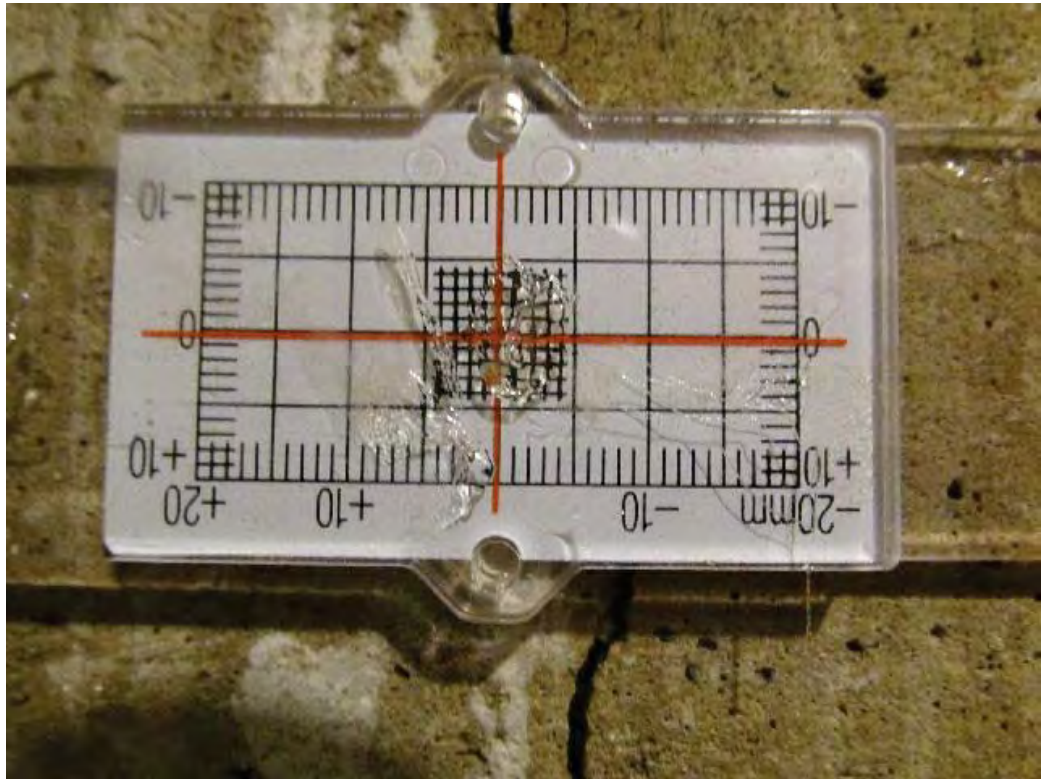
**PHOTOGRAPH NO.5**

- ▶ Tell-Tale Marker 1
- ▶ Location: Grid Line 10
- ▶ Comments: No additional movement

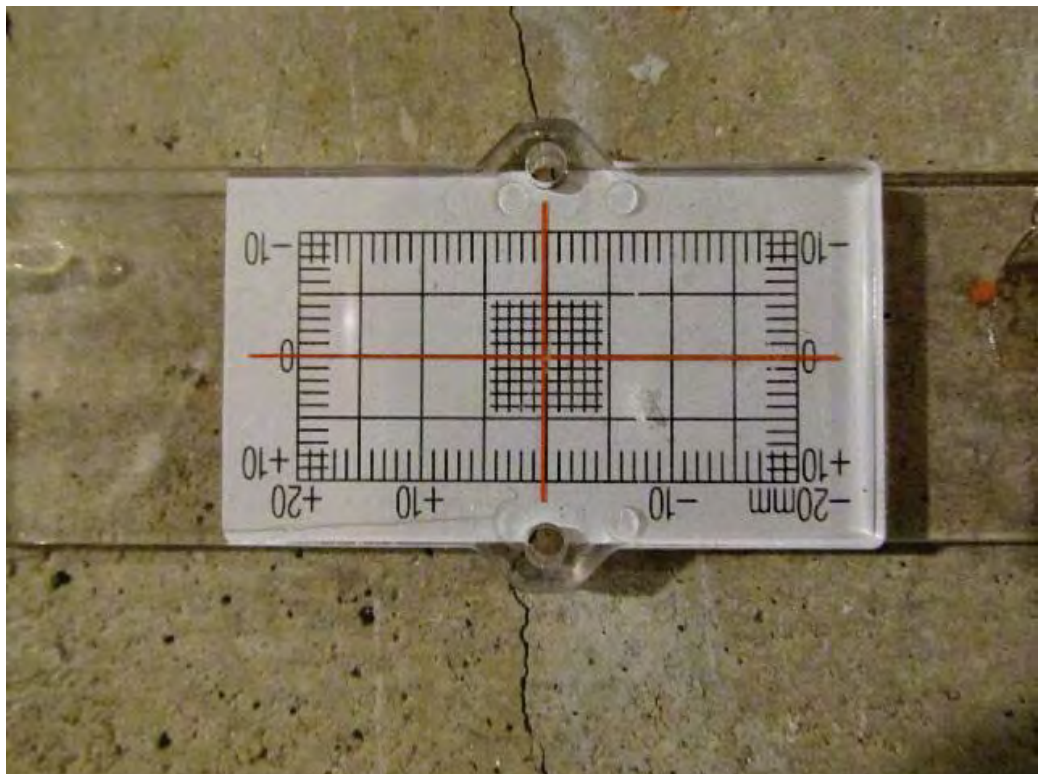
**PHOTOGRAPH NO.6**

- ▶ Tell-Tale Marker 2
- ▶ Location: Between Grid Line 14 & 15
- ▶ Comments: No movement

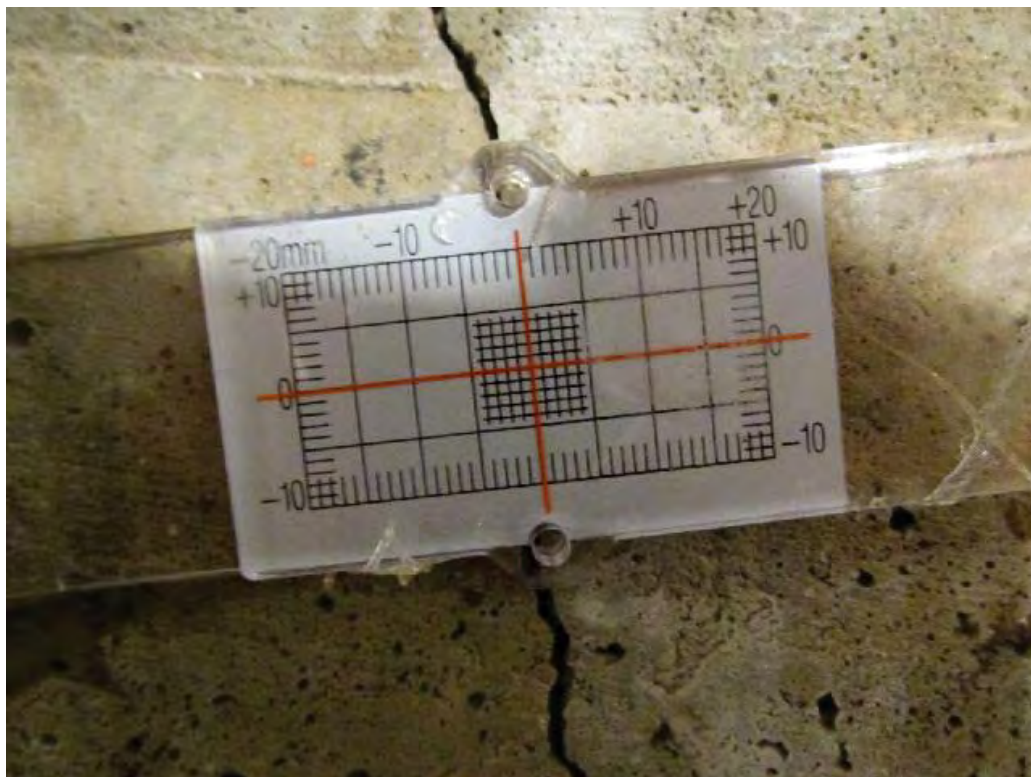
**PHOTOGRAPH NO.7**

- ▶ Tell-Tale Marker 3
- ▶ Location: Grid Line 19
- ▶ Comments: No movement

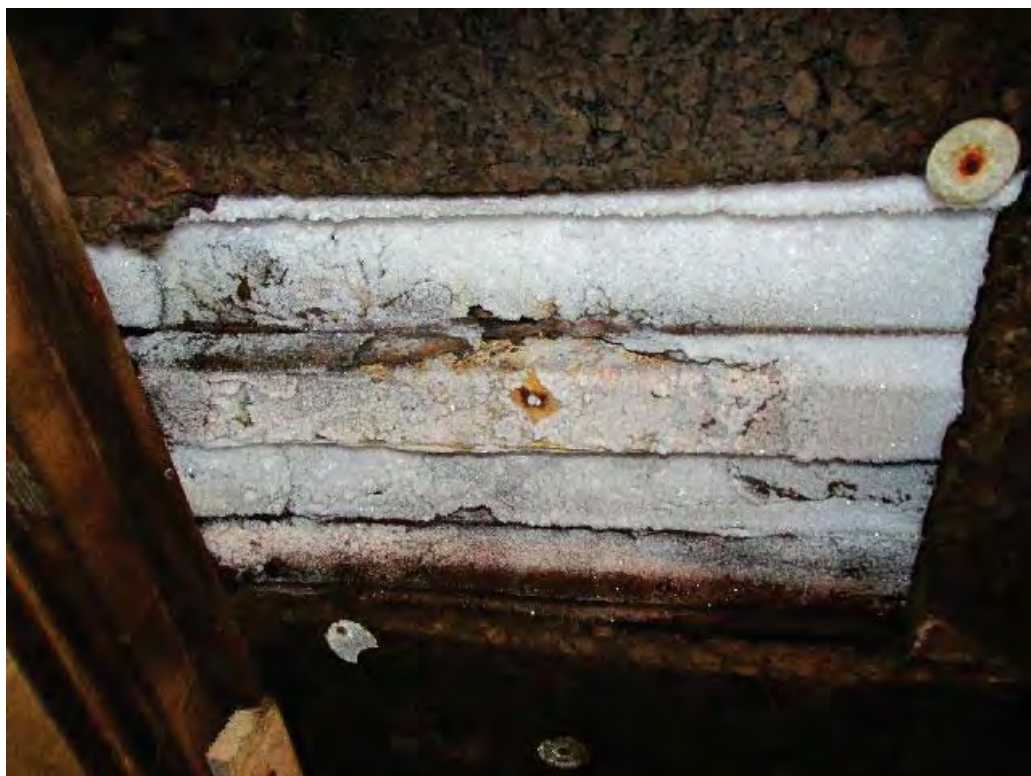
**PHOTOGRAPH NO.8**

- ▶ Exposed Deck / Slab
- ▶ Location: Between Grid Line 11 & 12
- ▶ Comments: Typical layer of ice on exposed concrete slab / steel deck

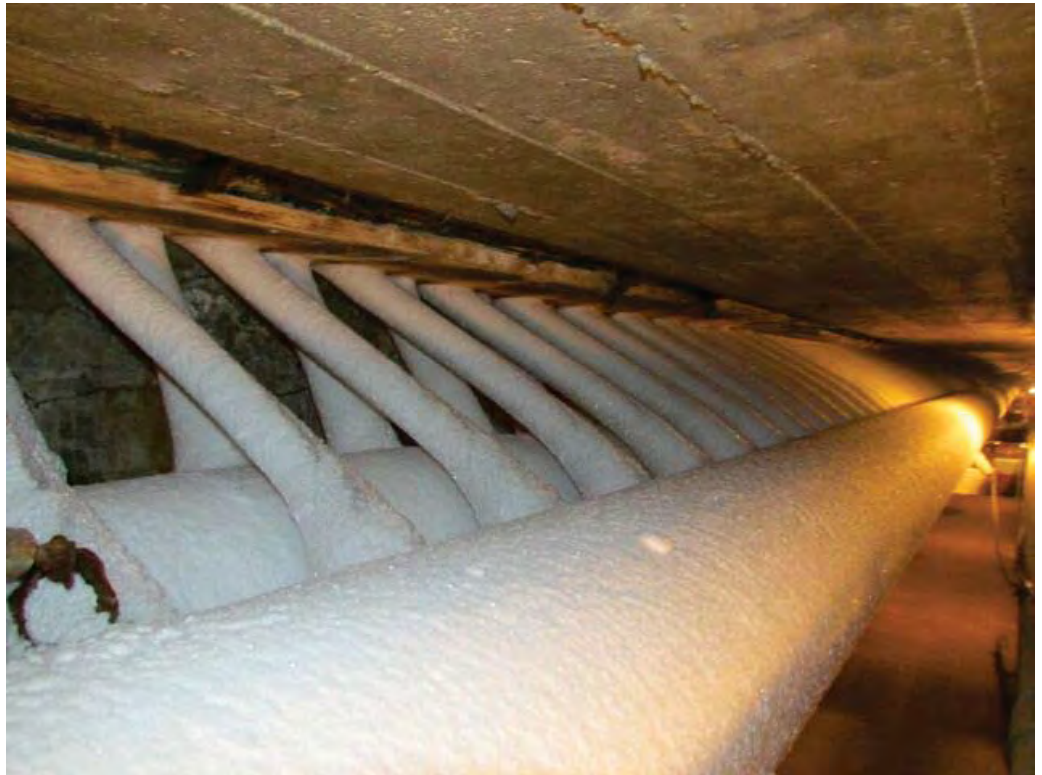
***PHOTOGRAPH NO.9***

- ▶ Header Pipes & Brine Pipes
- ▶ Location: General
- ▶ Comments: Typical layer of ice on pipes

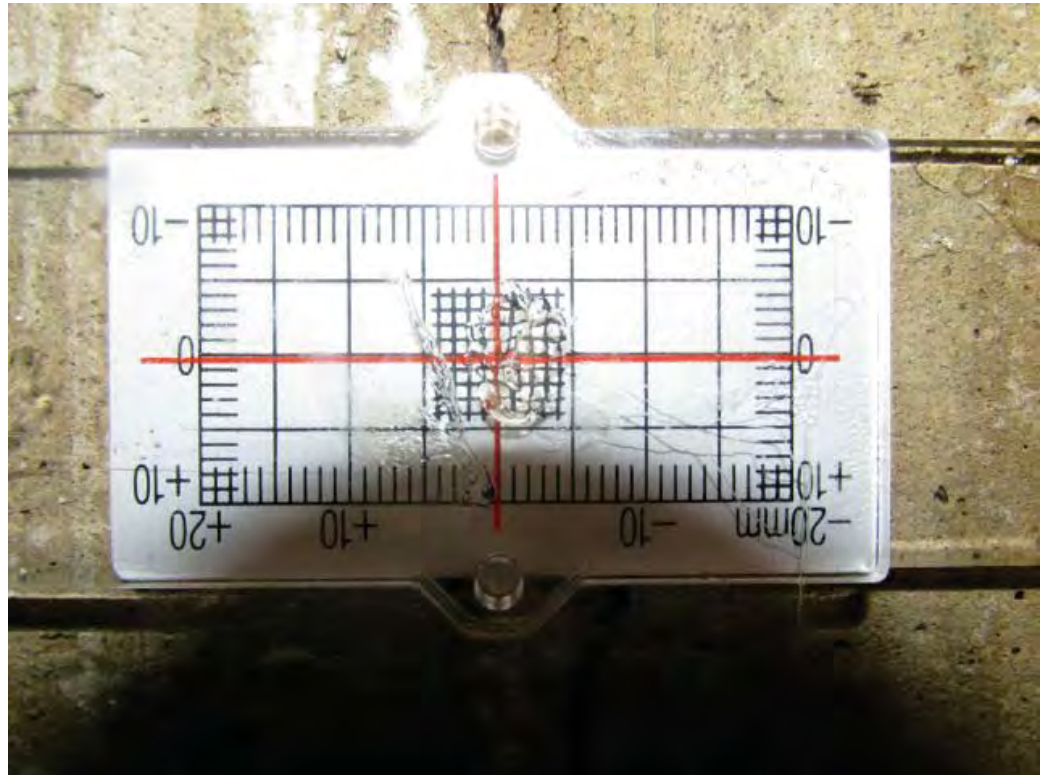
***PHOTOGRAPH NO.1***

- ▶ Tell-Tale Marker 1
- ▶ Location: Grid Line 10
- ▶ Comments: No additional movement

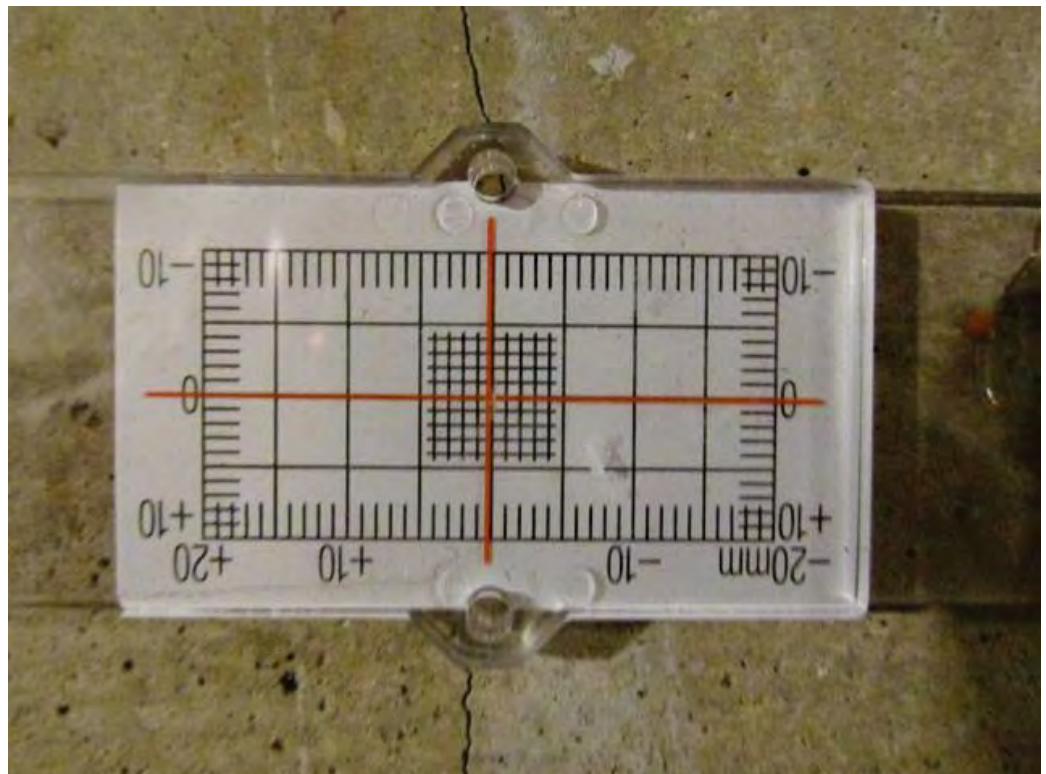
***PHOTOGRAPH NO.2***

- ▶ Tell-Tale Marker 2
- ▶ Location: Between Grid Line 14 & 15
- ▶ Comments: No movement

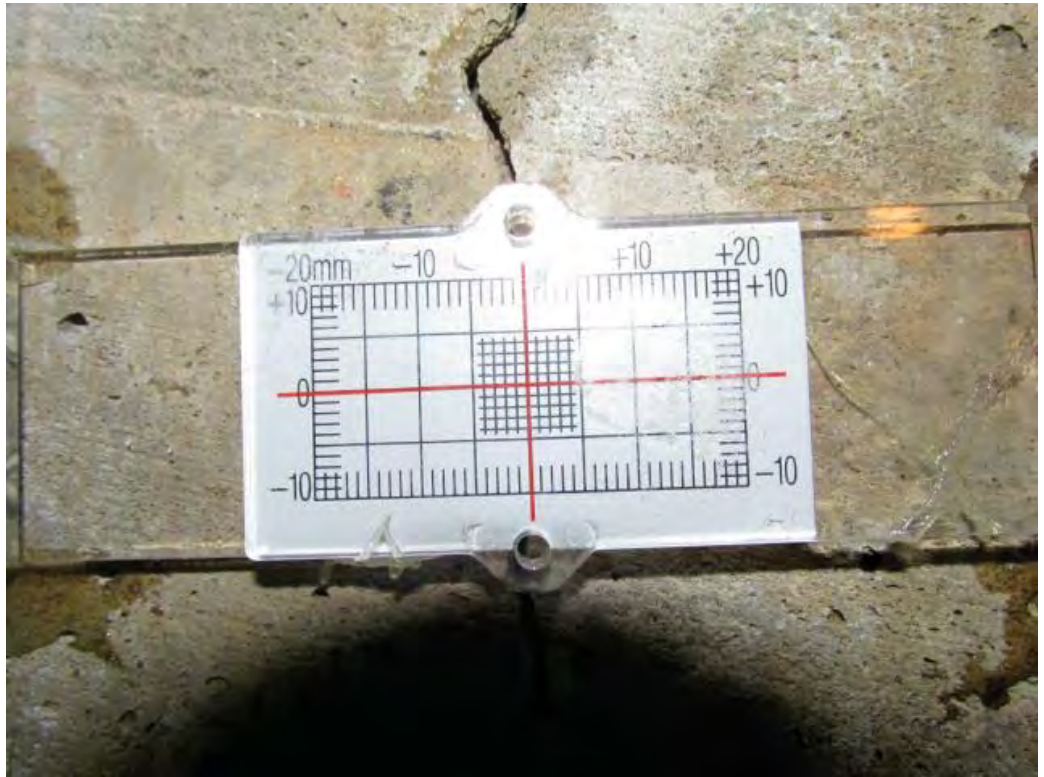
**PHOTOGRAPH NO.3**

- ▶ Tell-Tale Marker 3
- ▶ Location: Grid Line 19
- ▶ Comments: No movement

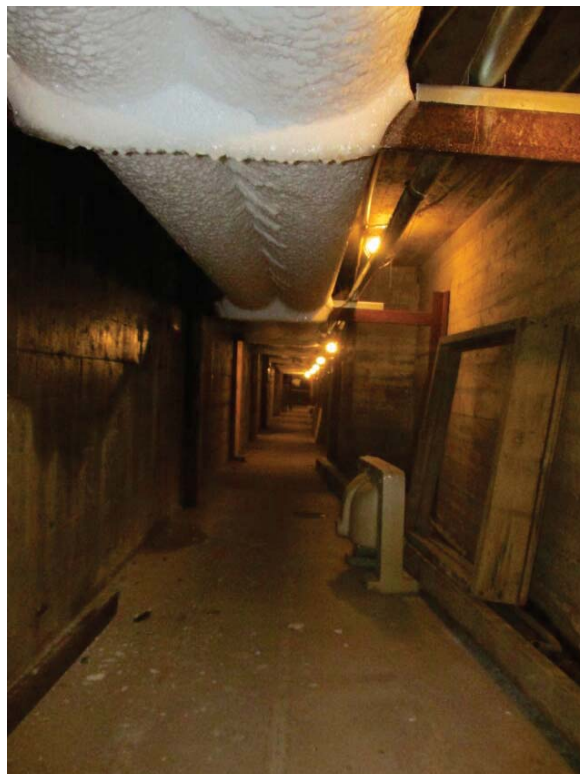
**PHOTOGRAPH NO.4**

- ▶ General View of Trench
- ▶ Location: Trench
- ▶ Comments: Ice build-up on brine pipes

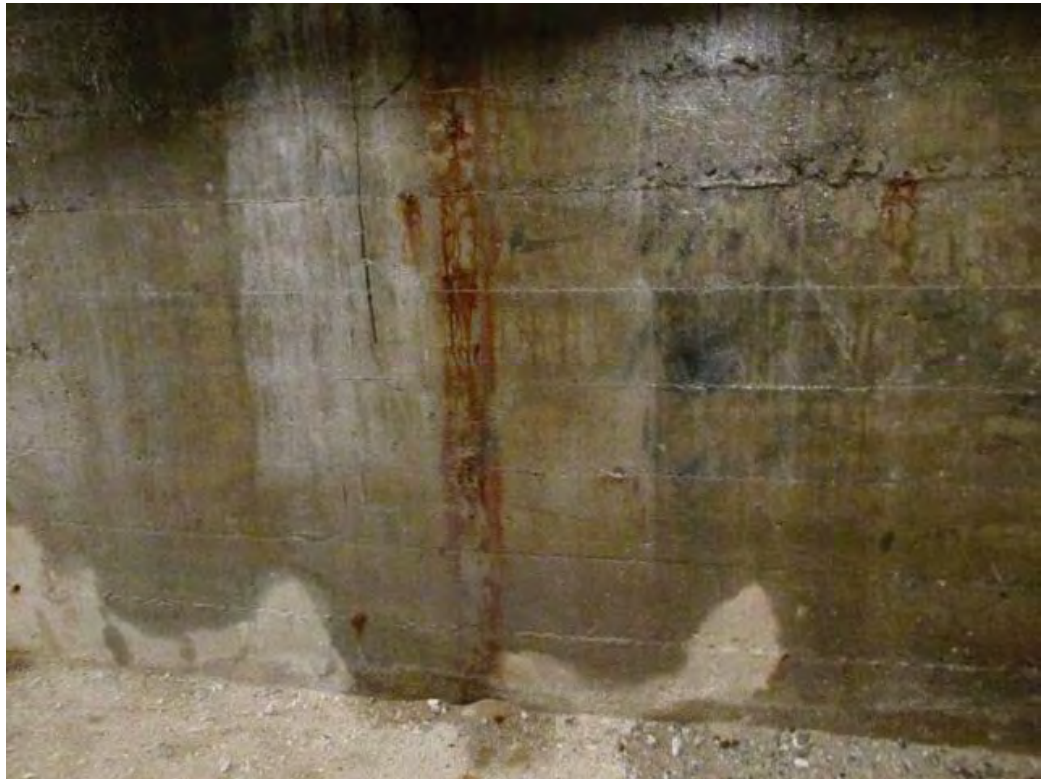
**PHOTOGRAPH NO.5**

5. A significant amount of moisture was observed on both sides of the South Wall, particularly towards the east and west ends. Moisture / water ponding was also noted on the concrete slab-on-grade at the tunnel ends.

- ▶ South Wall
- ▶ Location: South (outside) face of wall, between Grid Line 26 & 26
- ▶ Comments: Moisture on Wall

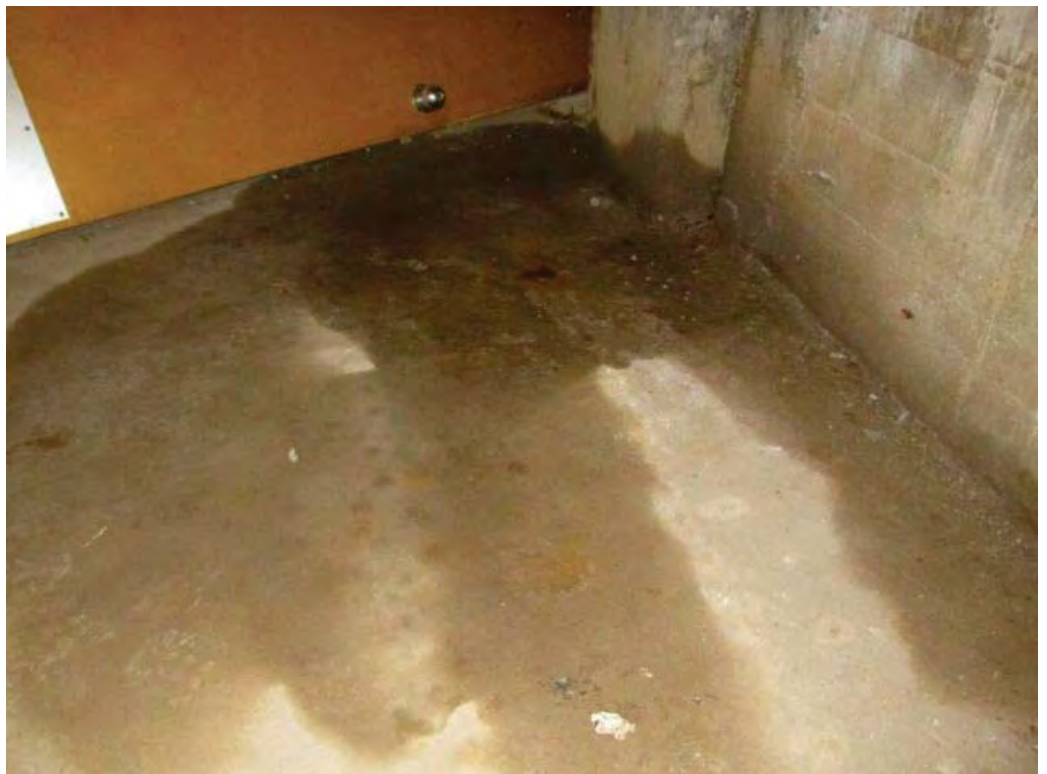
**PHOTOGRAPH NO.6**

- ▶ Slab-on-grade
- ▶ Location: Between Grid Line 0 & 1
- ▶ Comments: Moisture / water ponding on slab

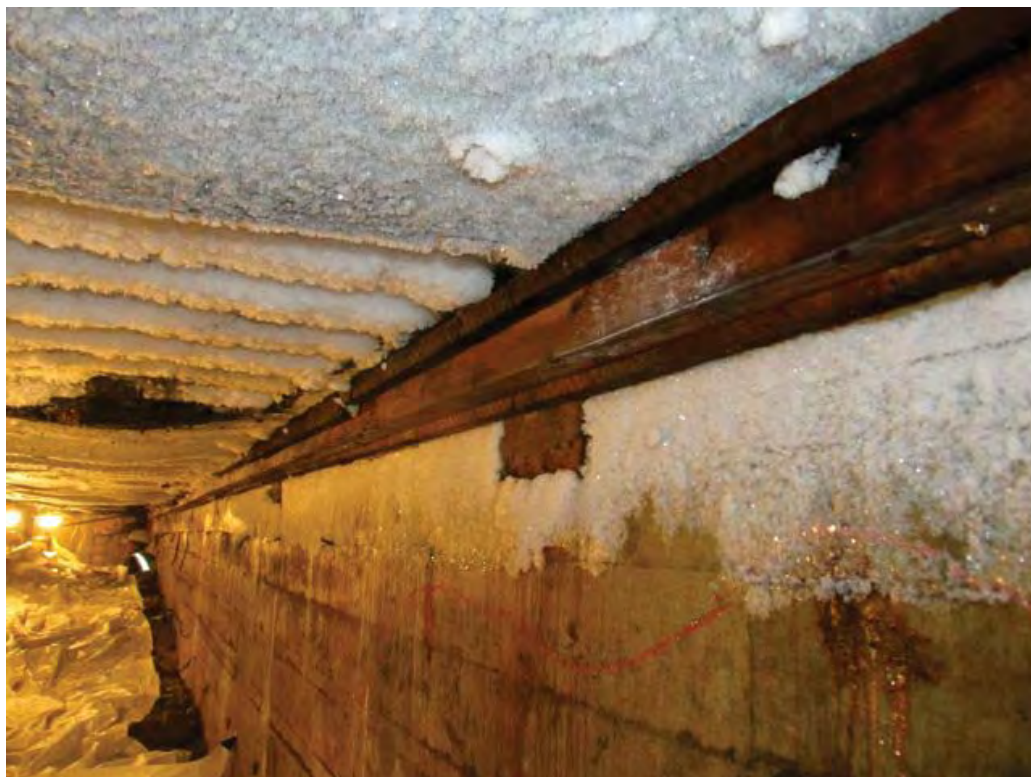
***PHOTOGRAPH NO.7***

4. At the time of our site visit, the slab underside in the first bay was for the most part not visible due to the build-up of ice, with the exception of the east and west ends where there was no ice. As well, it should be noted that a build-up of ice had formed along the top six inches (6") of the South Wall (on both sides), as well as the next wall to the north.

- ▶ South Wall
- ▶ Location: North (inside) face of wall
- ▶ Comments: Ice build-up at top of wall and on underside of slab

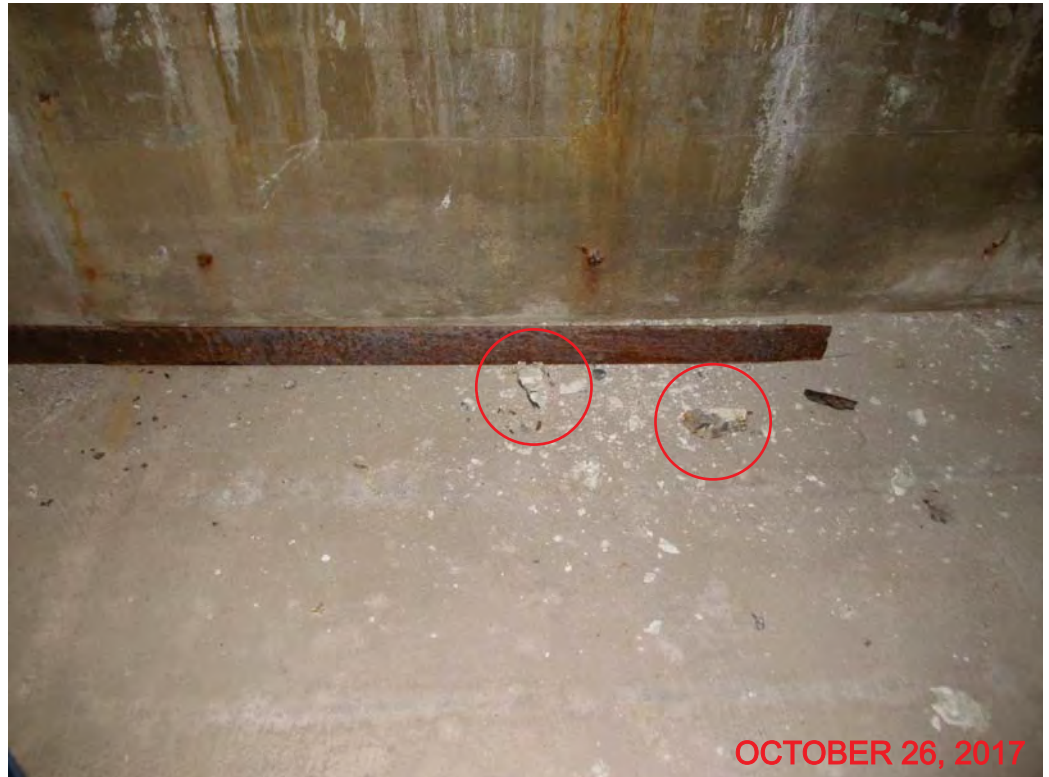
***PHOTOGRAPH NO.1***

- ▶ Debris on Floor
- ▶ Location: Between Grid Line 2 and 3
- ▶ Comments: Concrete / rubble debris on floor at October, 2017 review.

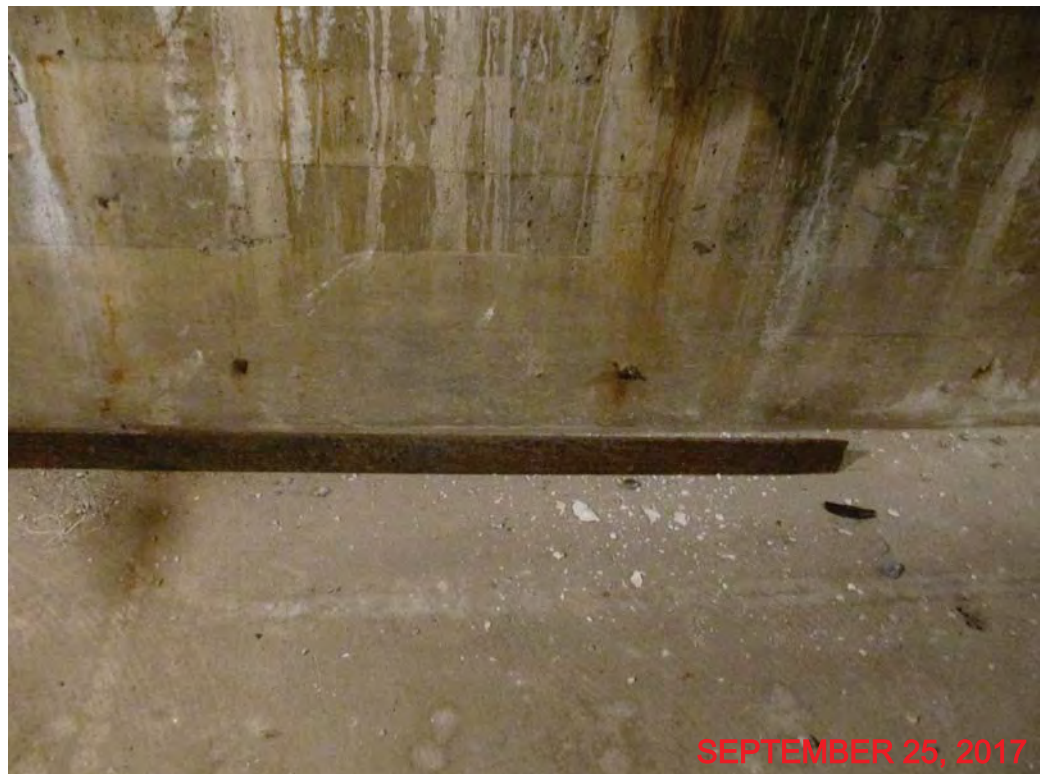
***PHOTOGRAPH NO.2***

- ▶ Debris on Floor
- ▶ Location: Between Grid Line 2 and 3
- ▶ Comments: Concrete / rubble debris on floor at September, 2017 review.
