**STRUCTURAL UPDATED REPORT  
SOUTH SUPPORTING ICE RINK WALL  
MEMORIAL CENTRE, PETERBOROUGH (ON)**

**PREPARED FOR  
THE CITY OF PETERBOROUGH  
BY  
CARVAJAL STRUCTURAL ENGINEERS INC.**

**CSE PROJECT-2022.18**

JUNE, 2018

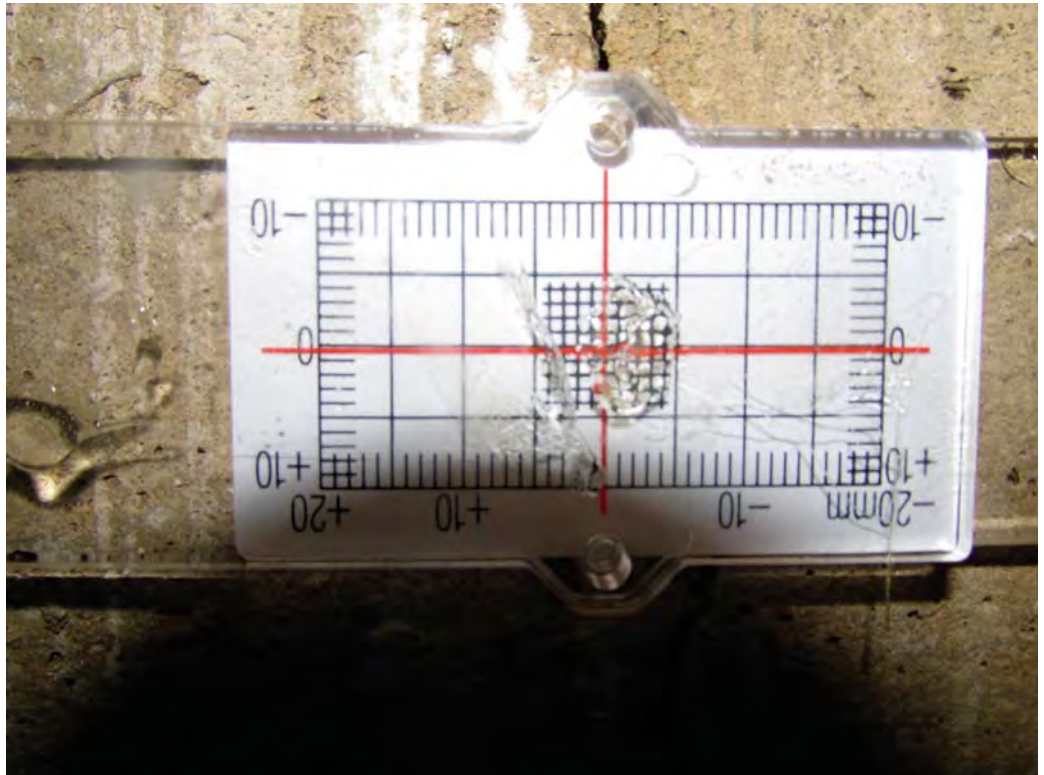
**PHOTOGRAPH NO.3**

- ▶ Tell-Tale Marker 1
- ▶ Location: Grid Line 10
- ▶ Comments: No additional movement

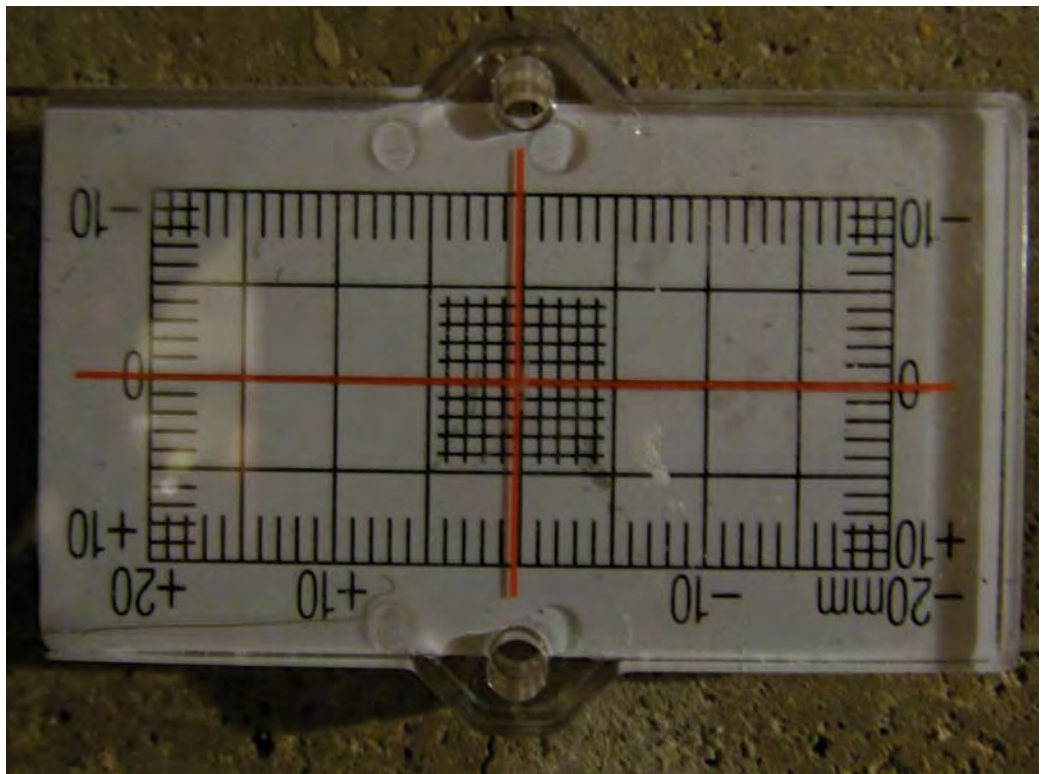
**PHOTOGRAPH NO.4**

- ▶ Tell-Tale Marker 2
- ▶ Location: Between Grid Line 14 & 15
- ▶ Comments: No movement

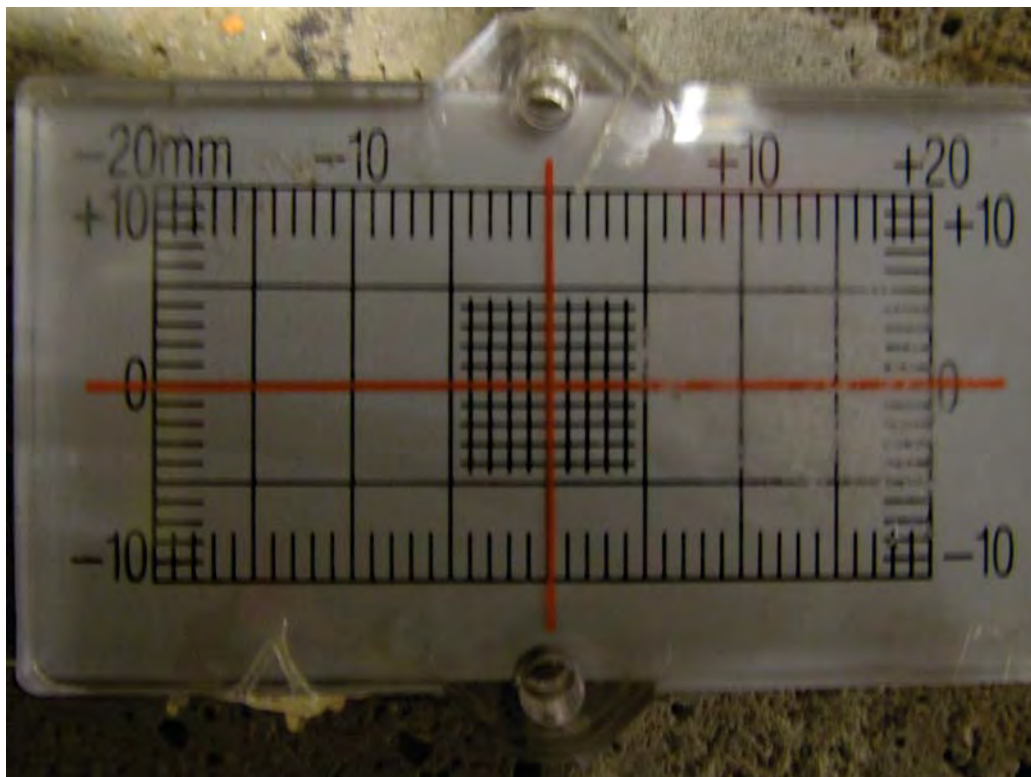
**PHOTOGRAPH NO.5**

- ▶ Tell-Tale Marker 3
- ▶ Location: Grid Line 19
- ▶ Comments: No movement

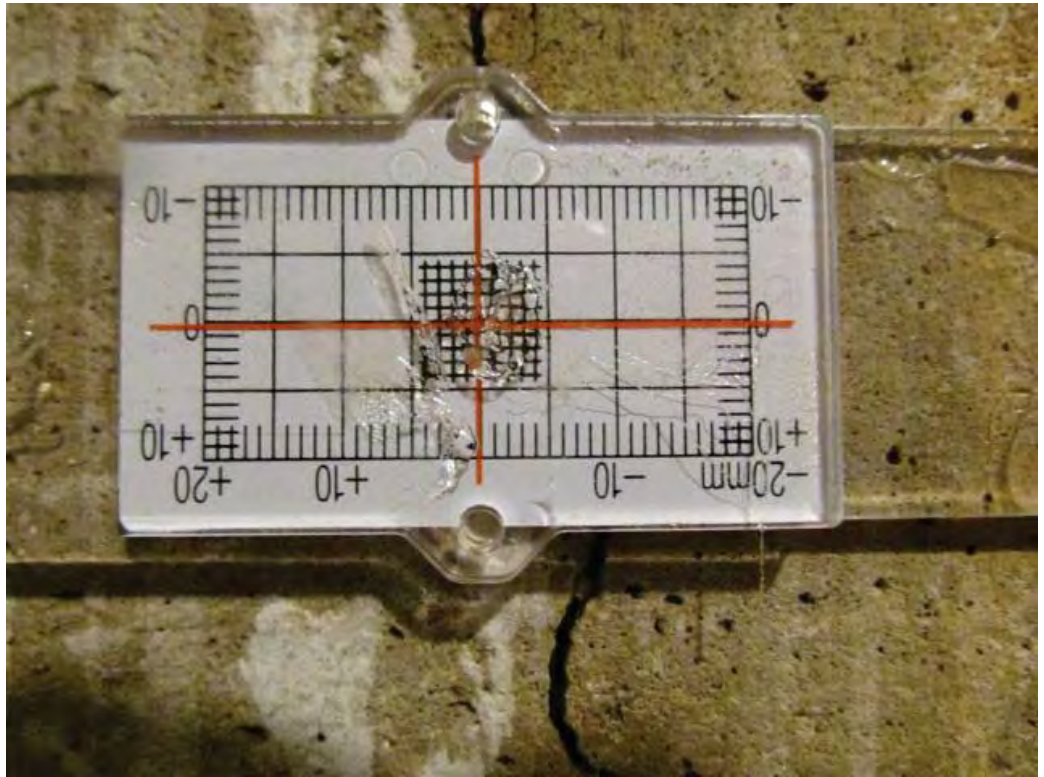
***PHOTOGRAPH NO.1***

- ▶ Tell-Tale Marker 1
- ▶ Location: Grid Line 10
- ▶ Comments: No additional movement

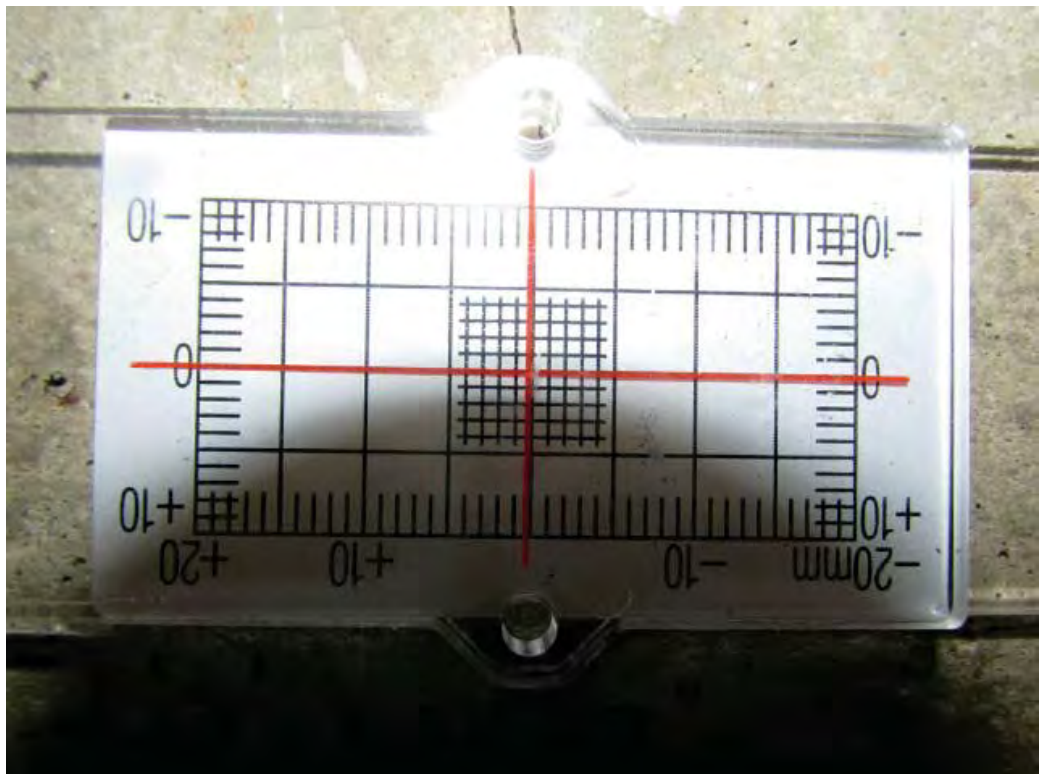
***PHOTOGRAPH NO.2***

- ▶ Tell-Tale Marker 2
- ▶ Location: Between Grid Line 14 & 15
- ▶ Comments: No movement

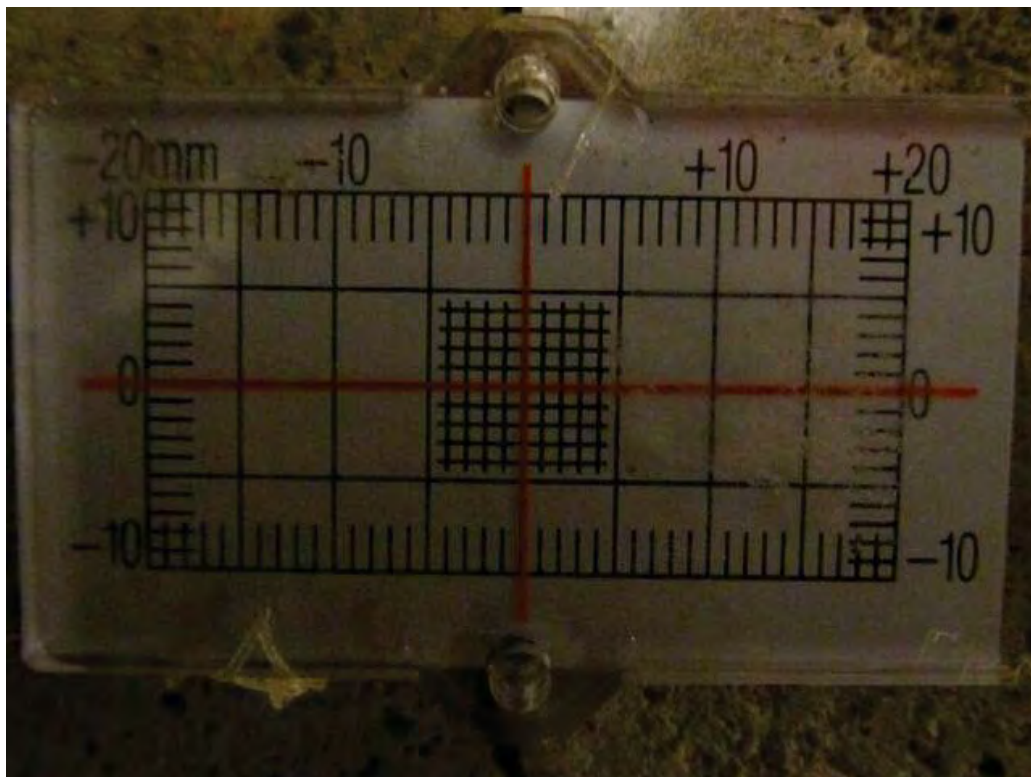
**PHOTOGRAPH NO.3**

- ▶ Tell-Tale Marker 3
- ▶ Location: Grid Line 19
- ▶ Comments: No movement

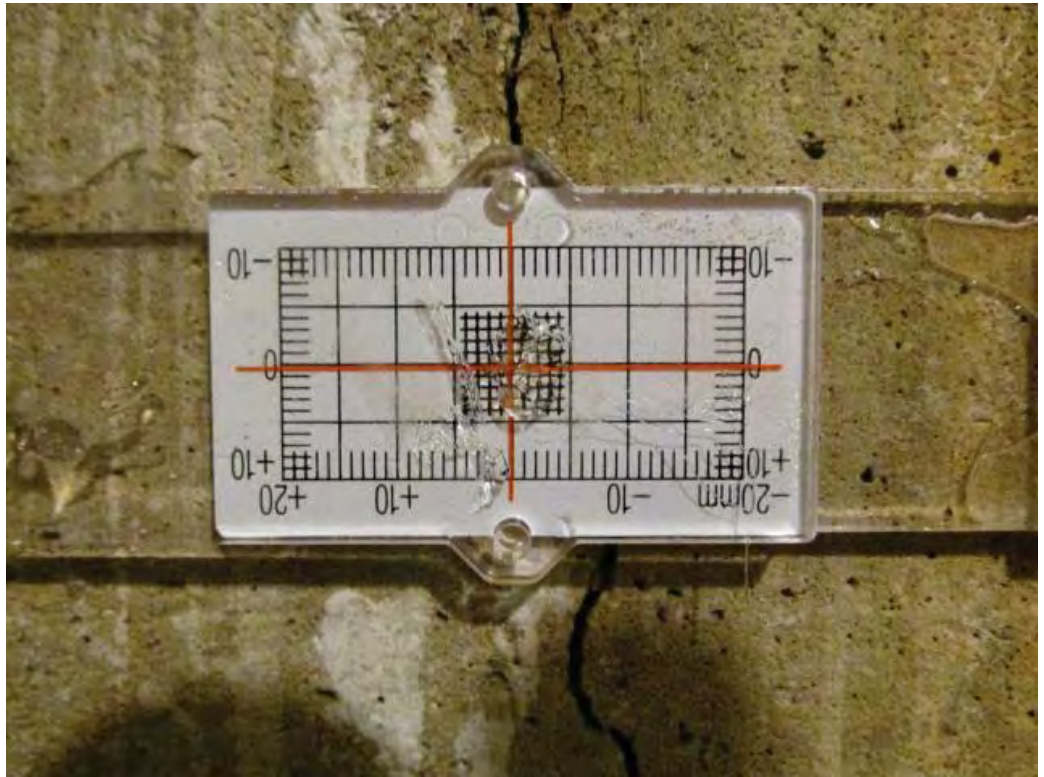
***PHOTOGRAPH NO.1***

- ▶ Tell-Tale Marker 1
- ▶ Location: Grid Line 10
- ▶ Comments: No additional movement

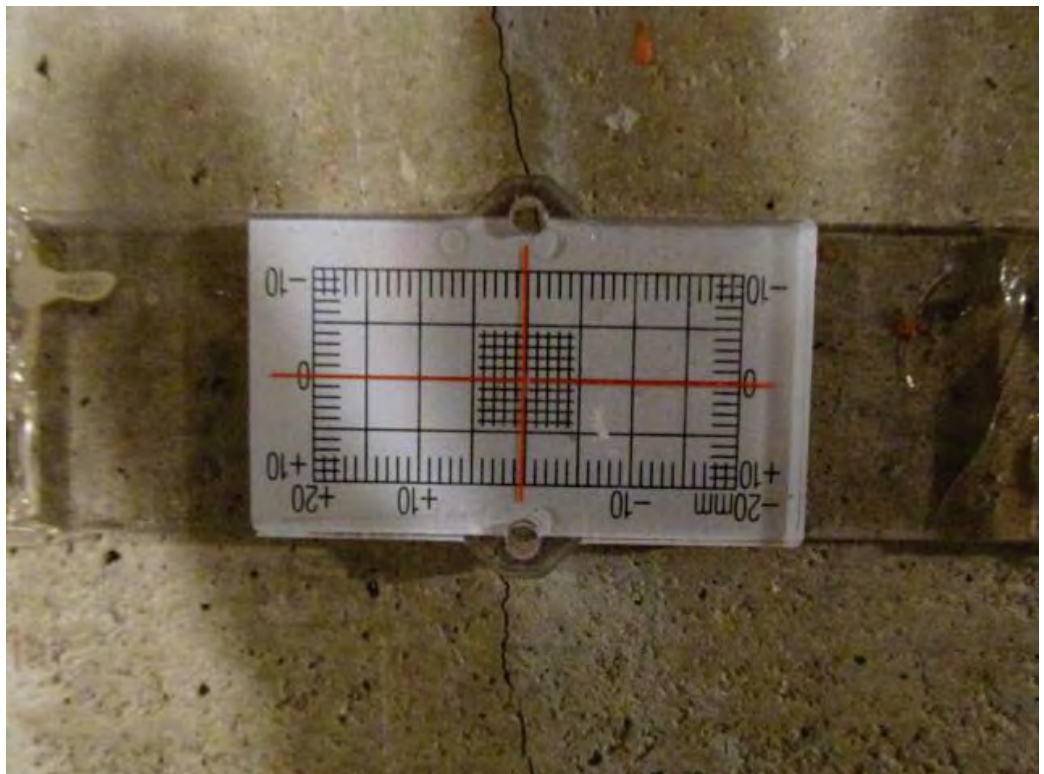
***PHOTOGRAPH NO.2***

- ▶ Tell-Tale Marker 2
- ▶ Location: Between Grid Line 14 & 15
- ▶ Comments: No movement

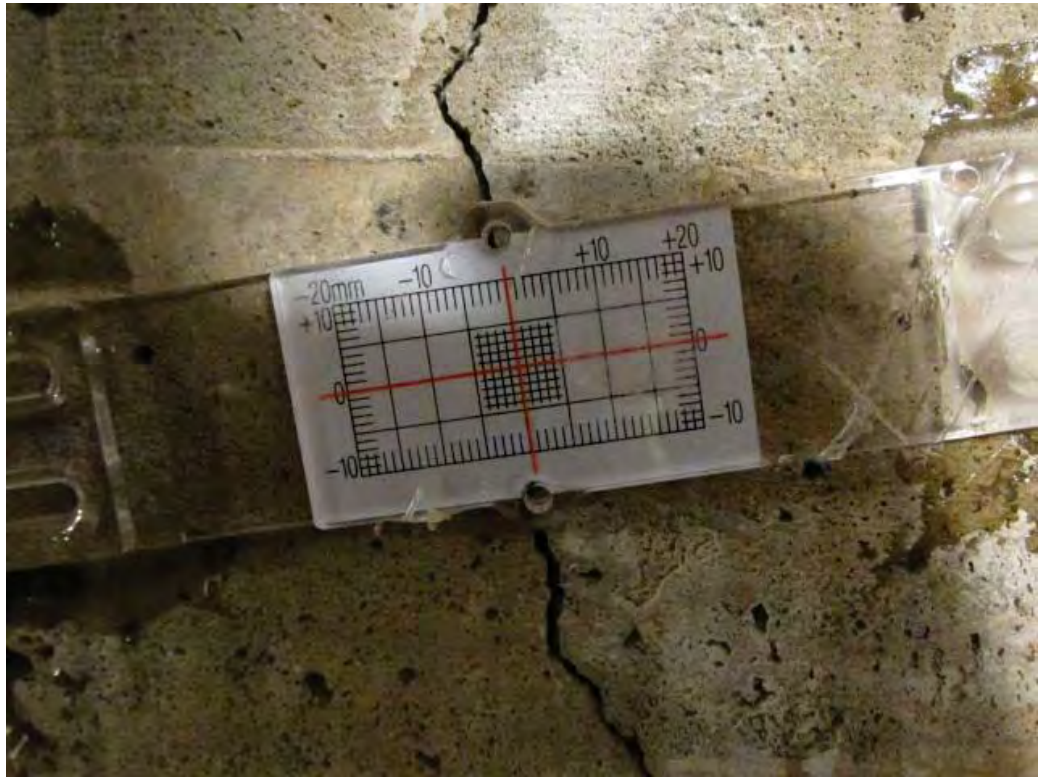
**PHOTOGRAPH NO.3**

- ▶ Tell-Tale Marker 3
- ▶ Location: Grid Line 19
- ▶ Comments: No movement

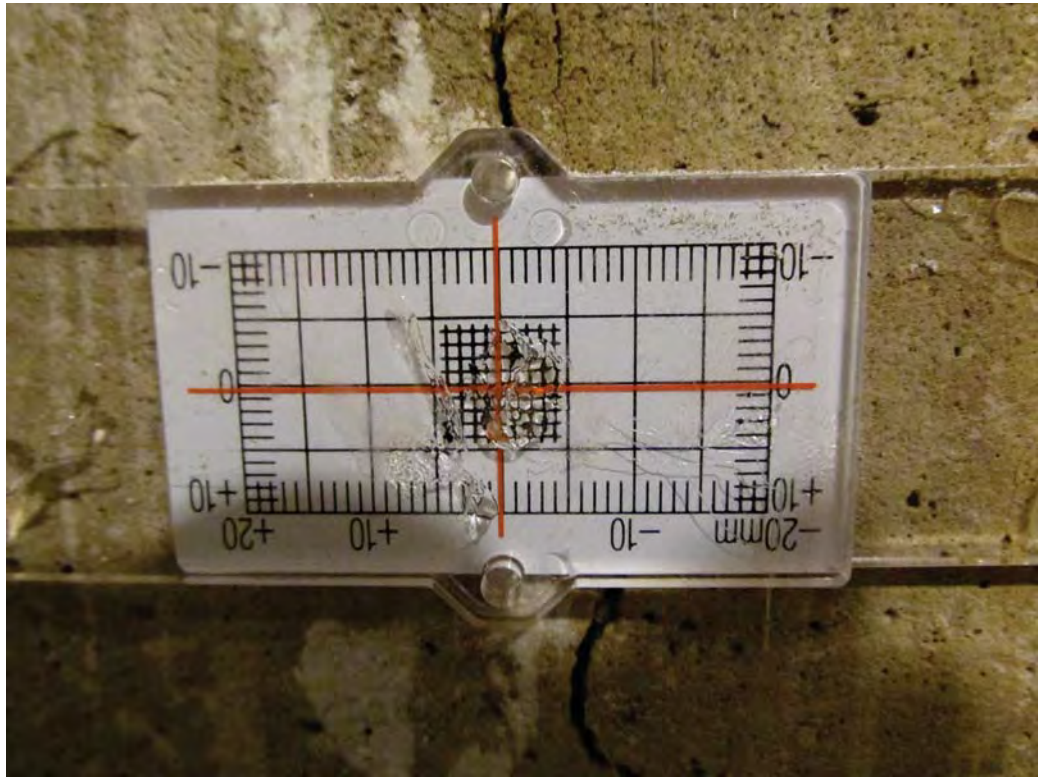
**PHOTOGRAPH NO.1**

- ▶ Tell-Tale Marker 1
- ▶ Location: Grid Line 10
- ▶ Comments: No additional movement

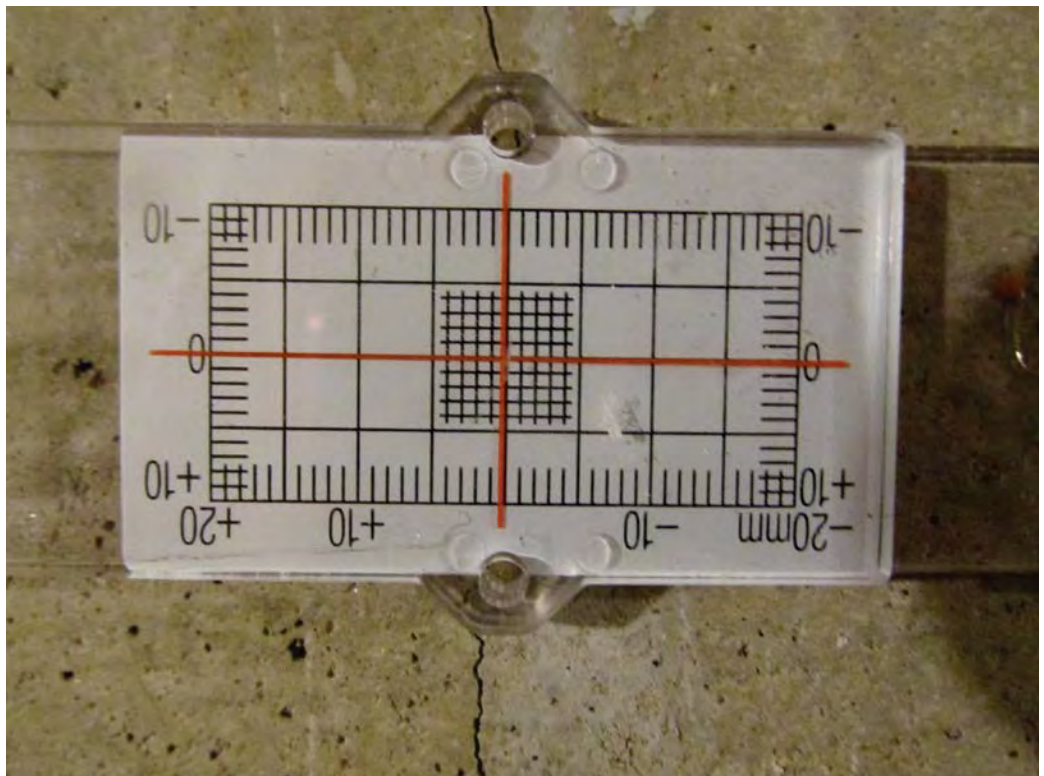
**PHOTOGRAPH NO.2**

- ▶ Tell-Tale Marker 2
- ▶ Location: Between Grid Line 14 & 15
- ▶ Comments: No movement

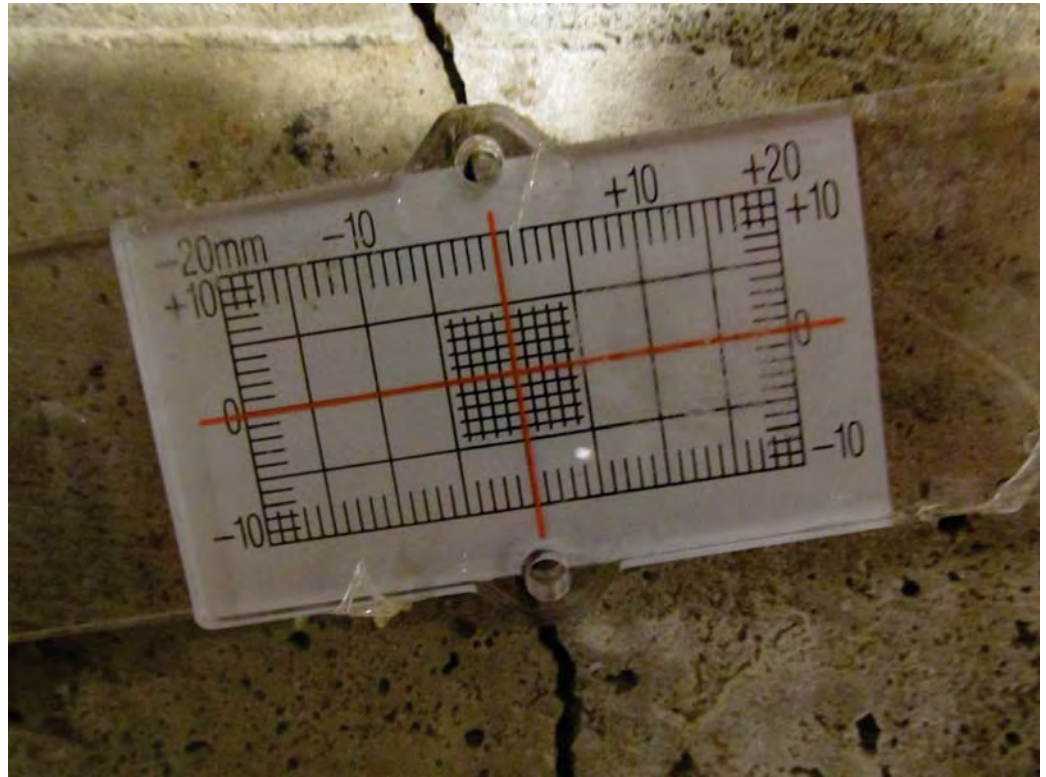
**PHOTOGRAPH NO.3**

- ▶ Tell-Tale Marker 3
- ▶ Location: Grid Line 19
- ▶ Comments: No movement
