Accessibility Assessment: Peterborough Transit Terminal

December 5, 2013

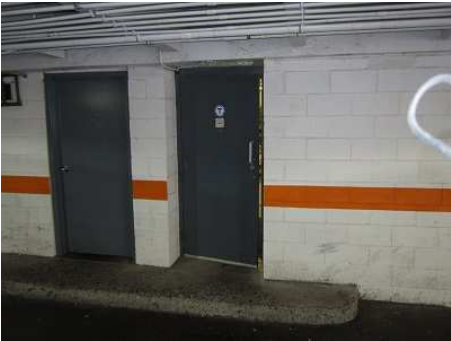
Observation: The rear exit from the staff area in the main building lacks a ramp to get out and exits directly into the path of traffic in the parking garage with insufficient sidewalk space outside the door.

Classification: Safety

Rating: F

The rear exit from the staff admin/office area to the parking garage poses a risk of physical harm as it exits directly onto the main entry of the parking garage and lacks any visual warning signage or signals to alert oncoming drivers. There are several possible options to improving both accessibility and safety of this exit. Option A below illustrates a recessed external passageway and door where the red area indicates a ramp area and drop curb. Option B illustrates how the ramp can begin inside the building to keep the existing doorway in place but still achieve full accessibility by lowering the door to the new ramp level. Option C (no illustration) uses a portable ramp that is easily accessible from inside the door but requires help from other staff. In the case of Option C, if the rear exit is deemed an emergency exit, then the temporary ramp is applicable but needs to be included within the fire safety plan for the building and staff trained on its deployment.

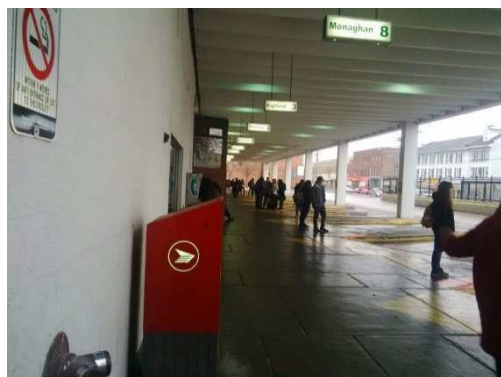
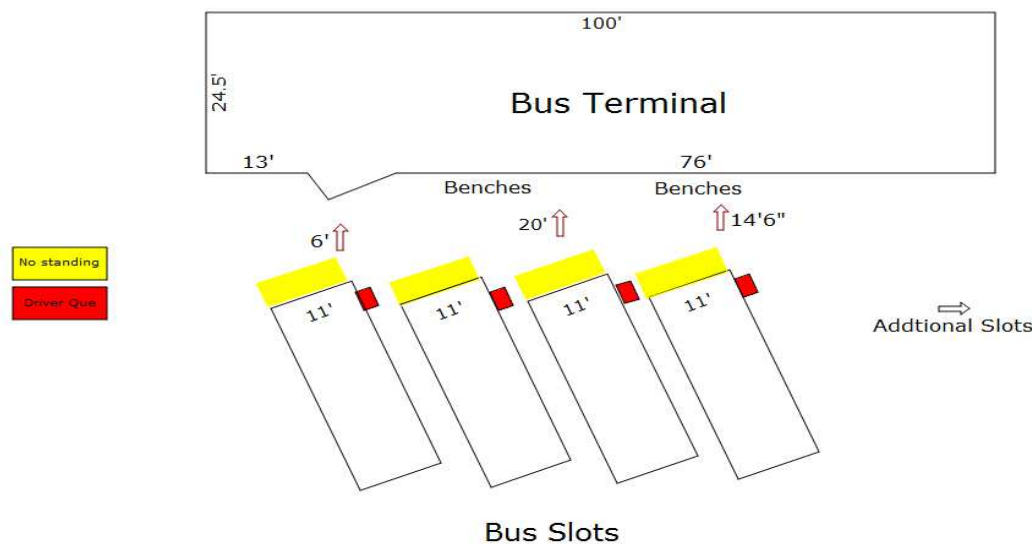
Observation 1: The current dispatch booth protrudes into the platform and reduces overall space for travel on the platform to approximately 4 feet (1219 mm) between the building and the bus parking.

The distance between the bus yellow zone and the terminal is minimal; particularly where the two level section for dispatch juts out.

Remove the portion of the old Dispatch area that juts out into the external platform area so that it is flush with the rest of the building. This should be incorporated into the draft plans should the city undertake a major renovation. This would help to maximize the space for pedestrian traffic along the platform in front of the building and improve accessibility and safety for those using mobility devices that may require more room to maneuver.

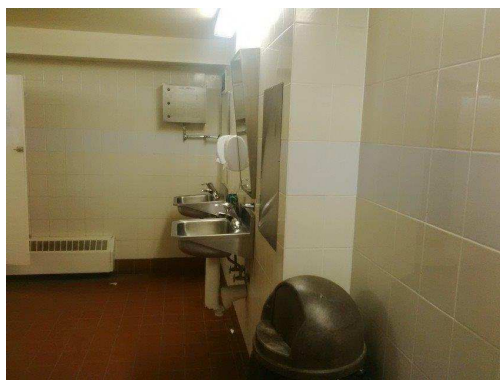
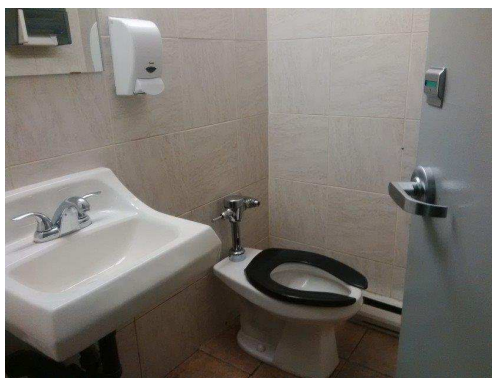
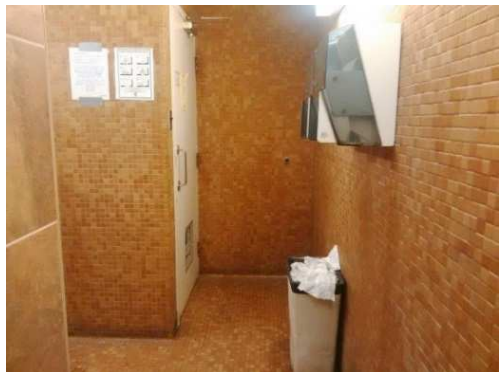
Observation: The current washrooms are not accessible

None of the washrooms are designated as accessible washrooms and each has multiple issues including lack of automatic door openers, grab bars in the stalls and general lack of space for those with mobility devices to maneuver in the washroom.

In the event that no major renovation occurs, there still needs to be a washroom that includes accessible features within the building. For a better understanding of what features to include see the renovation guidelines section below. If this work is done to the public washrooms it can provide access for both staff and public as needed.

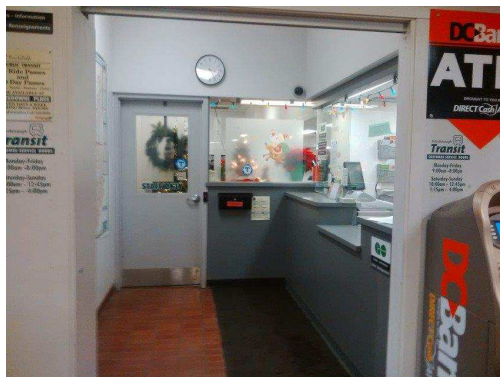
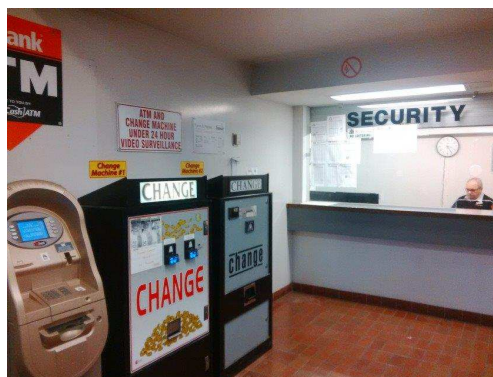
Observation: The ticket counter and security counter lack accessible counter features

Under the proposed new building code service counters need to have a designated accessible section suitable for wheeled mobility devices or persons seated in chairs complete with lowered counters, open space beneath the counter and colour contrasted edging on the counter.

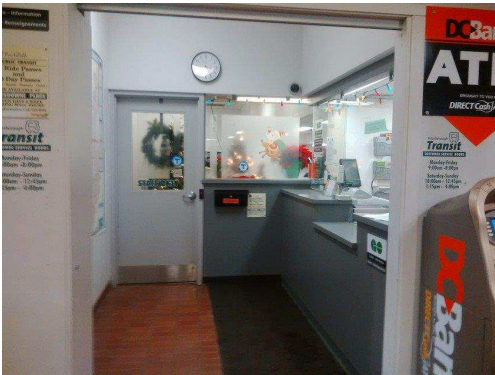
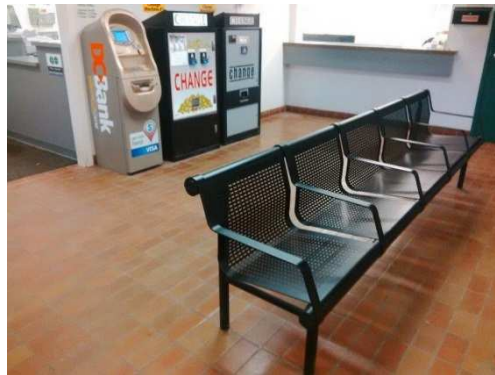
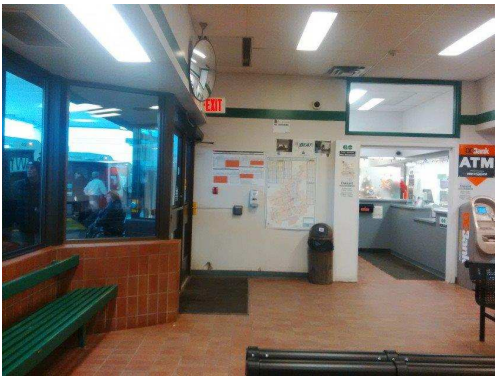
Observation: Usability and Accessibility could be improved for all patrons through queuing lines and signage.

Implement a queuing system for the ticket counter that will ensure an organized pedestrian flow to interact with staff in a more efficient manner. This system should provide for more easy direct access for those with disabilities

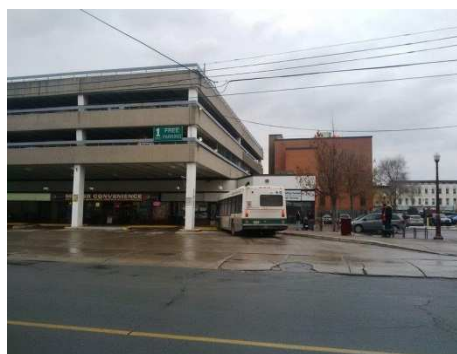
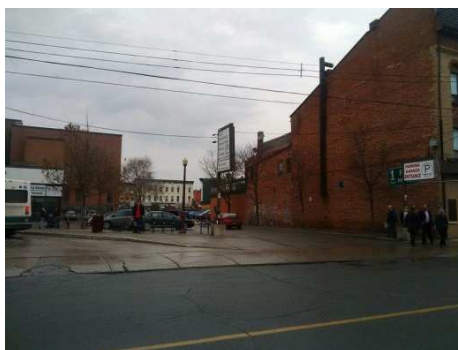
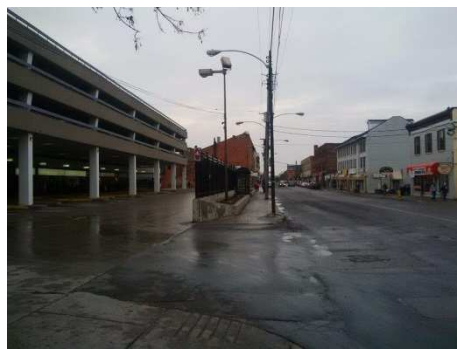
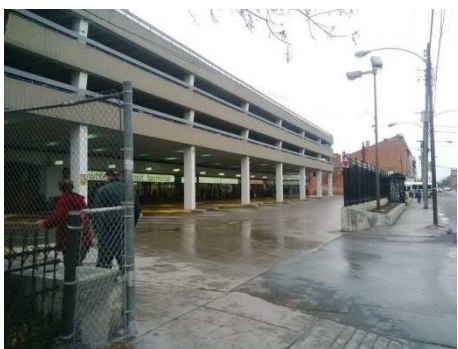
Observation: Both the East and West Street approaches to the building lack signage indicating where to access the terminal and where pedestrian traffic is not allowed.

Observation: The bus entrance from the street lacks defined danger zones to indicate areas where pedestrians should not enter.

To improve pedestrian traffic flow and decrease the occurrence of pedestrian traffic through the bus parking zone, we recommend painting a caution strip on the pavement at the front of the bus entrance to the terminal parallel to Simcoe Street to indicate pedestrians are not to walk

through that area. In addition we believe it would be beneficial to place signs on both the east and west approaches that clearly indicate the path to take to access the terminal.

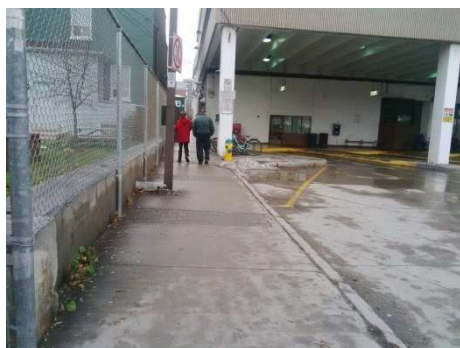
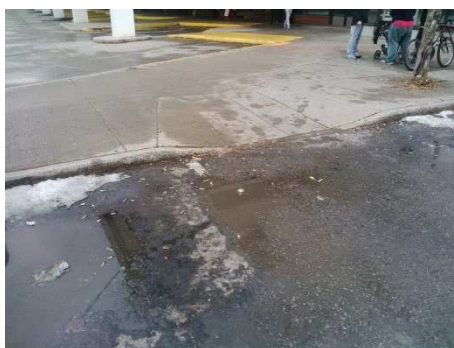
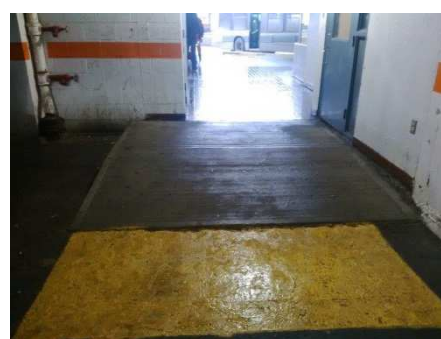
Observation: The surface has cracks and holes which are trip hazards at various points along the loading zones

Observation: The loading zones lack non-visual cues to assist those with vision impairment

Observation: The ramp from the parking garage to access the terminal is uneven and changes surface four times within 25 feet (7620 mm) which creates a slip fall contrast hazard for people with visual disabilities.

There are specific slip/fall hazards that should be addressed for the safety of the general public. We would recommend several options. Option 1: Repair existing holes in the tile and concrete surfaces. Option 2: Standardize the surface by replacing the tiled area with concrete. Option 3: Apply a non-slip substance to the tiled areas specifically to reduce the risk of slip/fall. Option 4: Specific to those with visual disabilities, incorporate tactile surfaces to indicate queuing areas and danger areas around where busses park. It is further recommended to consider standardizing the walkway from the external platform area to the city parking garage to eliminate the issue with uneven surfaces and inconsistent surface textures.

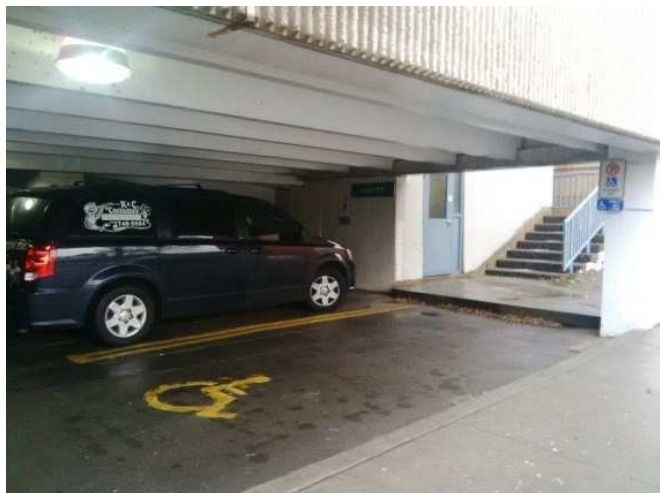
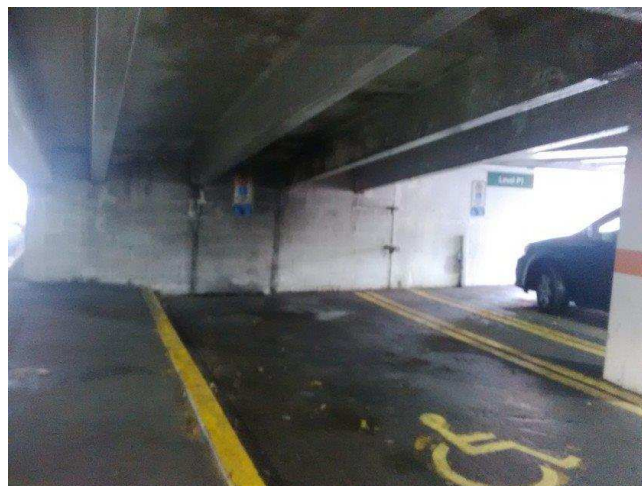
Observation: 3 of the 7 designated accessible parking spots are potentially unusable by those with special needs and do not meet the proposed Built Environment Standard recommendations.

Of the seven, two are in questionable locations that could hinder use of the parking spots due to a low overhang and physical proximity to a raised curb, and one is virtually unusable due to the location adjacent to a pillar and a raised curb with no curb cut.

The three designated Accessible parking spaces that are located under the city garage ramp should be relocated to the central location where the other four are located or alternately in the outside lot in order to make sure that all the Accessible parking spaces are usable. The spaces should be repainted and sized to provide a mixture of Type A – Mobility Aided and Type B – Distance Limited spaces in accordance with the proposed built environment standard regulations. We also recommend designating one of the spots on the east side of the terminal as an accessible vehicle drop off spot to provide safe easy access to the terminal.

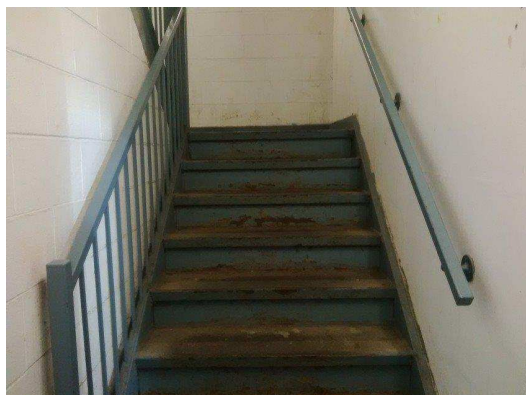
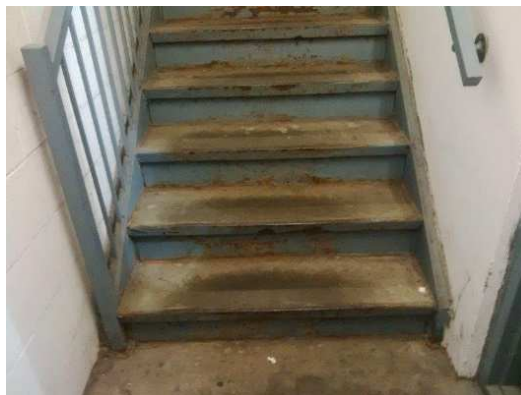
Observation: The railing is not at the correct height.

Observation: The stairs lack proper edge strips.

Observation: The ground level fire extinguisher in the stairwell is not properly secured in place.

There is no signage in the stairwell to indicate which floor you're on. The stairs do not have edge strips as outlined in the proposed built environment standard.

The stair access to the transit terminal from the City Parking garage needs to be addressed as it poses a safety risk to the public. Further, any improvements considered should specifically be undertaken to meet the proposed draft Built Environment Standard. Specifically, the handrails need to be raised to a minimum of 34 inches (864 mm) high. The front edge of the individual stairs need to be upgraded to include edge strips that extend the full width of the tread and provide a tonal contrast with the rest of the tread to provide visual cues as to the edge of the stairs. We recommend the edge strips be of the variety that provide a textured grip strip and a photo-luminescent colour strip which meets the colour difference requirement for stair edges and also aids in emergency evacuation situations by helping people exit the building safely even if the lighting systems fail. Finally, the fire station needs to be repaired to ensure the fire extinguisher in the stairwell is accessible yet secured in place.
