Accessibility Assessment:

Art Gallery of Peterborough

December 5, 2013

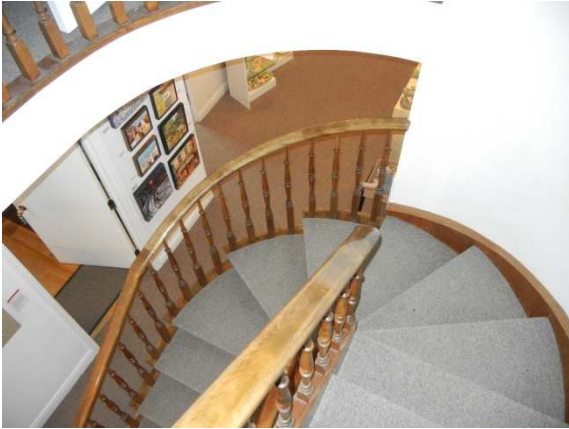
Original Building – Spiral Wood
Staircase

Other than the ramp, there are two main staircases. The first is located in the original section of the building (north end). This spiral wood staircase is 3'2" wide and what is unique about this staircase is that it is spiral and makes a full 180 degree turn at the halfway point in a span of 8'8". Any consideration for purchase of emergency evacuation equipment would require specific measurements to be taken to ensure that any of the emergency devices used to carry the disabled down these staircases in the event of an emergency would be able to make that turn. The turning radius may also deter the installation of devices such as a chairlift. This staircase leads from the main to the second level only.

The upstairs classroom area has only the ramp access as a means of accessible entry and exit from the 2nd floor. In the event of an emergency where the ramp was blocked off there would be a need for assisting those with mobility issues to exit the building via one of the two available stairwells. In order for staff to successfully assist in this process an evacuation chair needs to be purchased to ensure safe exit for all patrons on the 2nd floor. In addition, it would be helpful to purchase a portable ramp to assist with safe exit of the building via either the front or back doors from the gift shop/meeting area as both areas would require assistance for those with mobility issues to exit and a portable ramp could help decrease the time taken to exit the building in an emergency.

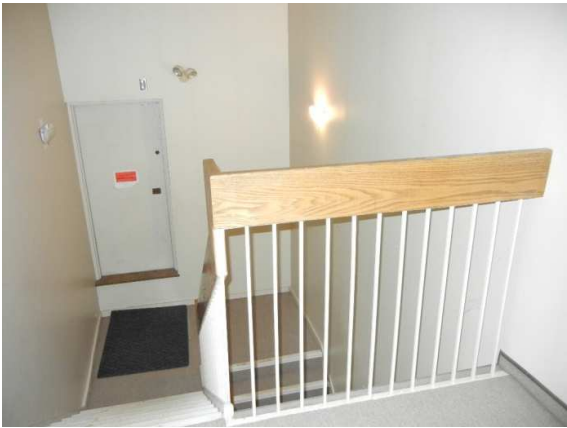
Emergency/Main Stairwell

The second staircase located just off the main entrance extends to all three levels. This is an emergency exit, is well lit, wide and in good repair. The stairwell has 5 landings and provides ample space for the manoeuvring of emergency devices to help the disabled out in case of an emergency. The stairwell has one handrail that is made of wood with steel rods for the banister.

The stairs are commercial grade broadloom and there are no threshold impediments.

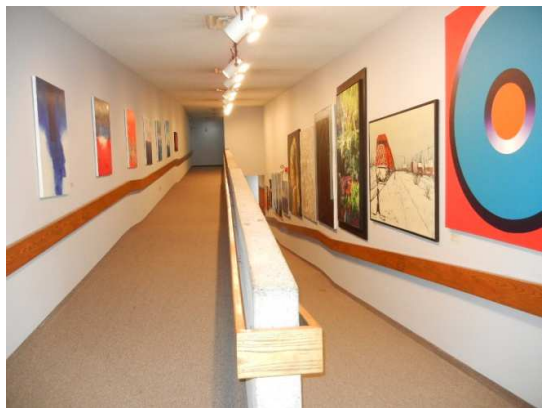
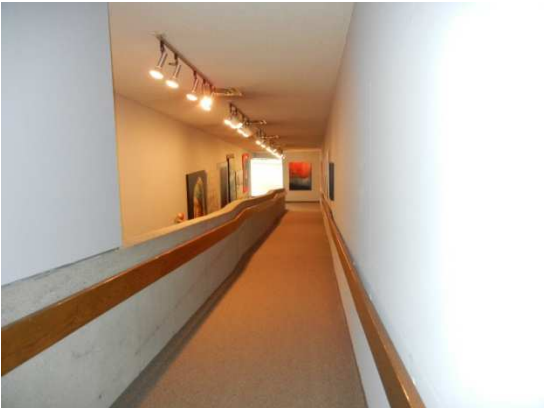
Observation: The central ramp system that provides access to the various levels presents a challenge for those with special needs due to the overall length of the ramp and the location of various features in the building.

The ramps are concrete and span the width of the modernist wing of the AGP. The ramp and landings are 80’ long and 4’9” in width, hand rail to hand rail. The handrail is solid wood type. There is artwork exhibited on the walls of the ramp which places the pieces in very close proximity to the guests and difficult for those in wheelchairs to stop on the sloped portion to admire the works. Resting spots were noted on the ramp and the slope is 3.5 degrees. The

ramps are the only way for a disabled person in a wheelchair to get from the second level to the bathrooms on the lower level or in the office area, through the gift shop, on the main level.

The ramps have low plush commercial grade carpet which does not impede wheelchairs.

The overall length of the ramp and the placement of the washrooms on the main and lower levels of the building turn one of the best accessibility features in the building into a negative point. An individual in a wheelchair using the upstairs classroom area that needs to use the washroom could have to travel approximately 1000 feet to travel to the lower level washrooms and back to rejoin his/her class. If they were attempting to go to the main floor washrooms they would be faced with a challenge to use them since the main floor washrooms have 29" doorways. In order to improve overall access to features in the building and travel time to get to the various parts of the gallery we recommend the installation of an elevator that would access all three floors. We've identified three options to consider for this project.

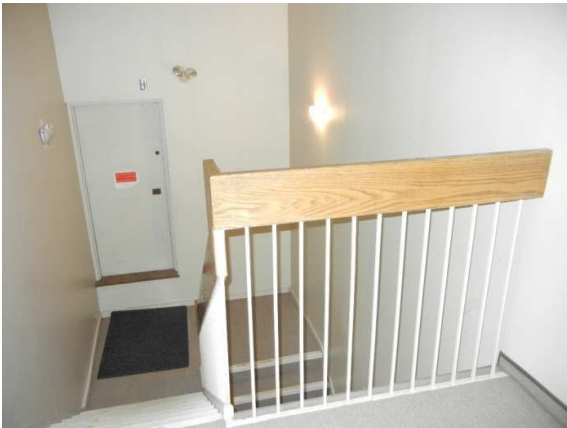
Emergency/Main Stairwell

Observation: Stairs in the building only have a handrail on one side instead of on both.

The second staircase located just off the main entrance extends to all three levels. This is an emergency exit, is well lit, wide and in good repair. The stairwell has 5 landings and provides ample space for the manoeuvring of emergency devices to help the disabled out in case of an emergency. The stairwell has one handrail that is made of wood with steel rods for the banister.

As part of the proposed accessible built environment standard, stairs are required to have railings on both sides set at a minimum height of 34" and a maximum height of 38". At a minimum, the emergency exit stairs in the modern section of the building should have an extra railing added at the appropriate height. It may not be feasible to add additional railings to the stairs in the older section of the building but it may be a good idea to limit use of those stairs to attempt to ensure patrons are using the new exit stairs where you can ensure they are using proper features.

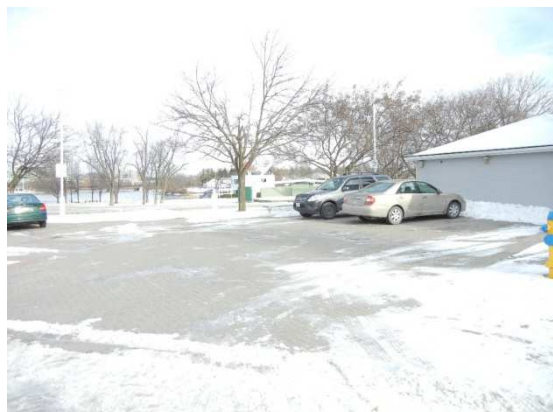
Current staff parking/possible alternate Accessible parking location

There is restrictive parking located immediately in front of the detached structure on the north side of the building. This parking is designated for the staff of the AGP and is not public parking.

We recommend one of two options for the accessible parking spots. The preferred option is to relocate the accessible parking to the area currently used for staff parking in front of the outbuilding that houses the kiln. Staff parking could either be reserved in the Del Crary Park lot or perhaps at the south end of the building by the loading dock. Proper signs and painting for these spots would be required as well as repositioning the bike rack at the front of the building to clear a direct path to the front entrance. Alternatively, the other option is to leave the accessible parking spots where they are but to move the parking spot signs closer to the road to clearly indicate the spots, paint the spots on the road so it is clear that those spots are not part of the roadway at the front but are designated parking spots and review the city and art gallery maintenance plans to ensure that the area is being cleared of snow and ice during winter months to ensure a clear path of access to the art gallery.

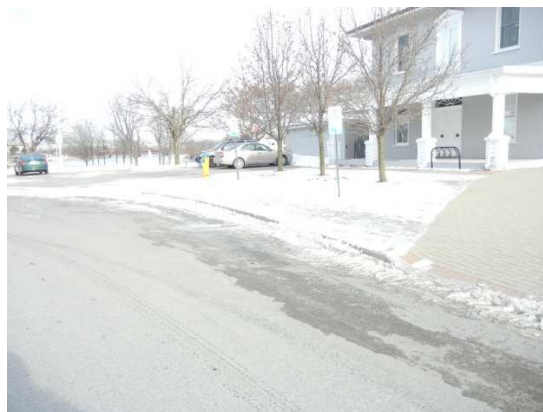
Designated Accessible Street Parking

Observation: At the time of the assessment the sidewalks and pathways from the designated Accessible Parking were snow and ice covered and represent a danger for anyone trying to park there and enter the building.

Observation 2: The currently designated Accessible parking spots are not clearly marked.

There are two accessible designated parking spots on the road immediately in front of the AGP. At the time of the assessment the spots were not cleared of snow and were icy. The curb is not well marked.

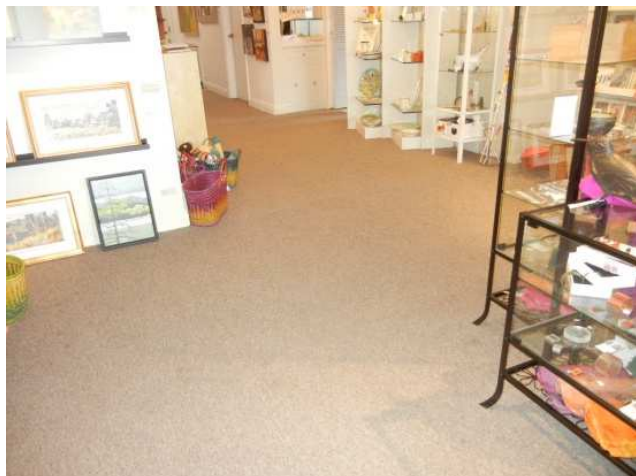
Observation: The shelving for gifts and other supplies in the gift shop, the adjoining meeting room and the upstairs classroom in many places have the lower shelves right on the floor which can present challenges for many in trying to access the items on those shelves.

We recommend that any resources or merchandise on shelving units in the gift shop, meeting and classroom areas should be at accessible heights being raised off the floor a minimum of 12 to 18 inches off the ground and no higher than 48 inches to achieve optimum display and access. This would apply to art supplies, lockers, retail shelving, and media/book/magazine shelving. Furthermore, all labels or signs for resources or merchandise should align to the standards previously mentioned with regard to font size and contrast with background to ensure maximum readability.
