RISK SUMMARY

500 George Street North Peterborough, ON K9H 3R9

A site visit was conducted on Nov 23, 2010 with Ken Doherty as well as several other employees from the City of Peterborough in attendance.

The purpose of the inspection was to identify potential risks associated with the 9 park areas where winter activities such as tobogganing and snowboarding have been taking place, as well as developing a risk management approach to handle these areas in the future. To date these areas have not been formally sanctioned by the city as designated areas for such activities, and the city has shown interest in eliminating some of the park areas for such activities altogether.

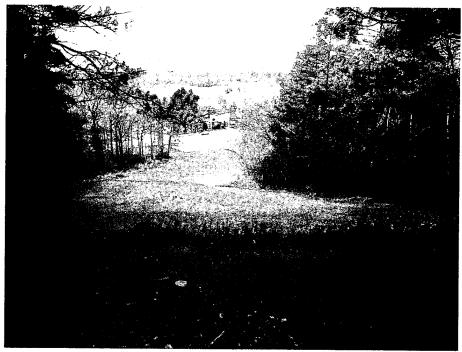
Liability - Priority Rating 2

Armour Hill East Slope - No Signage

Considering that this is the most popular hill and that it attracts both toboggans and snowboards, proper signage should be placed at the top and bottom of the hill. The signage should include but not limited to emergency call measures, location of nearest phone. The need for supervision should be considered as well as the intended use for the hill.

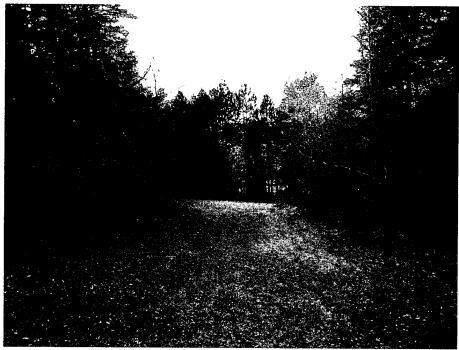
Liability - Priority Rating 2

There is potential for a longer run which you have to navigate through a small opening. This could be very dangerous and cause collisions with either trees or users that are further down the hill. We recommend closing up the gap by planting shrubs or trees to deter from its use.

Armour Hill East Slope - Steep / Narrow Run

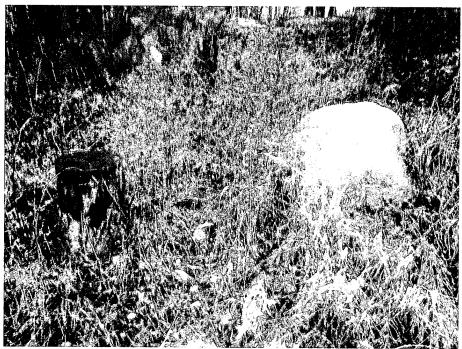
Liability - Priority Rating 2

Currently, there is a large size rock and tree stump protruding on the slope. We recommend removing these two items in order to make the hill safer.

Protruding Rock and Stump on Slope

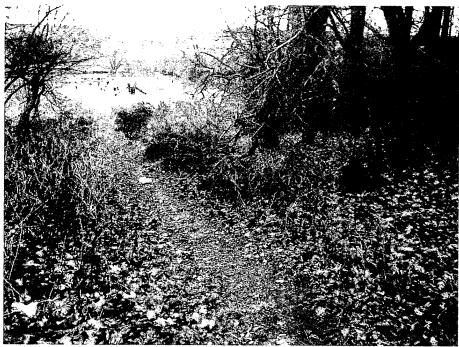
Liability - Priority Rating 2

Currently there is a potential narrow run down the slope that could lead to a collision. We recommend deterring the use of this longer narrow run.

Narrow Run

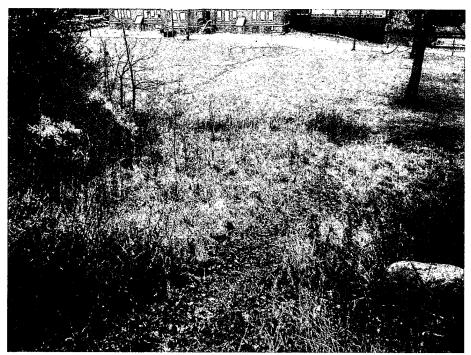
Liability - Priority Rating 2

The slope shown here has a tree that is a potential impact point. It is recommended that hay bales be used as protection.

Tree - Potential Impact Point

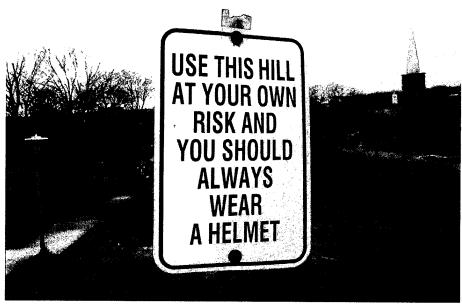
Property - Priority Rating 2

This general signage does not address the sanctioned specific winter activities. Emergency call measures, location of nearest phone and need for supervision should be considered. We recommend uniform signage be posted at all City of Peterborough sanctioned sledding hills.

Signage Wording

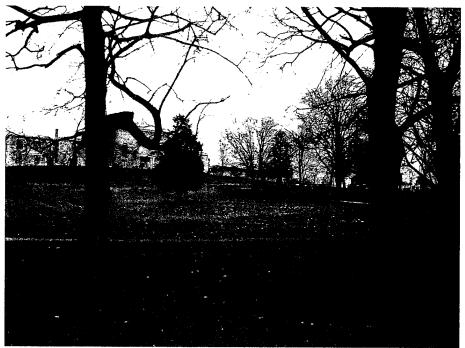
Liability - Priority Rating 2

Currently, the slope has many impact points which are covered by rubber tires. It is recommended that hay bales be used instead as protection since in cold conditions rubber tires can freeze and become very hard.

Impact Points - Covered by Rubber Tires

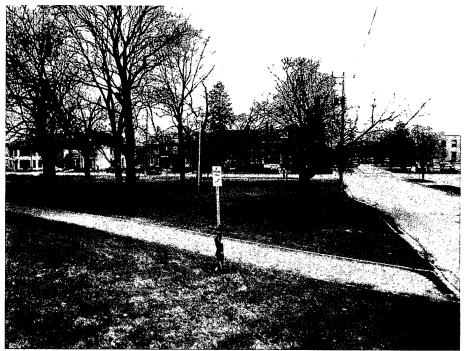
Liability - Priority Rating 2

Currently there is a pedestrian path intersecting the toboggan hill. We recommend putting up signage at both entrances warning pedestrians of this danger.

Pedestrian Path Intersects Toboggan Hills
