**CONDITION REPORT**

**Object:** Metal Sculpture  
**Owner:** Art Gallery of Peterborough  
**Location:** 250 Crescent Street, Peterborough ON

**Title:** 'Three Part Groundscreen'  
**Artist:** Peter Kolisnyk  
**Date of Object:** 1986

**Examination Date:** August 2011

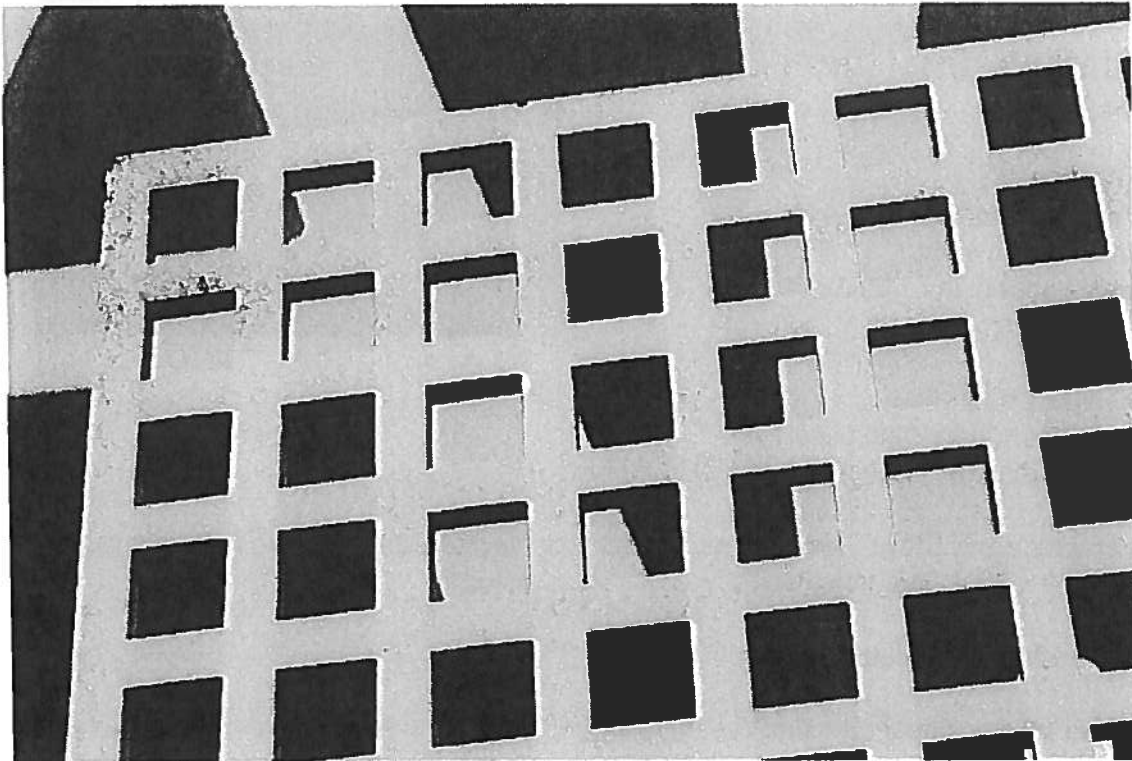
Rust (iron oxide) staining is evident across the front and back of all three panels

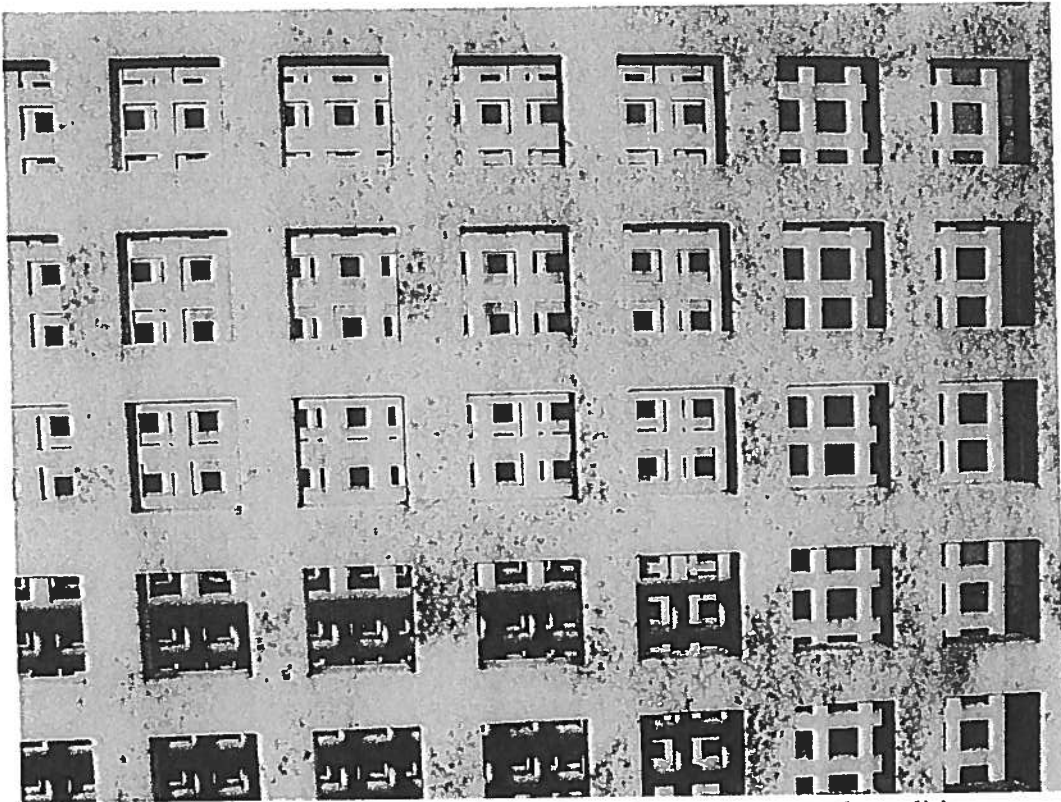
Rust (iron oxide) speckling due to exterior environmental conditions

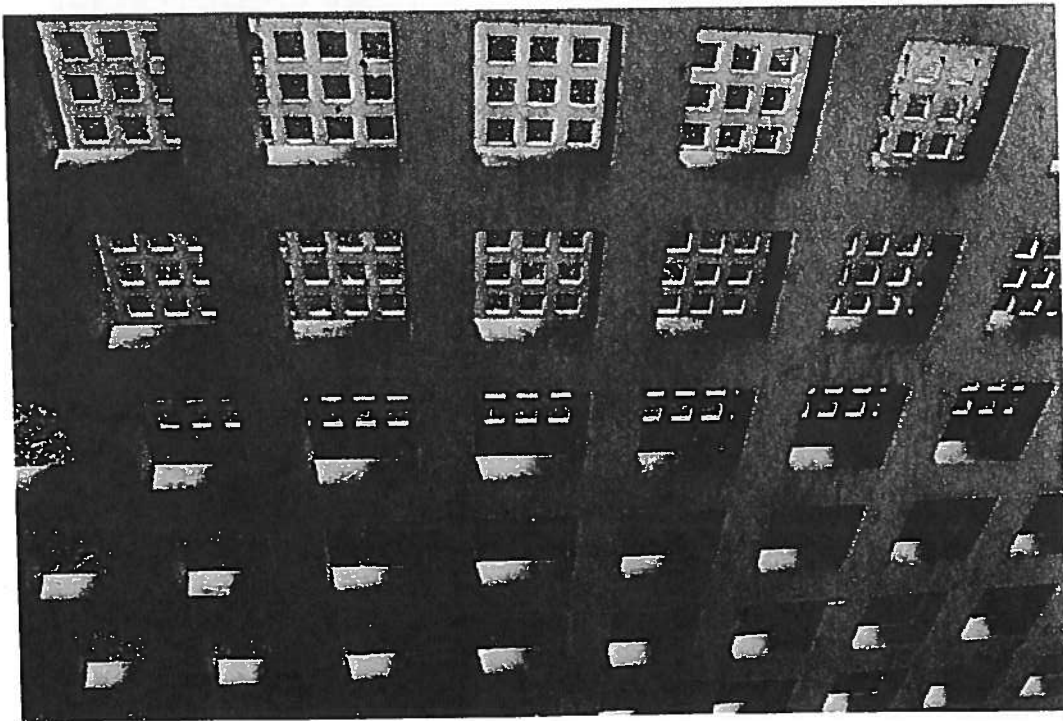
Corrosion is fairly extensive, but is superficial damage only (unless left untreated)

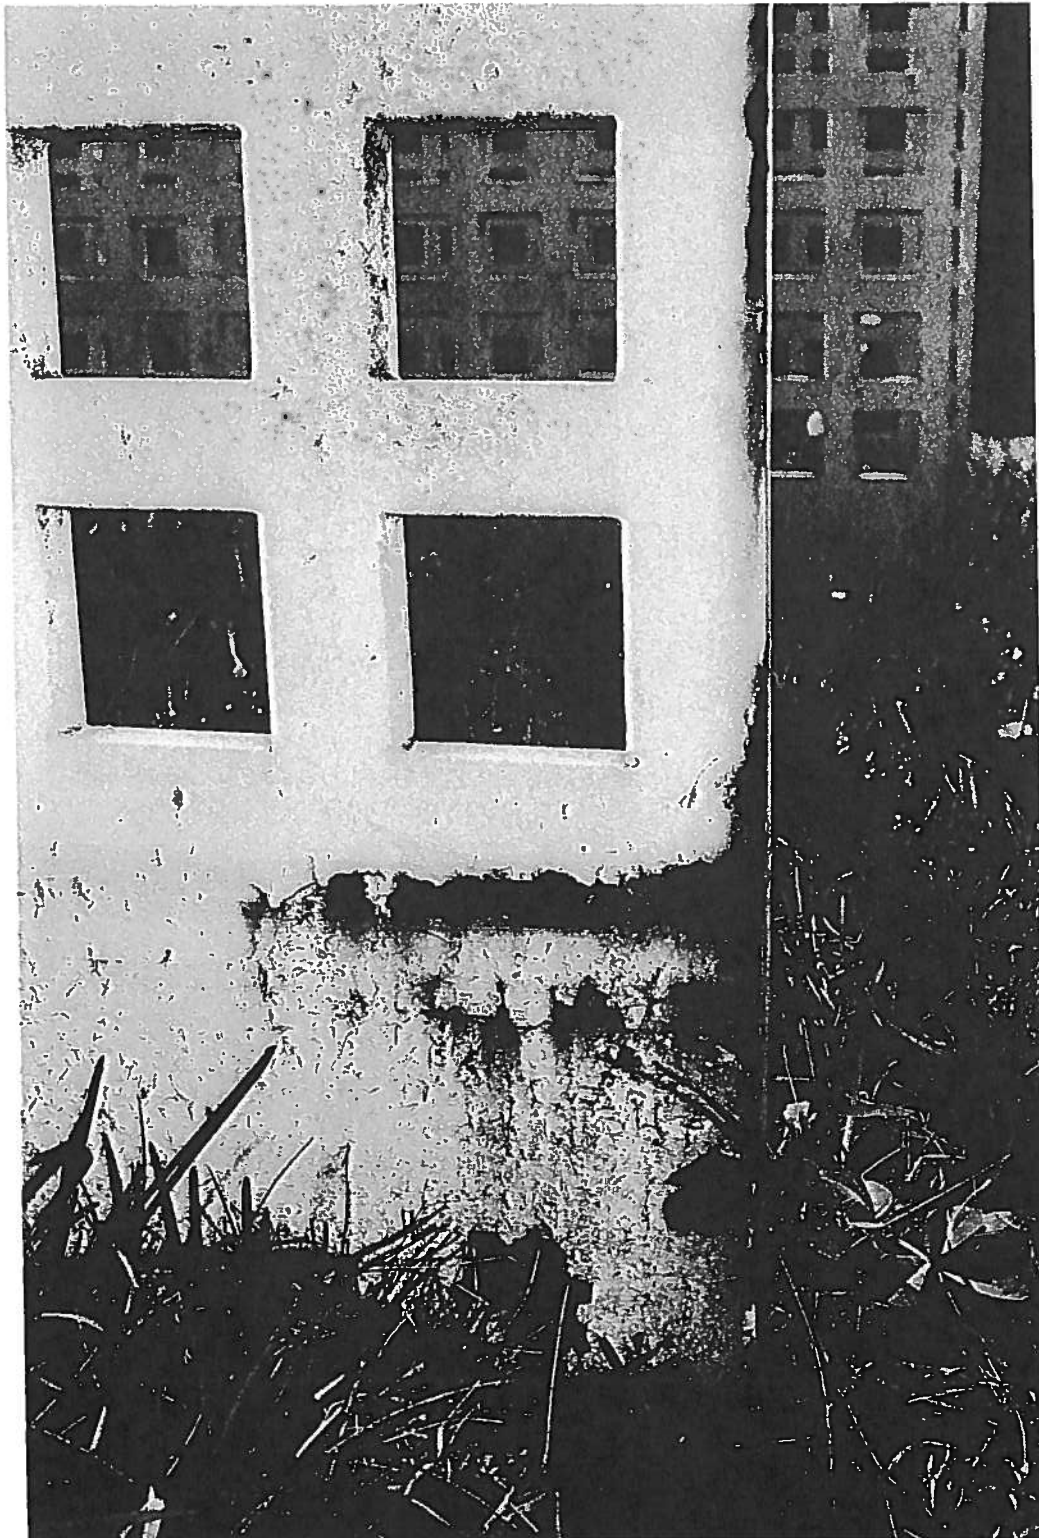
The area at greatest risk on all three panels is the base, where the steel is in contact with soil and there is little water drainage.

Corrosion is heaviest at panel base, along with evidence of mould/mildew growth

- Providing proper drainage around each panel's base should be the highest priority for treatment.
- Base of each panel should be protected from landscape maintenance equipment (i.e. weed trimmers and lawn mowers).
- Removing existing paint and applying a more robust coating system will improve overall appearance and provide better protection for the steel.
