Subject: Report USTR18-003

Raymond Street / Westdale Avenue Traffic Operational Review

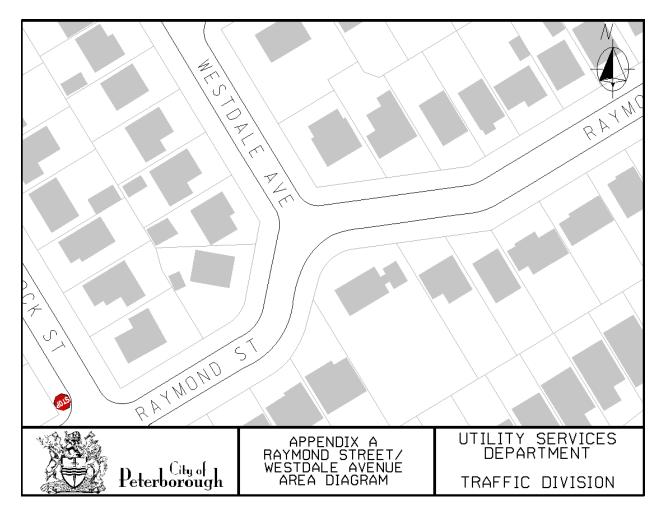
## **APPENDIX A - EXISTING AREA DIAGRAM**

Westdale Avenue intersects Raymond Street from the north to create and non-typical "Y" intersection as shown in Appendix A. There is currently no intersection control at the intersection of Raymond Street and Westdale Avenue and drivers are expected to observe the right-hand rule when entering the intersection. The right-hand rule under the Highway Traffic Act, dictates that when two vehicles enter an uncontrolled intersection at the same time, the driver on the left shall yield the right-of-way to the driver on the right. An example would be if a southbound driver on Westdale Avenue and an eastbound driver on Raymond Street were to approach the intersection at the same time, the southbound driver would have to yield the right-of-way to the eastbound driver, as the eastbound driver would be approaching on the southbound driver's right-hand side.

Sightline distances were measured and found to be below minimum TAC guidelines for all approaches. The front yard of the property on the south side of the intersection is elevated, making it difficult for vehicles travelling eastbound and westbound on Raymond Street to see vehicles approaching from the opposite direction. In addition, the abundance of trees, bushes, and vehicles parked on Raymond Street west of Westdale Avenue result in reduced sightlines on all approaches.

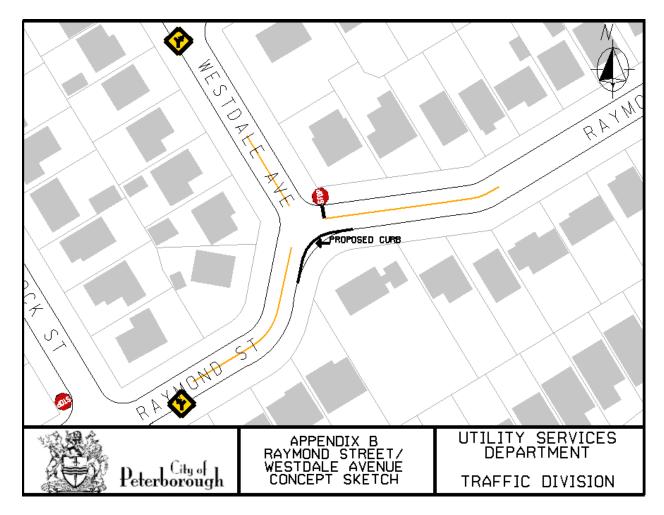
## **APPENDIX B - CONCEPT SKETCH**

The non-typical "Y" intersection geometry creates a large radius on the south side of Raymond Street through the intersection. This extra road width encourages westbound drivers travelling through the intersection to cut the corner into the eastbound lane, as well as eastbound drivers taking wide left-hand turns onto Westdale Avenue. To improve the geometry of the intersection, staff is of the opinion that the south curb line should be re-aligned to reduce the existing radius and narrow the pavement width. These geometric changes along with implementation of the stop sign on Raymond Street, yellow dividing line pavement markings, and intersection warning signs will encourage slower speeds and improve guidance through the intersection. A concept drawing of the recommended improvements is shown in Appendix B.

- a) That Stop control be implemented on Raymond Street at Westdale Avenue; and
- b) That a 2018 Capital Budget be created in the amount of \$35,000 for the Design and Construction of Improvements to the intersection of Raymond Street and Westdale Avenue as shown in Appendix B to Report USTR18-003 to be funded from the uncommitted balance in the 2018 Capital Budget for Traffic Improvements (Project 5-13-04).

The Raymond Street / Westdale Avenue Traffic Operational Review has shown that vehicle speed, vehicle volume, and collision history is typical of a local residential intersection within the City of Peterborough. Despite this, a review of sight lines, stopping sight distance and driver behaviour supports the need for right-of-way control. As a result, staff recommends the implementation a stop sign on Raymond Street on the east leg of the intersection for westbound traffic; yellow dividing line pavement markings on Raymond Street and Westdale Avenue; the re-alignment of the curb on the

south side of the intersection and; the installation of intersection warning signs to increase driver awareness and reduce the number of near miss collisions.
