107 Park Street North

HERITAGE IMPACT ASSESSMENT REPORT

September 4, 2025

Project # 23120

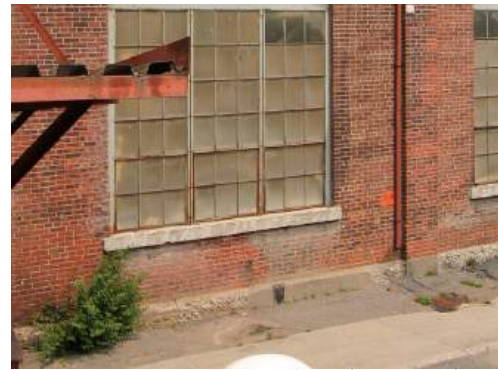
Foundations: Concrete foundations are evident in much of the construction. In many buildings, these concrete foundations demonstrate extensive deterioration; and reinforcing steel is exposed in many locations.

22. Deteriorating concrete base (ERA, 2023)

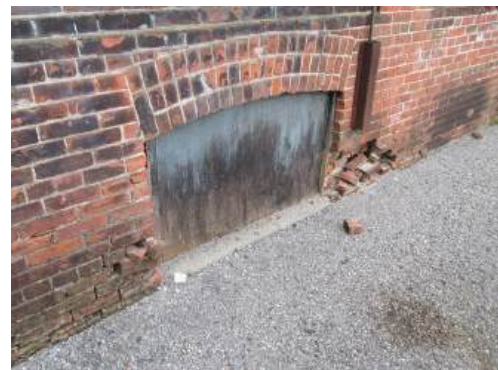
23. Brick deterioration (ERA, 2023)

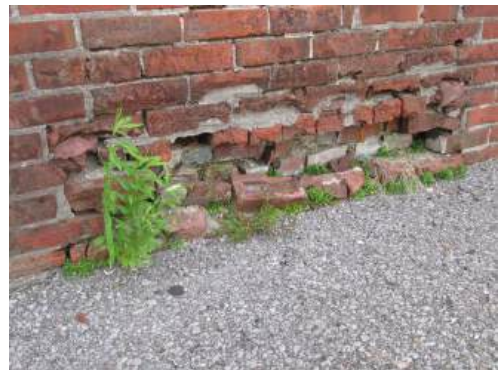
24. Brick deterioration and unsympathetic repair(ERA, 2023)

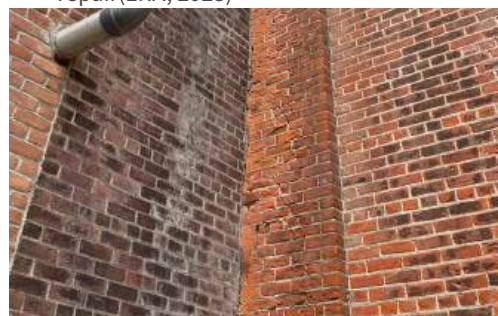
25. Brick deterioration at intersection of buildings ERA, 2023)

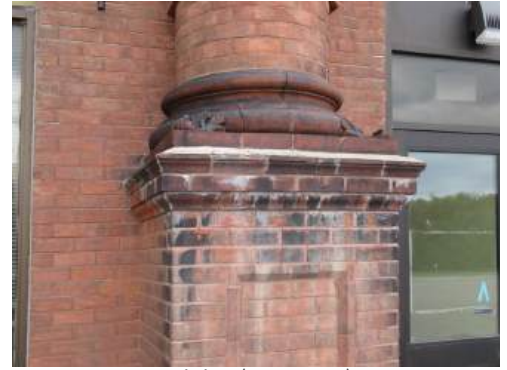
27. Masonry staining (ERA, 2023)

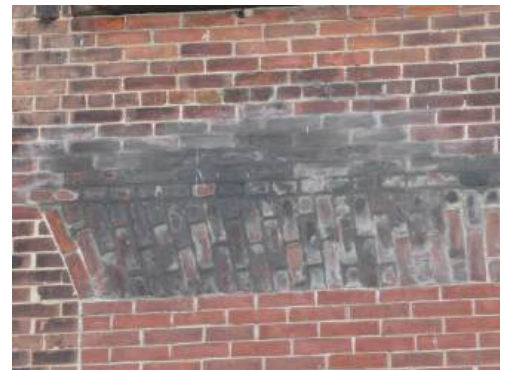
28. Masonry staining and efflorescence (ERA, 2023)

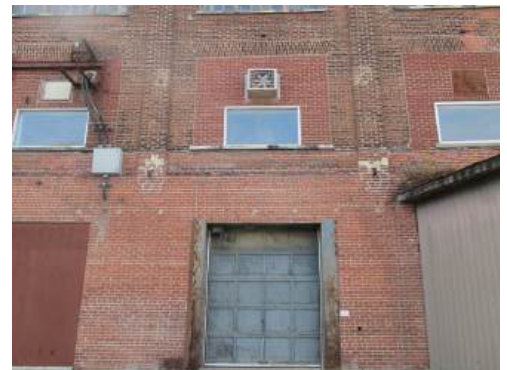
29. Infilled windows and entrances (ERA, 2023)

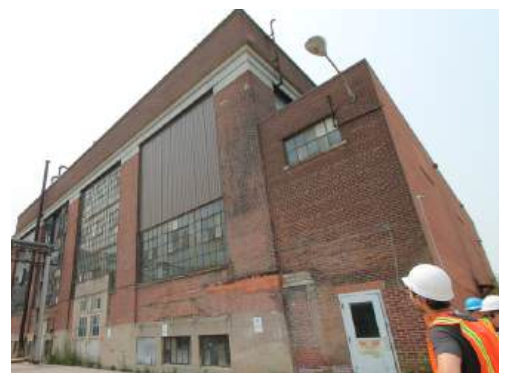
26. Infilled windows (ERA, 2023)

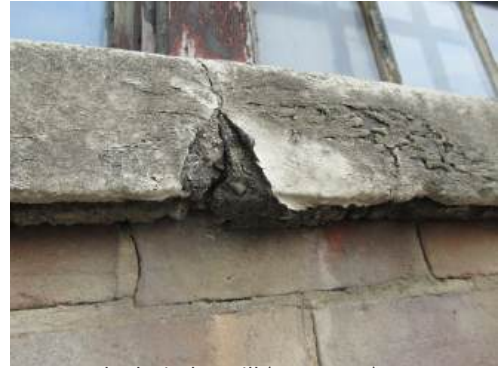
30. Cracked window sill (ERA, 2023)

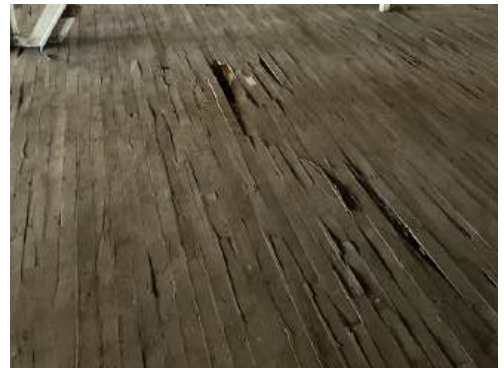
31. Condition of wooden floors (ERA, 2023)

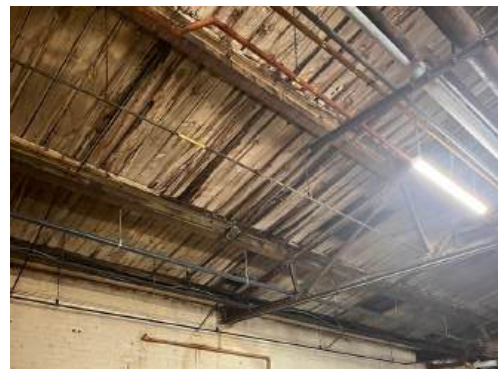
32. Interior water damage to ceiling (ERA, 2023)

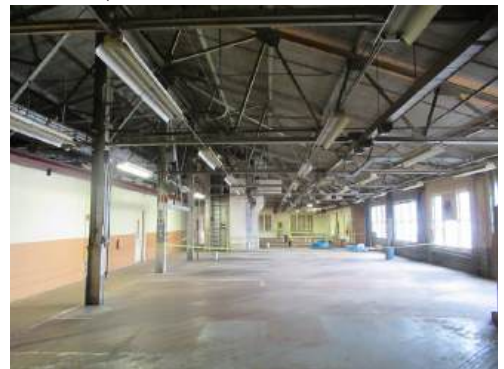
Roofs: The roofs of the currently occupied buildings are in good to fair condition. The roof of Building 30 was leaking towards the western portion of the building at the time of assessment. The roof canopy of Building 30 has some damage in the leaking area. Flashings are also found to be in fair condition throughout.

33. Area of roof leak damage, Building 30 (ERA, 2023)

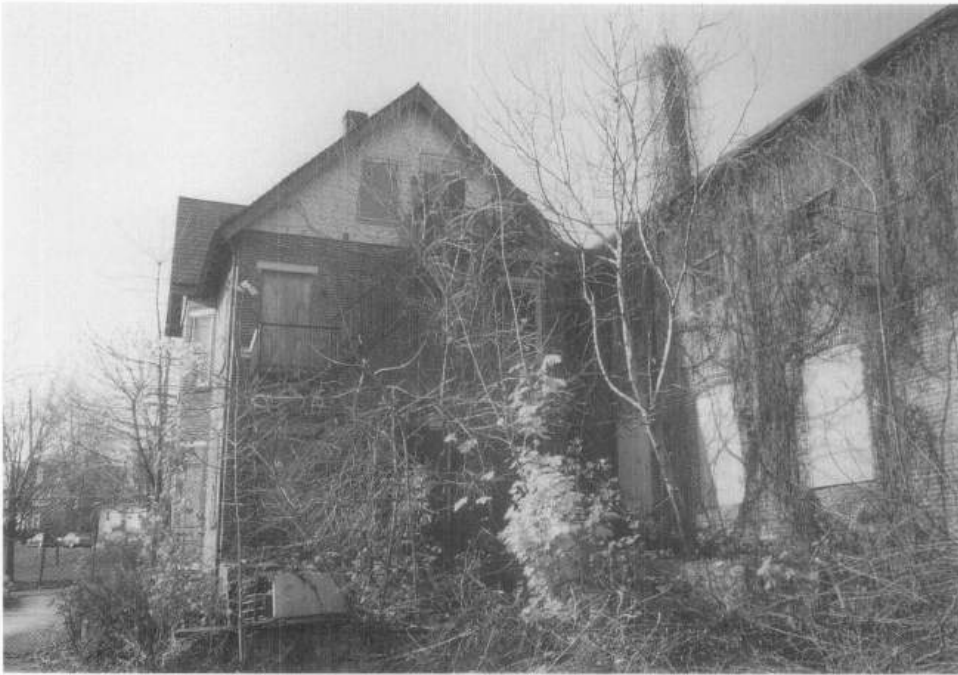
Figure 2. Improper treatment: Boarding up without adequate ventilation, lack of maintenance, and neglect of this property have accelerated deterioration. Photo; NPS file.

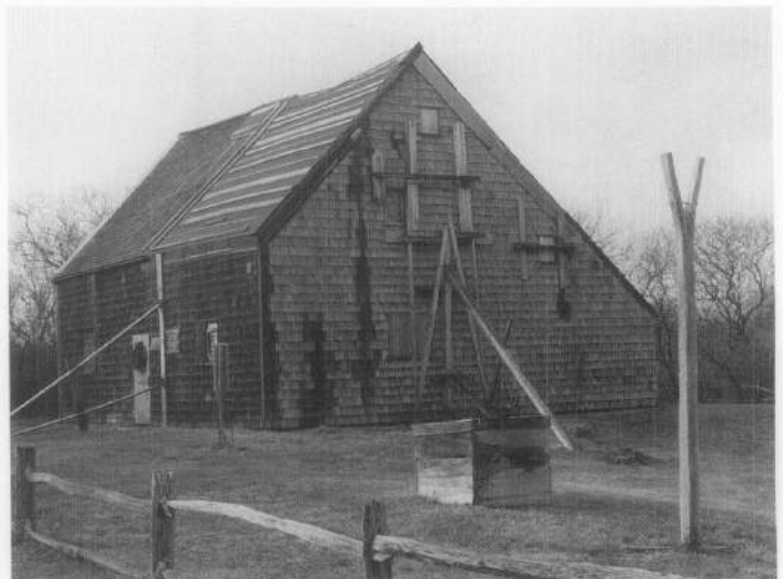
Figure 3. Buildings seriously damaged by storms or deterioration may need to be braced before architectural evaluations can be made. Jethro Coffin House. Photo: John Milner Architects.

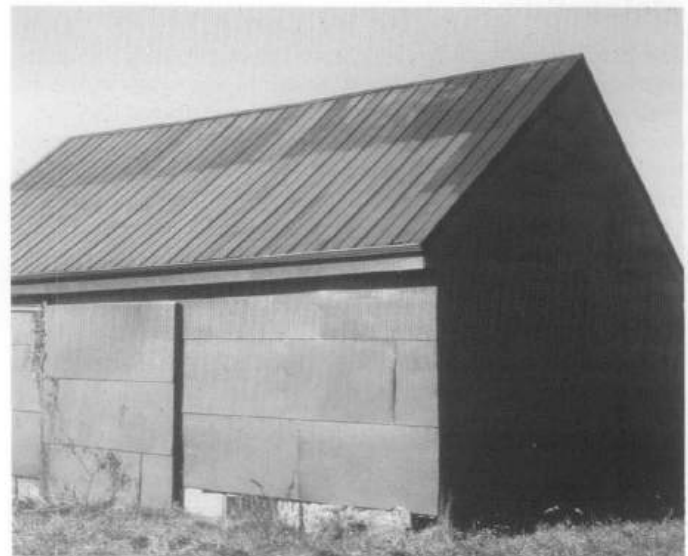
Figure 9. Severely deteriorated wooden siding on a farm building has been covered over with painted plywood panels as a temporary measure to eliminate moisture penetration to the interior. Foundation vents and loose floor boards allow air to circulate inside.
