City of  
**Peterborough**

**Subject:** Report USDIR15-005  
Overview of Snow Disposal Area Operations and Condition of  
the Kennedy Road Woodlot

A report to provide an update on the operation of the Snow Disposal Area and the condition of the Kennedy Road Woodlot.

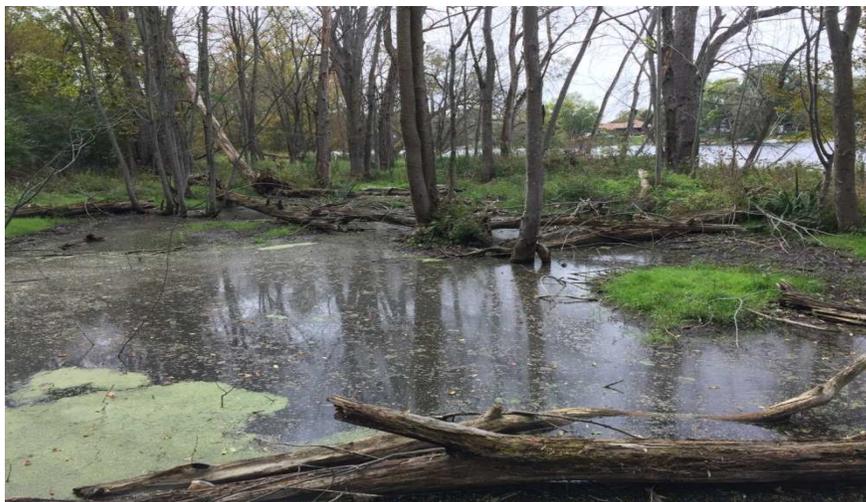
A topographic (ground levels) survey was undertaken in November 2014. Ground observations by Staff identified areas of standing water and anaerobic soil conditions. Some areas were seen to be laying wet constantly throughout the year as depicted in Figure No. 5.

Figure No. 5: Low-lying Areas within the Woodlot

Levels surveys have identified low-lying areas of the woodlot that regularly flood and do not always naturally drain or evaporate throughout the course of the following growth season. Watershed into to these areas has increased as a result of snow disposal, which, together with high river levels in recent years, has resulted in parts of the woodlot failing to dry out over the course of the summer.

In addition, there will be further investigation into the possibility of mitigating the impact of the low areas in the woodlot although this is most likely a longer term project.

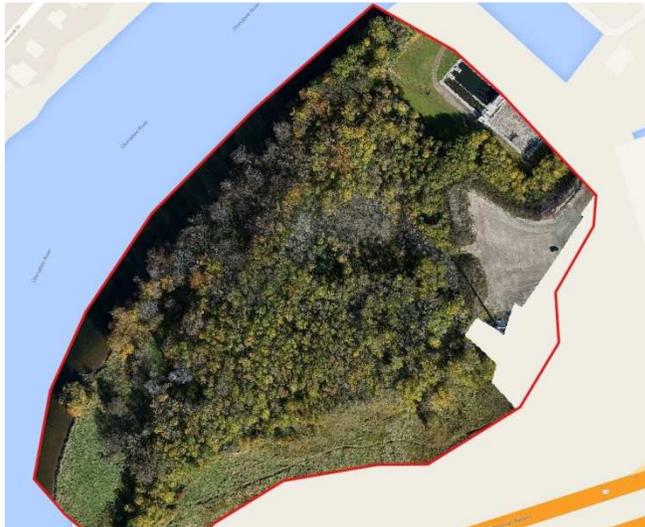
A number of aerial photography runs were done with the use of a drone in 2015. Figure No. 6 shows the results of one such run.

Figure No. 6: Drone photo Showing Dead and Dying Trees and Early Fall Colour

- Removal of dead trees to clear out dead wood and open up the woodlot to encourage regeneration. Some deadwood (standing and fallen) will be left for habitat and ecological benefit but within the parameters of good safety management. The anticipated start of this work would be in the winter of 2015/2016;
- Replanting of the woodlot with species more appropriate to the existing conditions. A fall 2016 start to this work would be anticipated.
- The reforestation program would include a Buckthorn management plan to allow for proper growth and regeneration of desirable trees.
