Heritage Restoration Project
Preliminary Document
January 10, 2015.

The Mount Community Centre Peterborough, On.

# COMMUNITY ON THE MOUNT Table of Contents

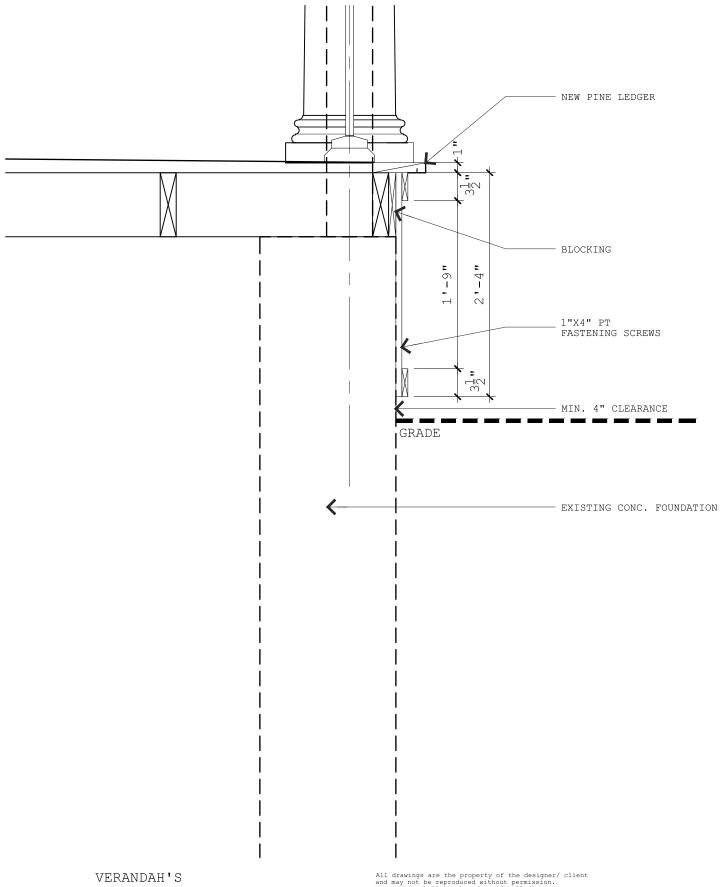
sk 1.1b

LOWER DECK SKIRT SECTION

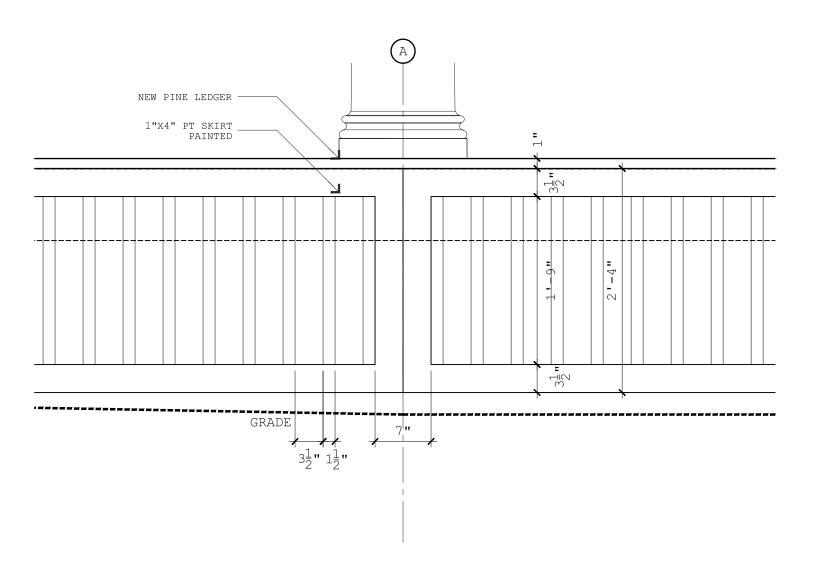
sk 1.1a

# VERANDAH'S LOWER DECK SKIRT ELEVATION

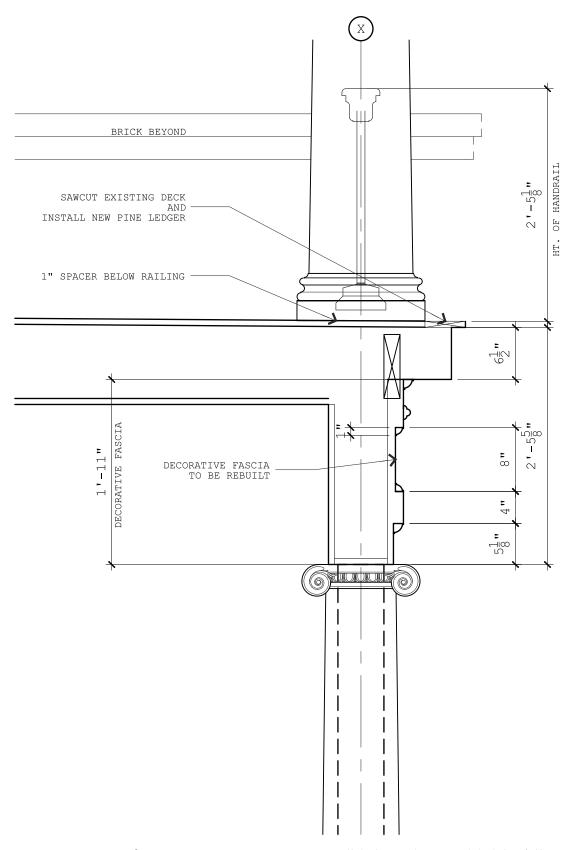
sk 1.2b

VERANDAH'S LOWER FASCIA SECTION

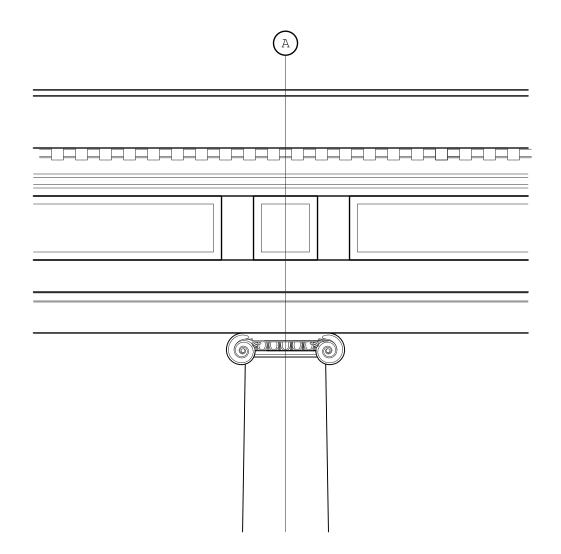
sk 1.3a

# VERANDAH'S UPPER FASCIA ELEVATION

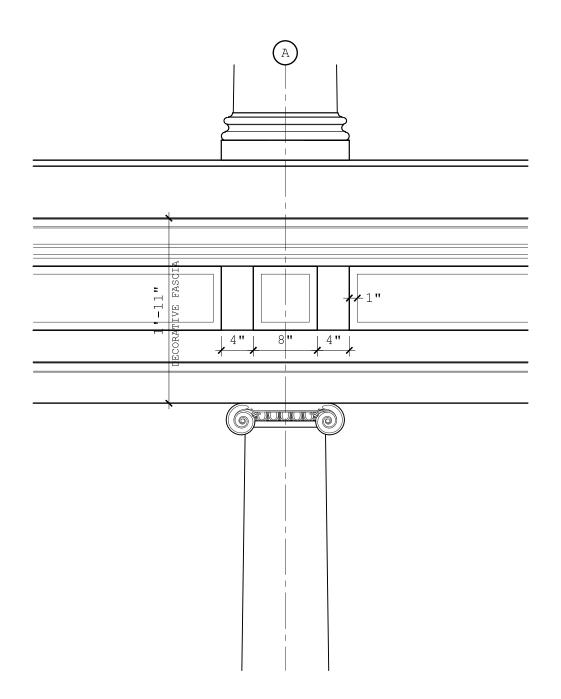
sk 1.2a

VERANDAH'S LOWER FASCIA ELEVATION

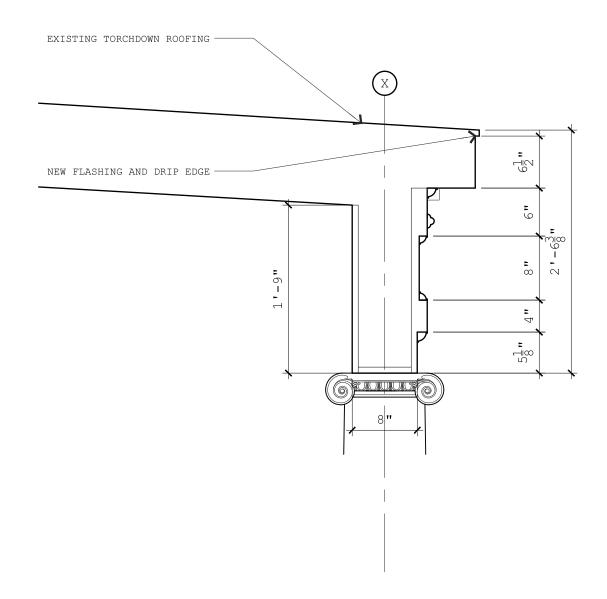
sk 1.3b

VERANDAH'S UPPER FASCIA SECTION

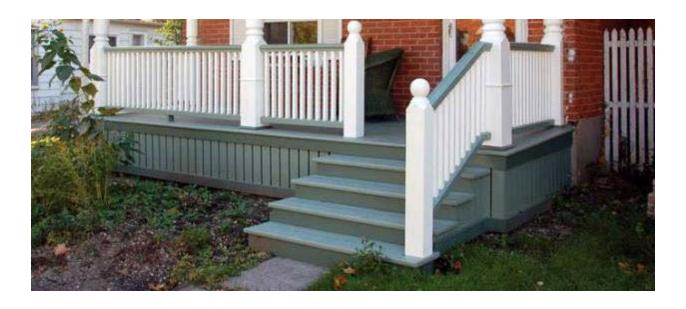
# 1.2 Skirt

The plywood skirt surrounding the decks has been removed and a more traditional design has been selected. This relatively common and simple skirt will enhance the base of the verandahs without detracting form the classical design of the columns and architectural details above. It will also allow for the crawl space below the ground floor decks to be properly ventilated.

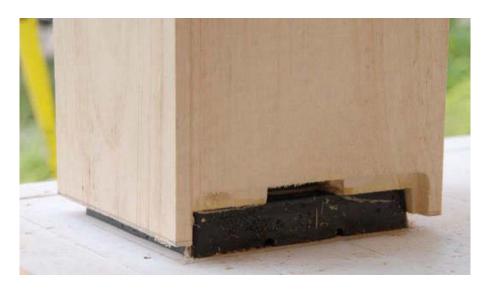
# 1.0 Column Base Support

By lifting the base of the columns and installing a non-rot support, the base of the historic columns is prevent form water damage in the future. Trim around the base covers the support and still allows fro proper drainage.

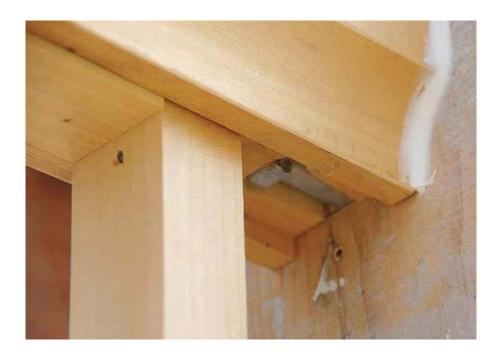
# 1.1 Railing Attachment

Proper metal attachments imbedded into the column and fastened to the railing shoe provide durable and strong attachment.
