# Peterborough County/City Waste Management Site Liaison Committee Meeting Tuesday, January 19, 2010 at City Hall

# JANUARY 19, 2010 SITE INSPECTION – SFA PETERBOROUGH CITY/COUNTY WASTE MANAGEMENT FACILITY (PCCWMF)

# SITE INSPECTION REPORT PETERBOROUGH CITY/COUNTY WASTE MANAGEMENT FACILITY (BENSFORT ROAD LANDFILL)

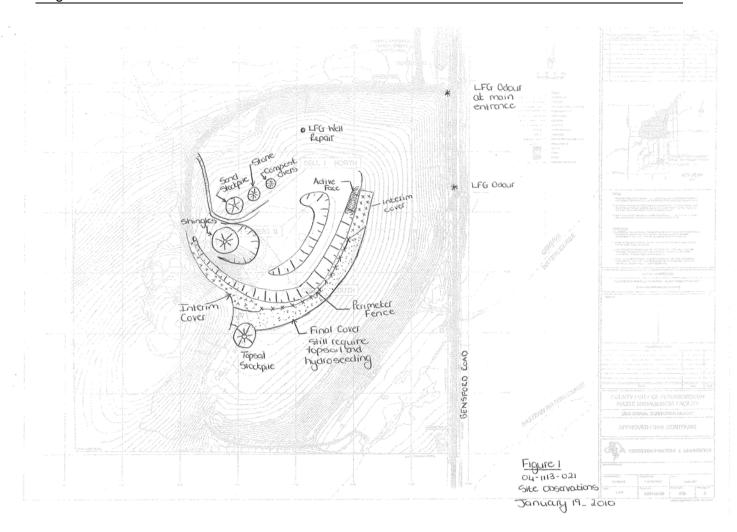
Attachments: Figure 1 - Site Inspection – January 19, 2010 Site Inspection Report

The site inspection was performed on the afternoon of January 19, 2010 by Mr. Chris Visser. The inspection consisted of an approximately 2 hour walk-over of the SFA (Cell 1-North, South and West) of the landfill site and the Public Drop-off area, and included observations of the site conditions and ongoing operations. Mr. Visser was accompanied by the landfill site manager, Mr. Craig Simmons, who provided additional information on site operations and recent maintenance works completed at the site. The following is a summary of the notable observations made during the walk-over inspection (refer to the attached Figure 1 for general locations and to the Site Inspection Report for notes).
