Properties Eligible for Listing on the Heritage Register of the City of Peterborough

The following properties have been identified as having met at least one of the criteria.

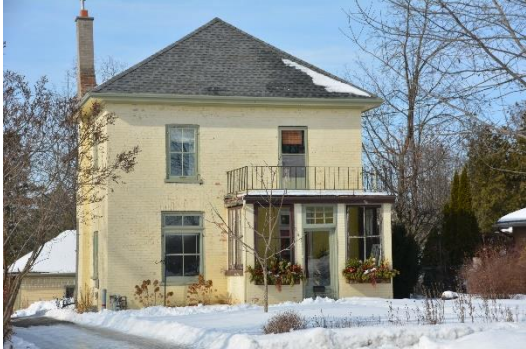
Address	Statement of Significance Heritage Value	Photo
247 Burnham Street	<p>247 Burnham Street was constructed circa 1905 and was originally occupied by George C. Carruthers, a miller at Meldrum & McAllister. The property contributes to the historic landscape of Burnham Street.</p> <p>Heritage Attributes: Two-storey brick construction; hipped roof; fenestration; offset entrance with covered vestibule porch with transom and sidelights and upper floor balcony.</p>

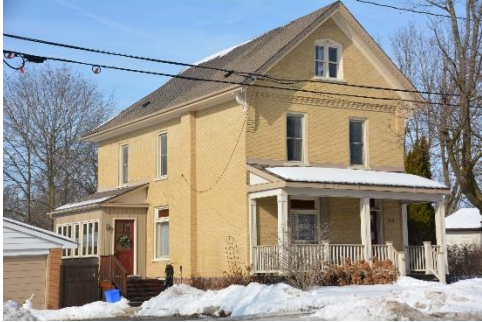
253 Burnham Street	<p>Constructed in the early 1900s, 253 Burnham Street is a good example of vernacular early twentieth century residential design, including moulded brick work and brackets and a gable front plan. The property contributes to the historic landscape of Burnham Street.</p> <p>Heritage Attributes: two-and-a-half-storey buff brick construction; gable front roof; central upper window and surround; fenestration; windows with decorative glass transoms, decorative brickwork and cornice brackets, entrance with transom; verandah.</p>

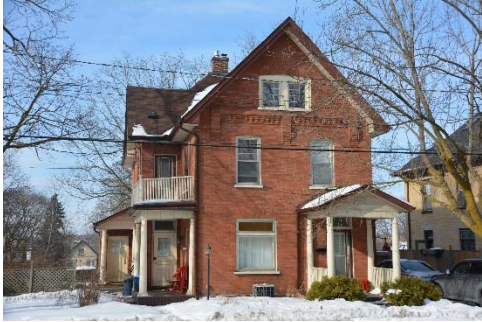
265 Burnham Street	<p>Constructed circa 1906, 265 Burnham Street is a good example of Edwardian style vernacular residential design. It also features decorative brick work below the top storey on a gable front plan. It is notable for its projecting entrance vestibule and side porch.</p> <p>Heritage Attributes: Two-and-a-half story red brick construction; gable roof; chimney; central window; fenestration with transoms; front and side gables; offset entrance with projecting vestibule with transom; decorative moulding; columns on side verandah and projecting vestibule.</p>

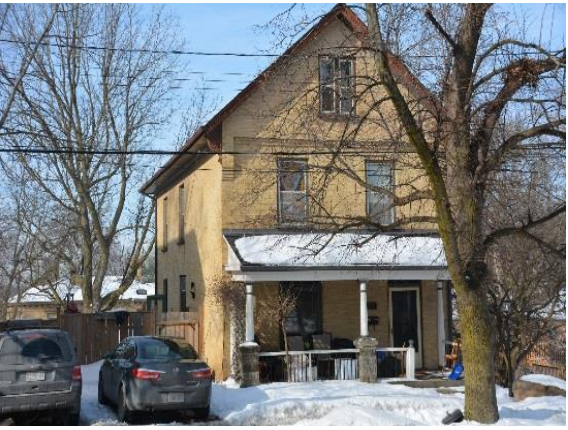
Address	Statement of Significance Heritage Value	Photo
<p>269 Burnham Street</p>	<p>Constructed in the late 19th century, 269 Burnham Street is a good example of vernacular early twentieth century residential design, including moulded brick work and brackets and a gable front plan. The property contributes to the historic landscape of Burnham Street.</p> <p>Heritage Attributes: two-and-a-half-storey buff brick construction; gable front roof; central upper window and surround; fenestration; windows with decorative glass transoms, decorative brickwork and cornice brackets, entrance with transom; verandah, columns; piers.</p>

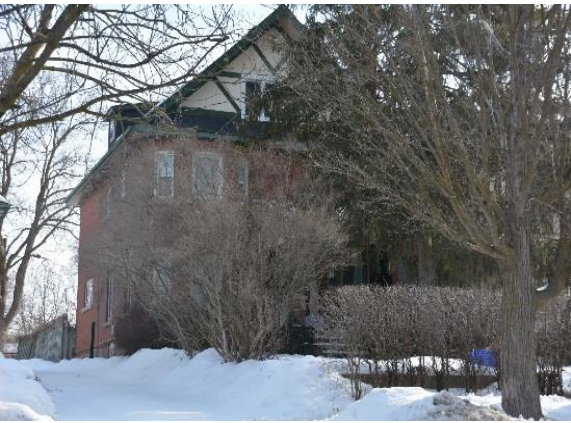
<p>272 Burnham Street</p>	<p>272 Burnham Street is an example of a two-and-a-half storey, bay and gable brick structure. The front gable contains a mock half timber detail and central tripartite window. The property contributes to the historic landscape of Burnham Street.</p> <p>Heritage Attributes: Two-and-a-half-storey red brick construction with gable end featuring stucco and half timbering; 2-storey projecting bay; second-storey dormers; fenestration; cut stone sills; verandah; offset entrance with transom; entrance porch including entablature stone pillars with coping.</p>

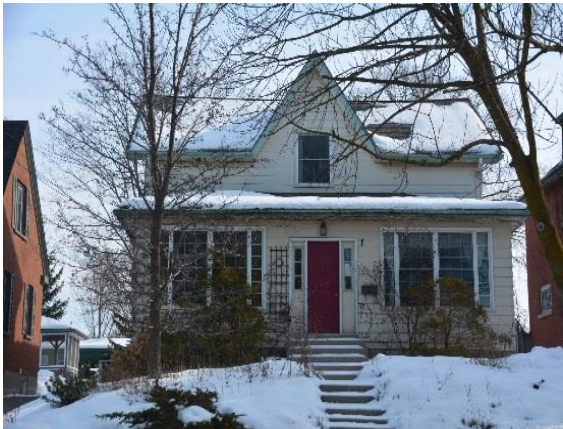
<p>278 Burnham Street</p>	<p>278 Burnham Street was constructed circa 1874 on land originally owned by John Mowry, a machinist for Mowry & Forsyth, manufacturers of agricultural implements, etc. in Ashburnham. The Mowry family occupied the house until 1899. It is a good example of Ontario Gothic style cottage. It displays features associated with the style including central gable, a gable roof and central entrance.</p> <p>Heritage attributes: One-and-a-half storey possibly frame construction; gable roof; central gable; central entrance with sidelights.</p>

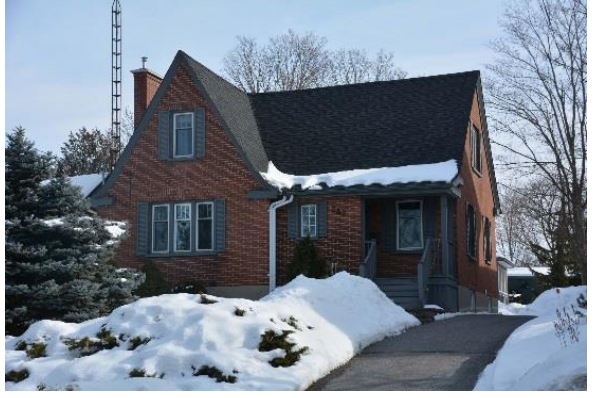
Address	Statement of Significance Heritage Value	Photo
282 Burnham Street	<p>282 Burnham Street is a good example of an Arts and Crafts style home with some Tudor revival style features. Its irregular composition, small window openings and windowpanes and bell cast gable end roof are characteristics of this style.</p> <p>Heritage attributes: one-and-a-half storey red brick construction; irregular composition; gable end roof; cornice returns; fenestration; brick chimney; recessed entrance.</p>

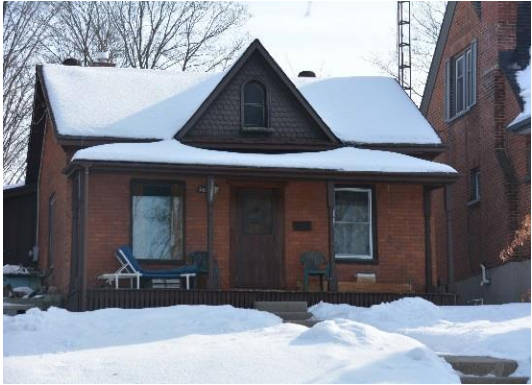
288 Burnham Street	<p>288 Burnham Street was constructed around 1870 and appears on the 1875 Bird's Eye View map of Peterborough from that year. It is a good example of an Ontario Gothic style cottage featuring brick construction and steep central gable, arched window and wide verandah.</p> <p>Heritage attributes: One-storey red brick construction; gable roof; central gable; rounded central window; fenestration; verandah with low pitched roof; entrance.</p>

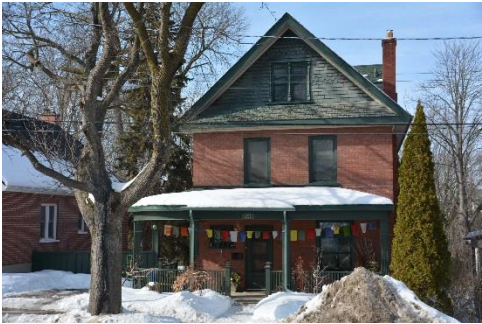
291 Burnham Street	<p>291 Burnham Street was constructed in the early twentieth century and is an example of the Edwardian Classical front gable style. It features a paired window with decorative moulding and shingles in the front gable. It is a contributing property to the character of the neighbourhood.</p> <p>Heritage attributes: Two-and-a-half storey red brick construction; hipped roof with front gable; shingles; double window with moulding; fenestration; offset entrance; verandah with low pitch roof.</p>

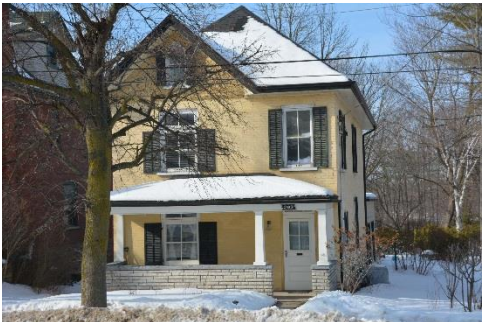
Address	Statement of Significance Heritage Value	Photo
293 Burnham Street	<p>Constructed circa 1903, 293 Burnham Street is an example of a vernacular residence constructed using some Queen Anne style features pared down to a simple design, including an offset gable front. The property contributes to the historic landscape of Burnham Street.</p> <p>Heritage Attributes: two-storey brick construction; offset gable; central gable window; front gable; hipped roof; asymmetrical massing; verandah; tapered square columns; offset entrance; fenestration; shutters; transoms above main floor and second floor window.</p>

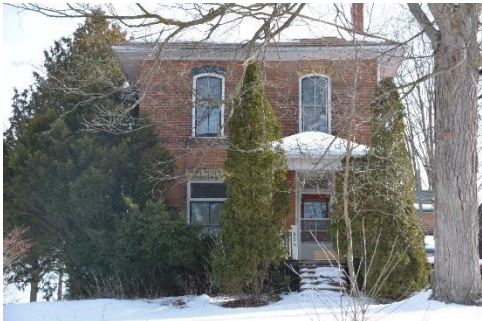
294 Burnham Street	<p>A typical Victorian vernacular style dwelling constructed in about 1890. The property contributes to the historic landscape of Burnham Street.</p> <p>Heritage Attributes: Two-storey red brick construction; hipped roof; rounded upper storey windows; brick voussoirs; fenestration; offset entrance with transom light and porch; main floor front widows with transom.</p>

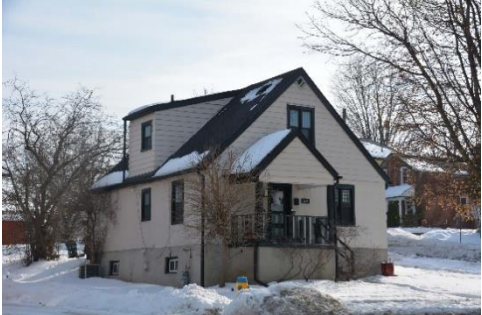
304 Burnham Street	<p>This property contributes to the historic landscape of Burnham Street.</p> <p>Heritage Attributes: One and a half storey possible frame construction; asymmetrical massing; gable roofs; offset entrance; fenestration</p>

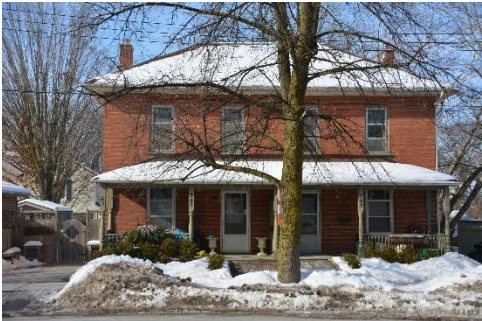
307-309 Burnham Street	<p>Constructed around 1880, the property contributes to the historic landscape of Burnham Street. The duplex reflects the demographic of the Burnham Street area and its proximity to early industry in East City. 307-309 was most likely rented to workers.</p> <p>Heritage Attributes: 2-storey red brick construction, hipped roof; fenestration; symmetrical composition; porch with turned columns; chimneys.</p>

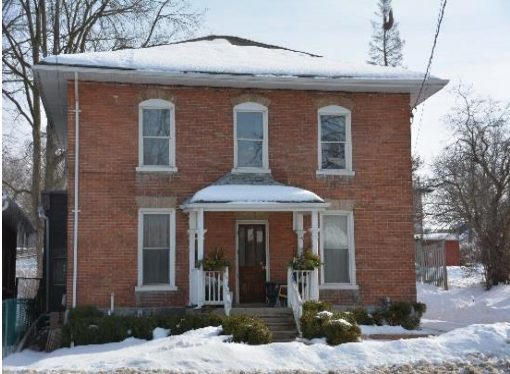
Address	Statement of Significance Heritage Value	Photo
<p>308 Burnham Street</p>	<p>308 Burnham Street is a good example of a 3-bay mid-Victorian style house constructed in the Georgian style for the working class. The property appears on the 1875 Bird's Eye View Map of the city. The home was constructed between 1865 and 1870. Its first occupant was Narcisse Mercier, a miller originally from Quebec and his six children. The Mercier family inhabited the home until at least 1906. Athanas, the eldest son of Narcisse Mercier, went on to form a partnership with Alfred McDonald. (McDonald & Mercier) and owned the Point St. Charles Ice Company. This property contributes to the historic landscape of Burnham Street.</p> <p>Heritage Attributes: 2-storey red brick construction on a symmetrical plan, hipped roof; voussoirs; fenestration; rounded upper-storey windows; central entrance with covered porch and awning roof.</p>

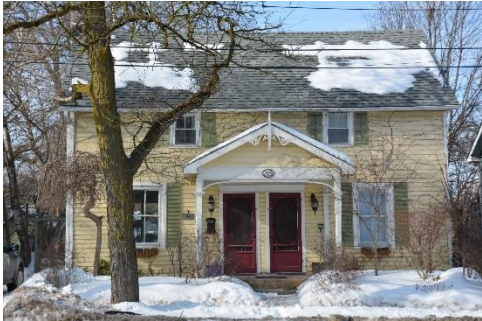
<p>315 Burnham Street</p>	<p>This structure appears on the 1878 Map replacing two earlier dwellings which appear on the 1846 Fleming Map. The existing building was constructed circa 1850 and contributes to the historic landscape of Burnham Street.</p> <p>Heritage attributes: Two-storey duplex with shiplap siding; gable roof; symmetrical massing with matching central entrance doors; pedimented entrance porch with decorative woodwork and finial detail.</p>

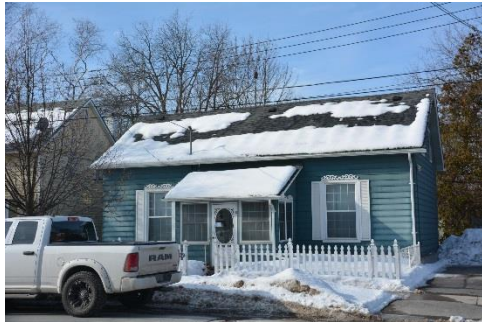
<p>319 Burnham Street</p>	<p>A wood framed regency style cottage; 319 Burnham Street appears on the 1875 Bird's Eye View Map. The property, constructed around 1851, contributes to the historic landscape of Burnham Street.</p> <p>Heritage Attributes: Symmetrical massing; central entrance featuring entrance porch; sash windows; gable roof.</p>

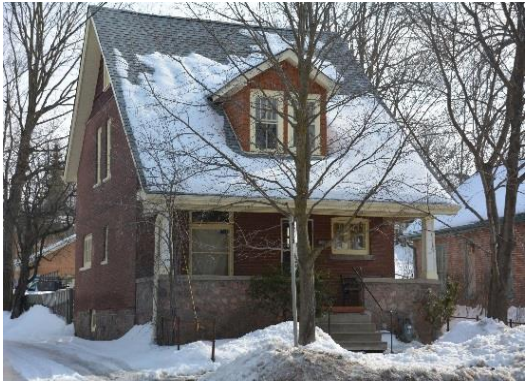
Address	Statement of Significance Heritage Value	Photo
326 Burnham Street	<p>Constructed in the Arts & Crafts style, 326 Burnham Street contains many features of the style including a gable roof with central dormer, rusticated stone porch detailing and smaller window openings. The property contributes to the historic landscape of Burnham Street.</p> <p>Heritage Attributes: one-and-a-half-storey red brick construction; steep asymmetrical gable roof; central dormer; rusticated stone-faced front porch; tapered square columns, offset entrance; fenestration including sills in window surrounds; main floor window with transom.</p>

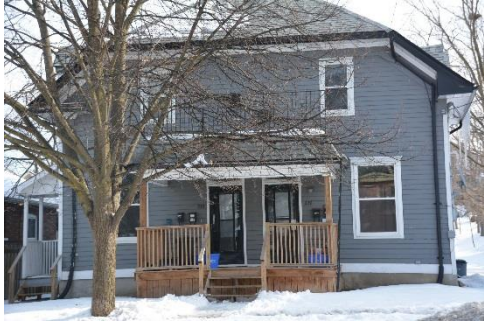
330-332 Burnham Street	<p>An example of vernacular multi-unit worker's housing. Though modified, it retains its original form and massing. This property contributes to the historic landscape of Burnham Street.</p> <p>Heritage Attributes: One-and-a-half storey construction; symmetrical massing; jerkin head hipped roof; fenestration; paired entrances.</p>

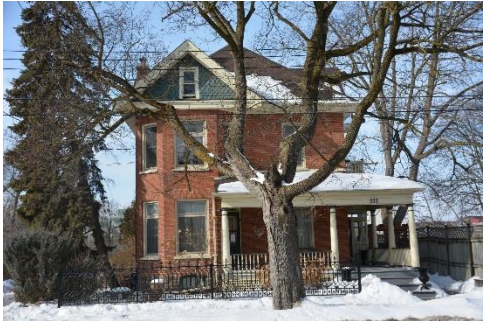
333 Burnham Street	<p>A good example of Edwardian bay-and-gable construction, the property contributes to the historic landscape of Burnham Street.</p> <p>Heritage Attributes: Two-storey red brick clad construction; two-storey bay with gable roof and central gable window; offset entrance; gable with wide eaves and shingles; hipped roof; fenestration; windows with transoms; verandah; entablature; columns.</p>

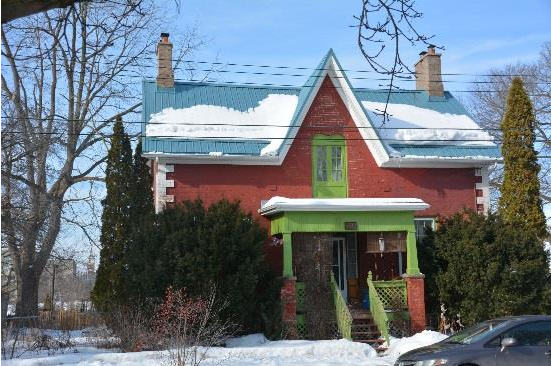
Address	Statement of Significance Heritage Value	Photo
339 Burnham Street	<p>Constructed in the 1850s, 339 Burnham Street is a good example of a 19th century Gothic cottage. It retains its original massing. The central gable construction and decorative quoins are typical of the Gothic Revival movement. The property contributes to the historic landscape of Burnham Street.</p> <p>Heritage Attributes: solid brick construction; centre gable with double rounded centre windows; symmetrical composition and massing; entrance porch, door and surround; fenestration; chimneys</p>

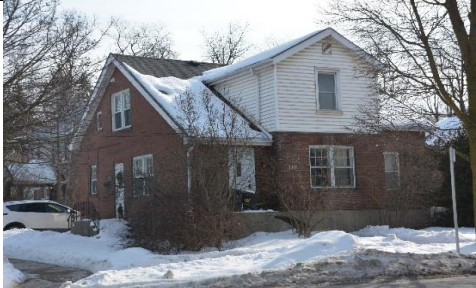
348 Burnham Street	<p>A typical 1930s bungalow, the property contributes to the historic landscape of Burnham Street.</p> <p>Heritage Attributes: One-and-a-half storey construction; side entrance; fenestration; large front facing gable dormer; gable roofs.</p>

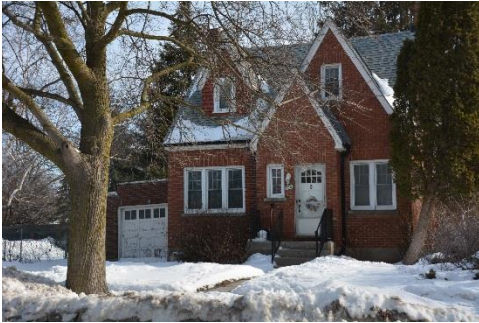
356 Burnham Street	<p>356 Burnham Street is constructed in a vernacular style with some Tudor revival style elements including steeply pitched cross-gabled roofs and features reminiscent of an English vernacular cottage and includes an attached garage.</p> <p>Heritage Attributes: Red brick construction; central gable with offset entrance with decorative light and side window; attached single garage with flat roof; steeply pitched cross-gables;</p>

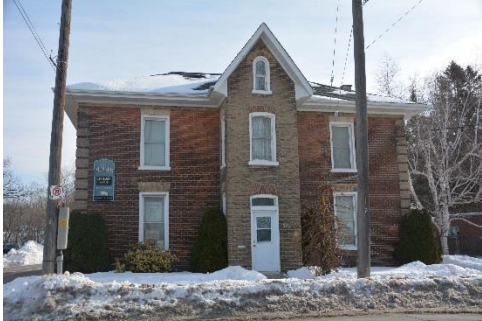
362 Burnham Street	<p>362 Burnham Street was constructed in the 1880s and features a unique projecting central front gable featuring buff/grey brick cladding. It contributes to the historic character of Burnham Street.</p> <p>Heritage Attributes: two-storey red brick construction with hipped roof and projecting 2-and-a-half storey bay with gable and brackets; symmetrical composition; wide eaves; buff brick voussoirs; buff brick quoins; central</p>

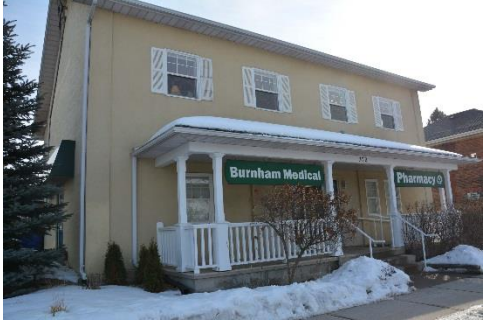
Address	Statement of Significance Heritage Value	Photo
	rounded gable window; fenestration; central entrance with transom.	
370 Burnham Street	<p>370 Burnham was constructed in the 1850s or 1860s on a symmetrical plan and may have been constructed as accommodation for the working class and their families in the mid-nineteenth century.</p> <p>Heritage Attributes: Two-storey stucco-clad construction; symmetrical massing; central entrance; gable roof; verandah; fenestration</p>

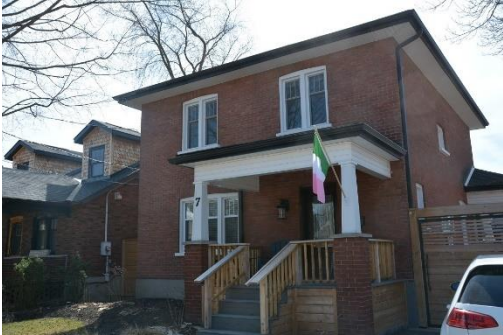
7 Charles Street	<p>7 Charles Street is a good example of Colonial Revival construction. It is a contributing property to the historic landscape of Charles Street.</p> <p>Heritage Attributes: Two-storey red brick construction; hipped roof; wide eaves; fenestration; offset entrance; entrance porch; entablature; square columns; brick piers with coping.</p>

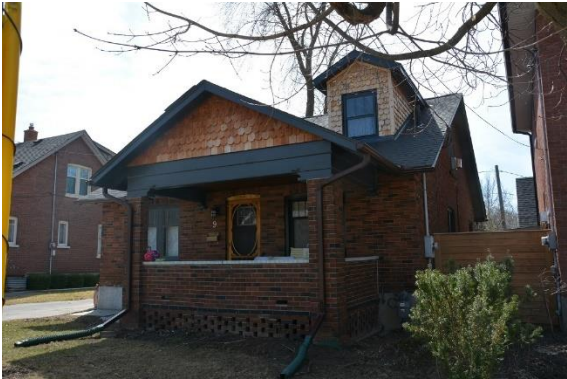
9 Charles Street	<p>9 Charles Street is an example of a worker's cottage most likely constructed in the 1920s or 1930s. It features some Arts and Craft style elements including its asymmetrical massing and decorative brickwork below an integrated porch which also a projecting gable front. It is a contributing property to the historic landscape of Charles Street.</p> <p>Heritage Attributes: one-storey construction; integrated verandah with decorative brick base; entablature; portico; grouped windows.</p>

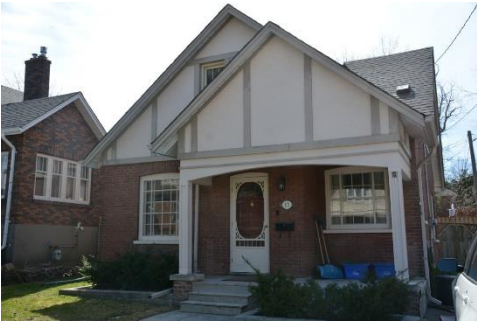
Address	Statement of Significance Heritage Value	Photo
<p>11 Charles Street</p>	<p>A good example of a bungalow constructed in the 1920s or 1930s for the working class, this property borrows elements from the Arts & Crafts style and Tudor Revival styles, as seen in its offset gable rooves and mock half timbering details. It is a contributing property to the historic landscape of Charles Street.</p> <p>Heritage Attributes: One-storey red brick construction; gable roofs with false timbered fronts; fenestration; brick knee-walls with coping; offset entrance; entrance porch with tapered entablature and square columns.</p>

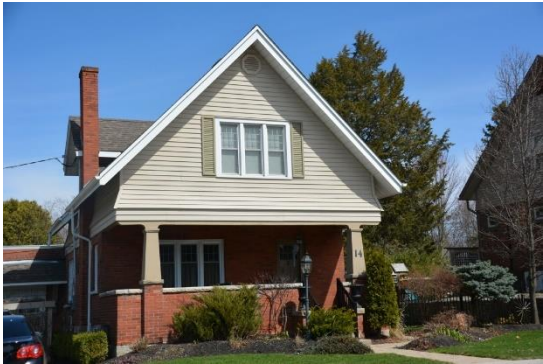
<p>14 Charles Street</p>	<p>14 Charles Street is a unique and well executed example of a 1920s bungalow incorporating elements of the Arts & Crafts style. It has an asymmetrical composition and projecting gable front dormer. It also features an attached garage. It is a contributing property to the historic landscape of Charles Street.</p> <p>Heritage Attributes: One-and-a-half storey brick construction; gable roof; side dormer; gable front second floor with clapboard siding and central double window; fenestration; offset entrance; integrated brick verandah with rusticated coping, entablature; tapered square columns; brick piers with coping; chimney.</p>

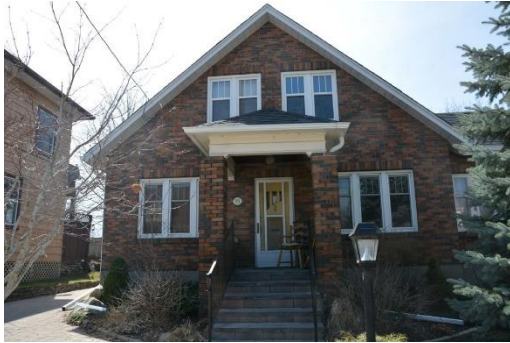
<p>15 Charles Street</p>	<p>Constructed in the 1920s or 1930s, 15 Charles Street is a typical example of a bungalow, a popular style in Peterborough at the time. It is a contributing property to the historic landscape of Charles Street.</p> <p>Heritage Attributes: One-and-a-half storey brick construction; symmetrical composition and central entrance with entrance porch; brick piers; entablature.</p>

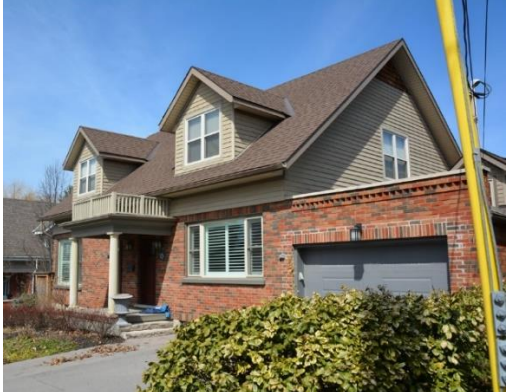
Address	Statement of Significance Heritage Value	Photo
18 Charles Street	<p>18 Charles Street is a 1930s style bungalow constructed in brick, featuring an integrated garage and dormers. While there are several new additions to the façade, it remains a contributing property to the streetscape of Charles Street.</p> <p>Heritage features: One-storey brick construction and integrated garage; decorative brickwork; symmetrical dormers; gable roof.</p>

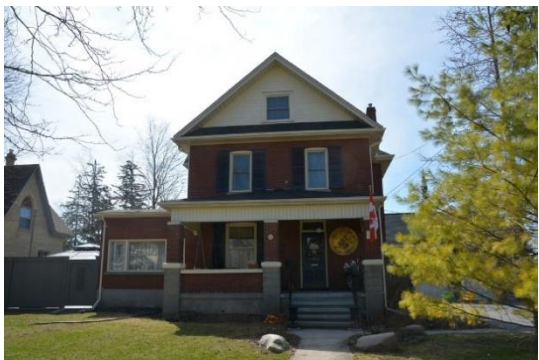
19 Charles Street	<p>Charles Street is a good example of an Edwardian Classical front gable house. It retains its front gable with central window and verandah supported by brick piers. It is a contributing property to the overall landscape of Charles Street.</p> <p>Heritage Attributes: Two-storey red brick construction; hipped roof with gable end; central window; offset entrance; verandah with entablature and brick piers; fenestration.</p>

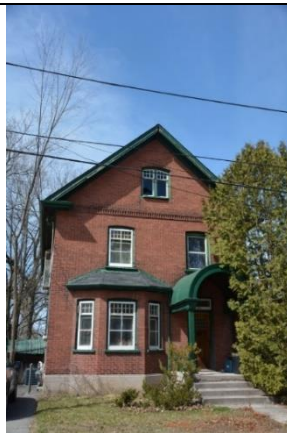
221 Engleburn Avenue	<p>221 Engleburn Avenue is an example of a Classical Revival home and is a contributing property to the historic landscape of the neighbourhood.</p> <p>Heritage Attributes: Two-and-a-half storey red brick construction; gable roof; return eaves; fenestration; paired central gable window with decorative multi-paned transom; projecting bay window with multi-paned transoms; decorative brickwork; arched, recessed entrance porch.</p>

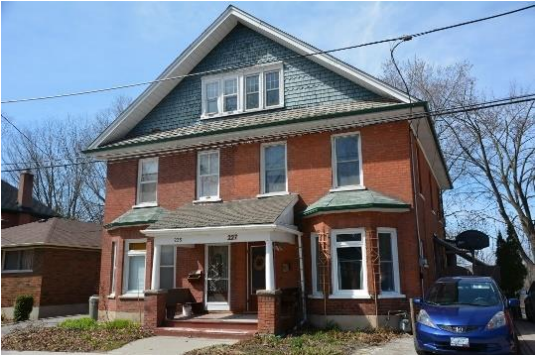
Address	Statement of Significance Heritage Value	Photo
225-227 Engleburn Avenue	<p>225-227 Engleburn Avenue is a unique example of an Edwardian Classical front gable style semi-detached home. This style is common in Peterborough, but most examples are single family homes. It retains its original details and massing, including symmetrical design, ground floor projecting bay windows and entrance porch.</p> <p>Heritage Attributes: Two-storey red brick construction; gable roof; gable with shingles; central paired windows; fenestration; central entrances for each unit; projecting bay windows at ground level; entrance porch; columns; brick piers and coping.</p>

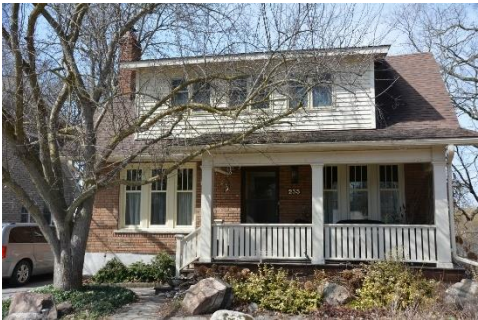
233 Engleburn Avenue	<p>233 Engleburn Avenue is a representative example of an Arts & Crafts style bungalow. Constructed in the 1920s or 1930s, the style was very popular in Peterborough. It showcases the main features of the style including the front wall dormer, offset entrance, broad, low pitched roof and verandah. It is a contributing property to the historic landscape of Engleburn Avenue.</p> <p>Heritage Attributes: One-and-a-half storey brick construction; gable roof; chimney; front wall dormer; fenestration; banks of windows along front; offset entrance; chimney.</p>

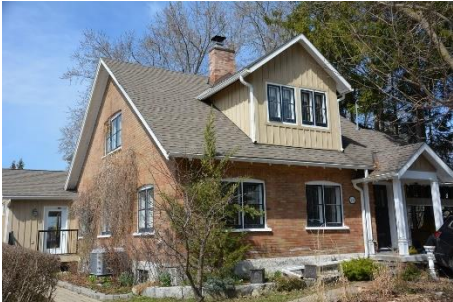
239 Engleburn Avenue	<p>Most likely constructed in the 1930s, 239 Engleburn Avenue is a contributing property to the historic landscape of the neighbourhood.</p> <p>Heritage Attributes: One-and-a-half storey brick construction; gable roof with small central dormer; asymmetrical massing; offset entrance with entrance porch, columns and pediment; fenestration; grouped windows; chimney.</p>

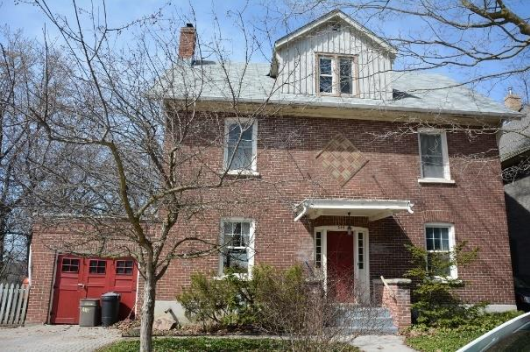
Address	Statement of Significance Heritage Value	Photo
<p>245 Engleburn Avenue</p>	<p>245 Engleburn Avenue has many features of a Georgian Revival house in Peterborough. It is a contributing property to the historic landscape of Engleburn Avenue.</p> <p>Heritage Attributes: two-and-a-half storey red brick construction with second storey decorative feature; gable roof with central dormer; symmetrical composition; fenestration; central entrance with sidelights; covered entrance; knee walls and coping; attached red brick garage including doors and decorative brickwork.</p>

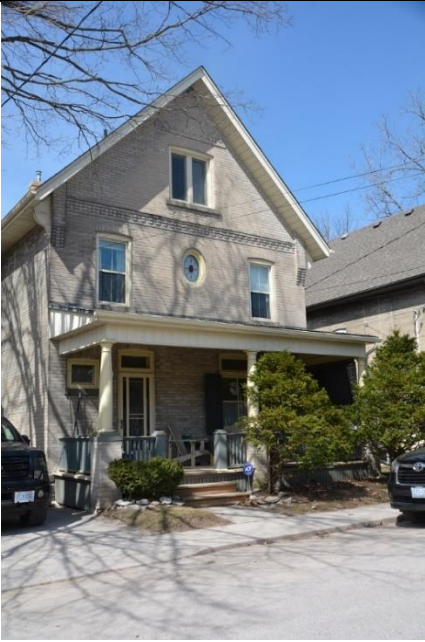
<p>247 Engleburn Avenue</p>	<p>Built circa 1910, 247 Engleburn Avenue is a good example of an early 20th century residential property constructed in the Edwardian style. The house also features moulded brick details and brackets on the gable end, as well as a central circular window. It is a contributing property to the historic landscape of Engleburn Avenue.</p> <p>Heritage Attributes: Two-and-a-half storey buff brick construction; hipped roof; front gable; brackets; double gable window; decorative brickwork; central circular window with stained glass detail; fenestration; windows with transoms; entrance with transom; verandah with brick piers and coping, entablature and Doric columns.</p>

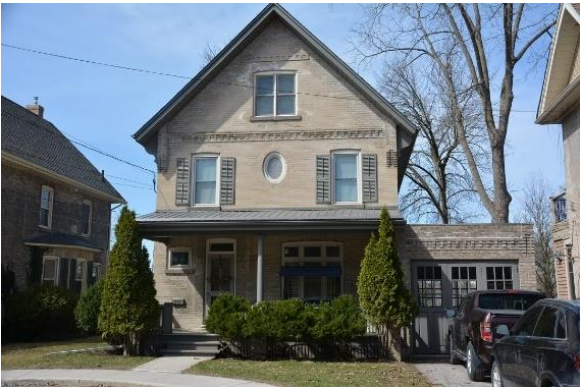
<p>251 Engleburn Avenue</p>	<p>Built circa 1910, 251 Engleburn Avenue is a good example of an early 20th century residential property constructed in the Edwardian style. The house also features moulded brick details and brackets on the gable end, as well as a central oval window. 251 Engleburn also features an excellent example of an early attached garage with what appear to be original garage doors. It is a contributing property to the historic landscape of Engleburn Avenue.</p> <p>Heritage Attributes: Two-and-a-half storey buff brick construction; hipped roof; front gable; brackets; double gable</p>

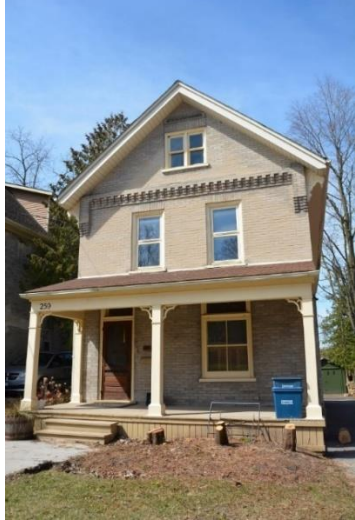
259 Engleburn Avenue	<p>Built circa 1908-9, 259 Engleburn Avenue is a good example of an early 20th century residential property constructed in the Edwardian style. The house also features moulded brick details and brackets on the gable end. It is a contributing property to the historic landscape of Engleburn Avenue.</p> <p>Heritage Attributes: Two-and-a-half storey buff brick construction; hipped roof; front gable; double gable window; decorative brickwork; fenestration; windows with transoms; entrance with transom; verandah with simple square columns and decorative brackets.</p>

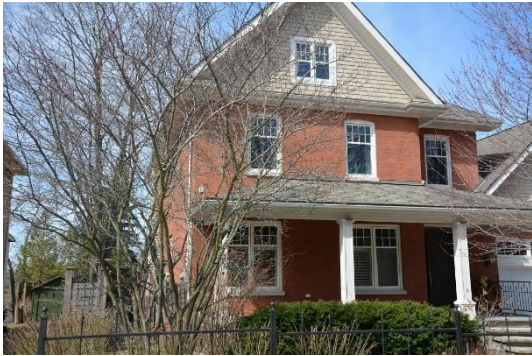
Address	Statement of Significance Heritage Value	Photo
<p>263 Engleburn Avenue</p>	<p>263 Engleburn Avenue was constructed circa 1907-1908 and is an example of an Edwardian front gable house. This housing type was popular in Peterborough in the early twentieth century. Notable features include the front gable with central window and verandah.</p> <p>Heritage Attributes: Two-storey red brick construction; hipped roof with central front gable and central window; fenestration; offset entrance; verandah.</p>

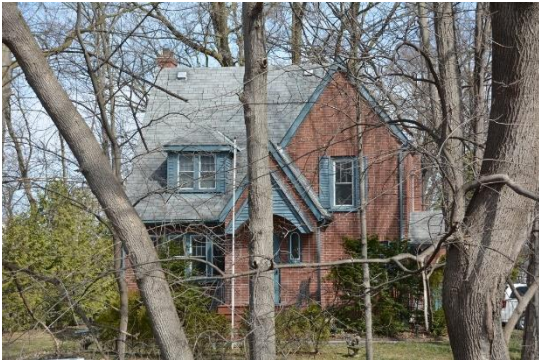
<p>301 Engleburn Avenue</p>	<p>301 Engleburn contains elements of the Arts and Crafts style with some Tudor revival style features. Its irregular composition, small window openings and windowpanes and bell cast gable end roof are characteristics of this style.</p> <p>Heritage attributes: one-and-a-half storey red brick construction; irregular composition; gable end roof; fenestration; banks of windows; brick chimney; recessed entrance with gable roof.</p>

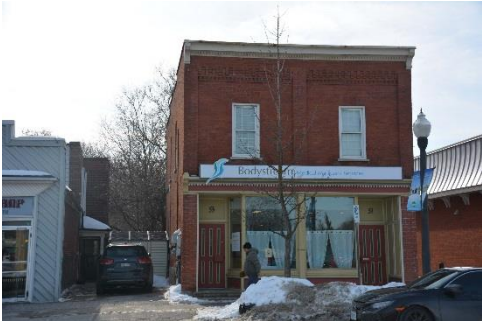
<p>51-53 Hunter Street E</p>	<p>51-53 Hunter Street E is a typical example of commercial architecture of the late 19th century. It is an important part of the commercial streetscape of Hunter Street East which has a distinctive character from Peterborough's commercial core.</p> <p>Heritage attributes: Two storey construction; flat roof; large glazed double store front; symmetrical side entrances; decorative brick below cornice line; fenestration.</p>

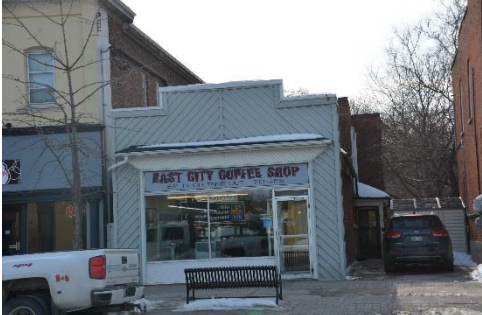
<p>55 Hunter Street E</p>	<p>55 Hunter Street is an example of commercial architecture serving the community of Ashburnham in the late nineteenth century. Though modified, it is part of the commercial streetscape of Hunter Street East which has a distinctive character from that of Peterborough's commercial core.</p>

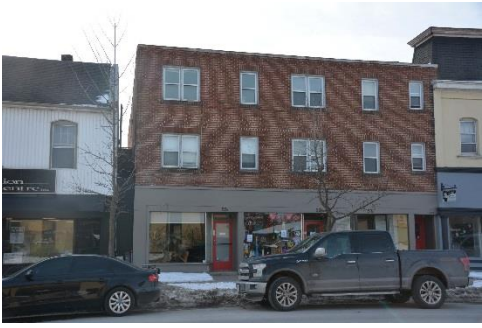
<p>59 Hunter Street E</p>	<p>59 Hunter Street E is an example of commercial architecture that served the community of Ashburnham in the late nineteenth century. It is an important part of the commercial streetscape of Hunter Street East which has a distinctive character from that of Peterborough's commercial core.</p> <p>Heritage Attributes: Two and a half storey red brick construction; flat roof; entrances; fenestration.</p>

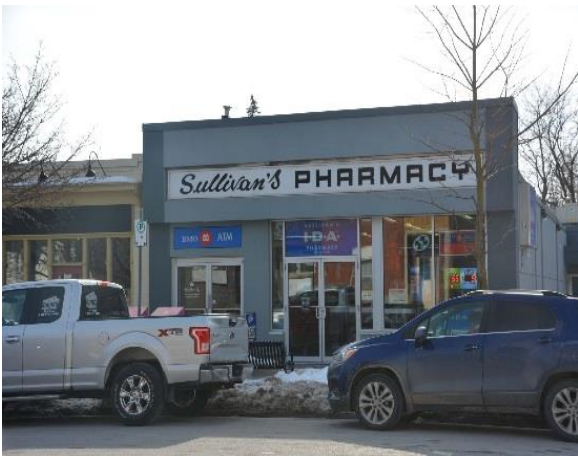
Address	Statement of Significance Heritage Value	Photo
<p>71 Hunter Street E</p>	<p>71 Hunter Street was a part of the commercial architecture of the community of Ashburnham in the late nineteenth century. It is an important part of the commercial streetscape of Hunter Street East which has a distinctive character from that of Peterborough's commercial core. Sullivan's Pharmacy has been in constant operation since the late 19th century in Ashburnham, at this location and further up this block. While heavily modified, it retains its scale and position within the streetscape.</p> <p>Heritage Attributes: One-storey construction; central entrance; continuation of commercial row.</p>

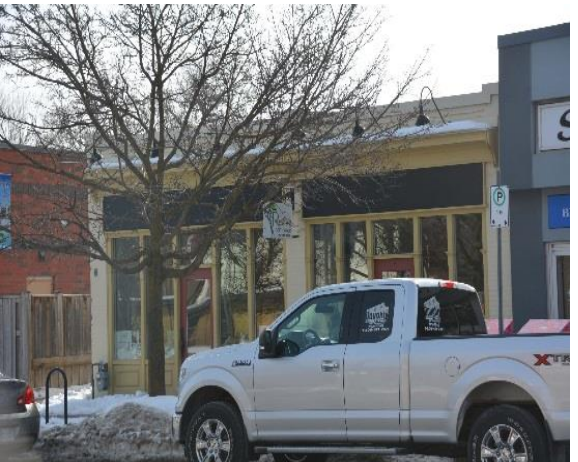
<p>73-75 Hunter Street E</p>	<p>73-75 Hunter Street E is a part of the commercial architecture serving the community of Ashburnham in the late nineteenth century. It is an important part of the commercial streetscape of Hunter Street East which has a distinctive character from that of Peterborough's commercial core.</p> <p>Heritage Attributes: One-storey construction; symmetrical entrances at each side; storefront and fenestration; continuation of commercial row.</p>

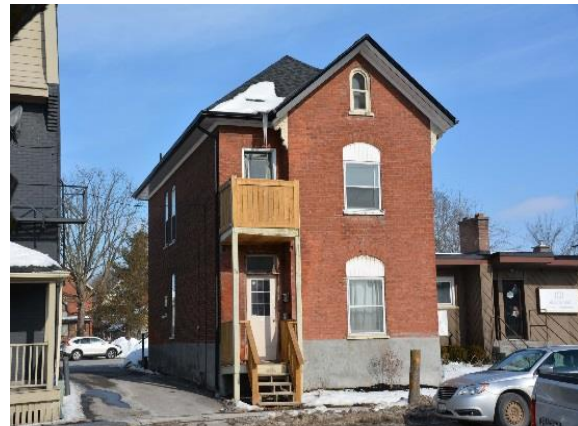
<p>74 Hunter Street E</p>	<p>The property at 74 Hunter Street East is a good example of a late nineteenth/early 20th century dwelling constructed with elements of the Queen Anne style.</p> <p>Heritage Attributes: Two-storey red brick construction; hipped roof; projecting gable; rounded windows (altered); fenestration; brackets; offset entrance with transom; asymmetrical massing.</p>

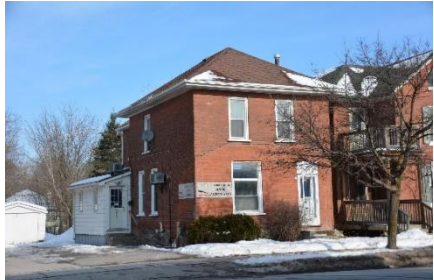
Address	Statement of Significance Heritage Value	Photo
112 Hunter Street E	<p>The property at 112 Hunter Street East is a good example of a modest residential property. It was most likely constructed in the early 1900s.</p> <p>Heritage Attributes: Two-storey red brick construction; hipped roof; offset entrance; fenestration; transom lights.</p>

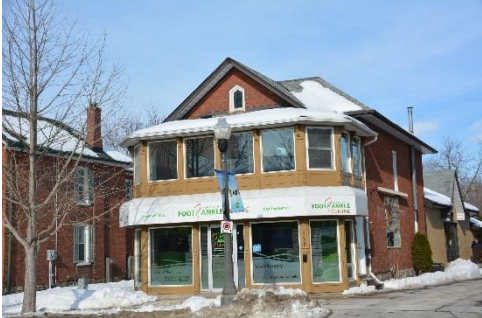
114 Hunter Street E	<p>Constructed in about 1900, 114 Hunter Street E features a simplified Queen Anne style including a two storey entrance porch.</p> <p>Heritage Attributes: Two-storey red brick construction; hipped roof; projecting gable roof with small window; fenestration; brackets; offset entrance with transom; asymmetrical massing.</p>	 
120 Hunter Street E	<p>Constructed in about 1880, the building would have had a similar appearance to 114 Hunter Street E, but has been modified with a front addition.</p> <p>Heritage Attributes: Two-storey red brick construction; centre projecting gable with small centre window; fenestration; hipped roof.</p>

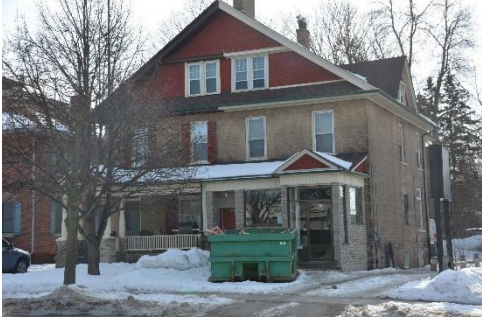
133 Hunter Street E	<p>A good example of an Edwardian-style duplex, this structure contributes to the historic streetscape of Hunter Street East.</p> <p>Heritage Attributes: Two-storey brick construction; shingled gable with pair of central gable windows; matching offset pedimented entrances; entablature; front porches; gable roof.</p>

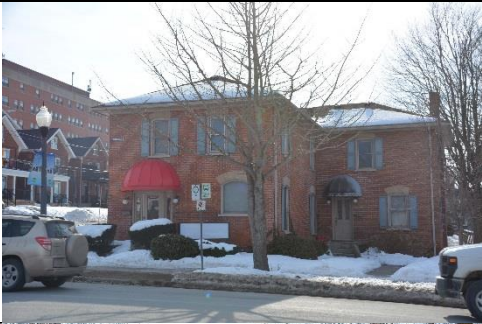
Address	Statement of Significance Heritage Value	Photo
147 Hunter Street E	<p>147 Hunter Street East is a good example of a vernacular Victorian dwelling from the 1880s.</p> <p>Heritage Attributes: Two-storey red brick construction; hipped roof with wide eaves; fenestration; buff brick voussoirs; offset entrance with sidelights and transom; shutters.</p>

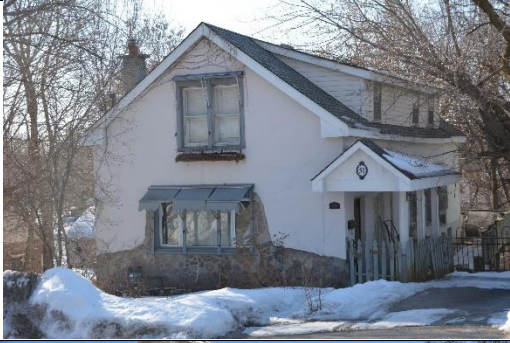
51 James Street	<p>Constructed circa 1870, 51 James features elements of a typical worker's cottage constructed in the 19th century. It also features a second storey dormer addition.</p> <p>Heritage Attributes: Two-storey rough cast construction; second storey dormer; gable roof; fenestration; entrance porch.</p>

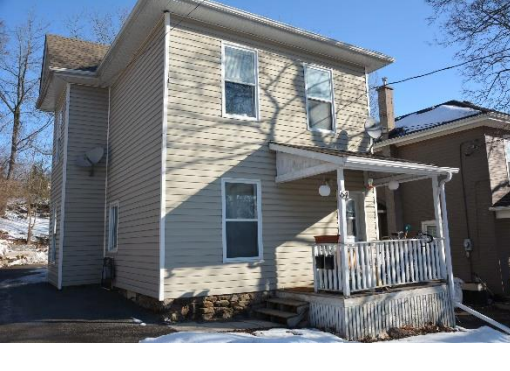
64 James Street	<p>Constructed in about 1890, 64 James Street is a good example of vernacular worker's housing. It was most likely constructed of brick. It is a contributing property to the historic character of the local area.</p> <p>Heritage Attributes: Two-storey construction; hipped roof; wide eaves; entrance porch; offset entrance; fenestration; stone foundation.</p>

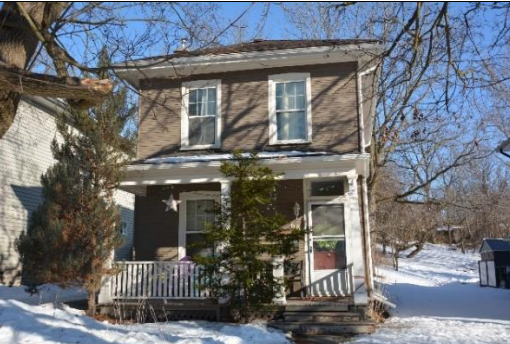
68 James Street	<p>Constructed around 1890, 68 James Street is a good example of vernacular worker's housing. It is a contributing property to the historic character of the local area.</p> <p>Heritage Attributes: Two-storey construction; hipped roof; verandah; offset entrance with transom; fenestration.</p>

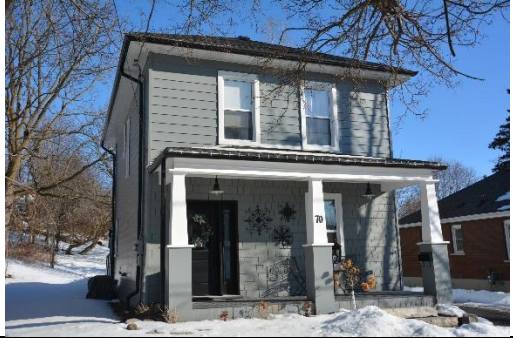
Address	Statement of Significance Heritage Value	Photo
70 James Street	<p>Constructed around 1890, 70 James Street has been modified but retains its original form. It is an example of vernacular worker's housing. It is a contributing property to the historic character of the local area.</p> <p>Two-storey construction; hipped roof; fenestration; offset entrance.</p>

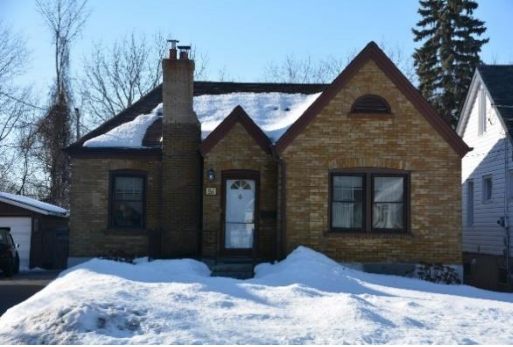
81 James Street	<p>81 James Street was most constructed in the 1920s or 1930s. It contains some elements of the Arts and crafts style including the asymmetrical massing and large chimney at the facade. It is a contributing property to the historic character of the local area.</p> <p>Heritage Attributes: One-and-a-half storey buff brick construction; double gable front hipped roof; bank of windows; central entrance; voussoirs; decorative brickwork on front façade including sills; front chimney.</p>

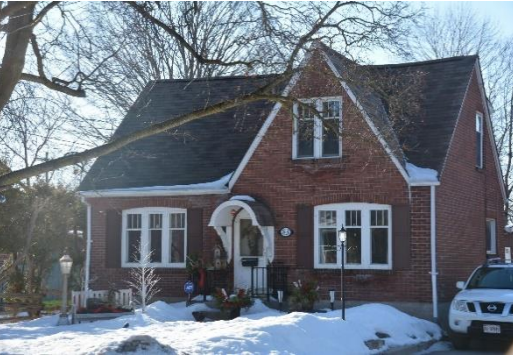
83 James Street	<p>83 James Street is an Arts and Crafts style home that was likely constructed in the 1920s or 1930s. It is a contributing property to the historic character of the local area.</p> <p>Heritage Attributes: One-and-a-half storey brick construction; gable roof; offset front gable with paired windows; banks of windows; central entrance including entrance porch with rounded roof and decorative brackets; round headed front door; fenestration.</p>

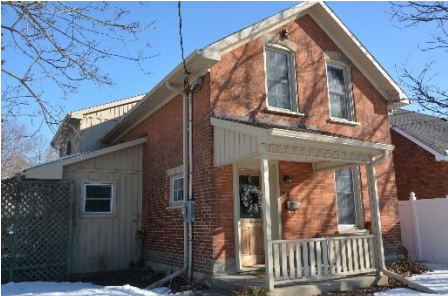
84 James Street	<p>84 James Street is a good example of vernacular worker's housing from the late nineteenth century. It is a contributing property to the historic character of the local area.</p> <p>Heritage Attributes: One-and-a-half storey construction; gable roof; entrance porch with columns; offset entrance with transom; fenestration.</p>

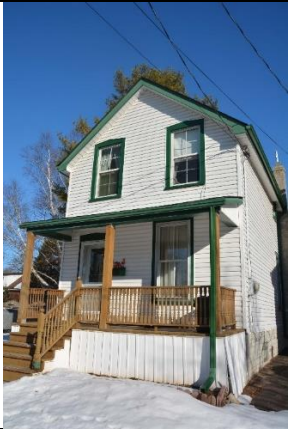
Address	Statement of Significance Heritage Value	Photo
112 James Street	<p>112 James Street is an example of worker's housing from the late nineteenth century. Though heavily modified, it retains its original form and is a contributing property to the historic character of the area.</p> <p>Heritage Attributes: One-and-a-half storey construction; gable roof; offset entrance; porch; fenestration.</p>

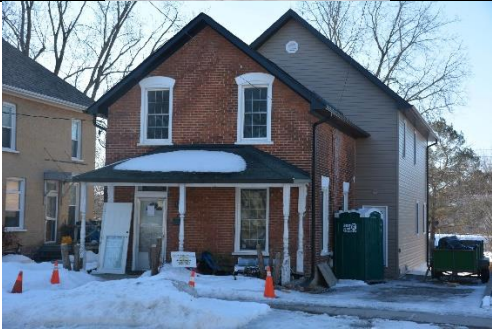
115 James Street	<p>115 James Street is a good example of a gable front Victorian vernacular dwelling. It is a contributing property to the historic character of the area.</p> <p>Heritage Attributes: One-and-a-half storey red brick construction; gable roof; voussoirs; fenestration; porch with turned columns.</p>

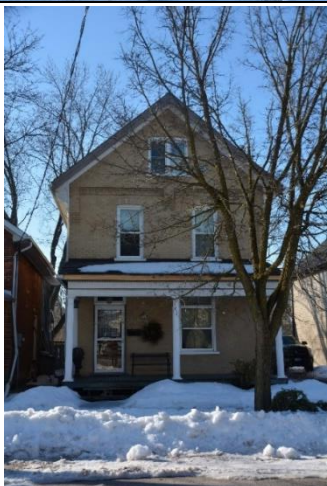
117 James Street	<p>117 James Street is a good example of an Edwardian classical dwelling. It includes unique moulded brick details and brackets on the gable end. It is a contributing property to the historic character of the area.</p> <p>Heritage Attributes: Two-and-a-half storey buff brick construction; gable roof with wooden brackets; paired gable window; decorative brickwork; verandah with rounded columns and entablature; offset entrance with transom; fenestration.</p>

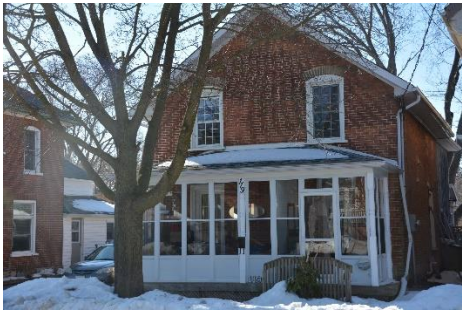
119 James Street	<p>119 James Street is a good example of a gable front Victorian vernacular residential building. It is a contributing property to the historic character of the area.</p> <p>Heritage Attributes: One-and-a-half storey red brick construction; gable roof; rounded upper storey windows; buff brick voussoirs; fenestration; enclosed porch.</p>

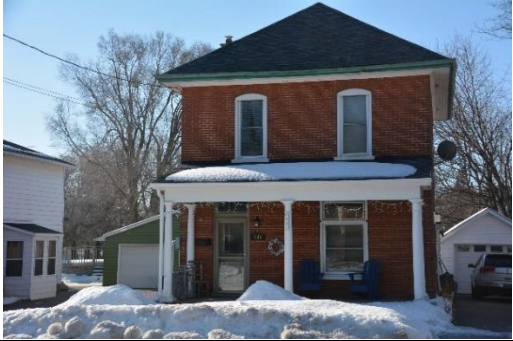
Address	Statement of Significance Heritage Value	Photo
<p>123 James Street</p>	<p>123 James Street is an example of a late Victorian vernacular dwelling. This was a popular dwelling style during the 1880s.</p> <p>Heritage Attributes: Two-storey red brick construction; hipped roof; rounded upper storey windows; fenestration; verandah with entablature and Doric style columns; offset entrance with transom; lower windows with transoms.</p>

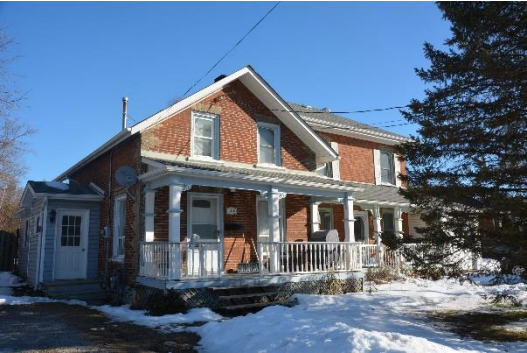
<p>128-130 James Street</p>	<p>Constructed between circa 1850-1890, the property contains attached homes constructed in different time periods. 128 James seems to have been constructed much earlier than 130.</p> <p>Heritage Attributes: 128: one-and-a-half storey brick construction; gable roof; fenestration with buff brick voussoirs; buff brick quoins; offset entrance; verandah.</p> <p>130: Two-storey brick construction; hipped roof; buff brick voussoirs; fenestration with rounded upper windows; central entrance and symmetrical massing</p>

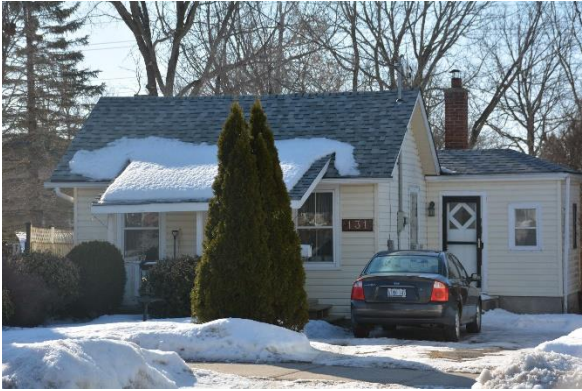
Address	Statement of Significance Heritage Value	Photo
131 James Street	<p>131 James Street is a good example of a vernacular worker's cottage from the late nineteenth century. It is a contributing property to the historic character of the local area.</p> <p>Heritage attributes: One-storey frame construction; gable roof; central entrance; fenestration; entrance porch.</p>

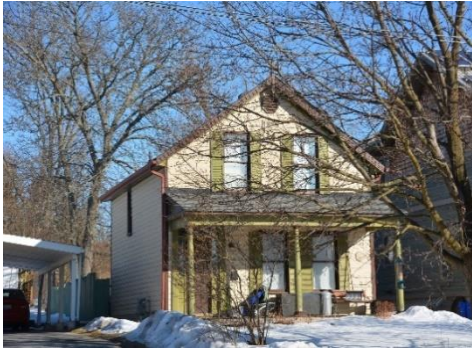
136 James Street	<p>136 James Street was constructed in 1850 and is a good example of a vernacular regency structure. It is a contributing property to the historic character of the local area.</p> <p>Heritage Attributes: One-and-a-half storey construction with clapboard siding; gable roof; shutters; offset entrance; fenestration; porch; columns.</p>

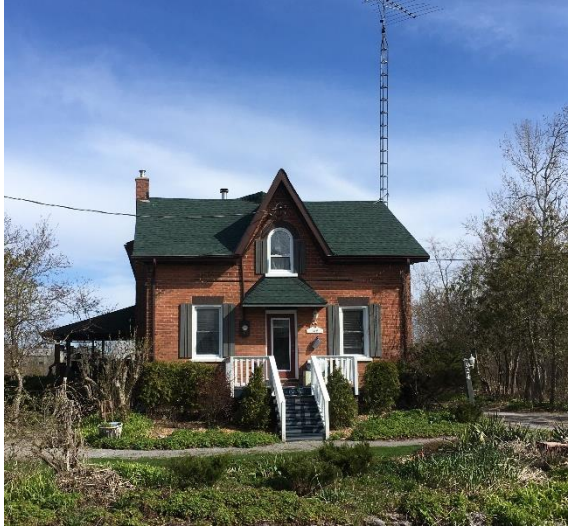
524 Maniece Avenue	<p>524 Maniece Avenue was originally constructed for John Heap, a brick maker who immigrated from England between 1865-1871.</p> <p>Heap and Butcher Brick Works, founded in 1878 by John Heap and Henry Butcher, was located just east of the present day Trent Canal in East City. It is likely that the home was constructed of bricks from the Brick Works which was located nearby, using the natural clay deposits. The business was in operation until about 1911. 524 Maniece is a good example of an Ontario Gothic style home, featuring a central rounded top gable window</p> <p>Heritage Attributes: One-and-a-half storey red brick construction; gable roof with front gable and gable window; symmetrical design; fenestration;</p>

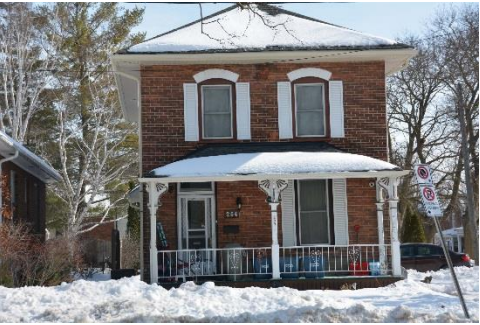
Address	Statement of Significance Heritage Value	Photo
254 Mark Street	<p>Constructed around 1900, 254 Mark Street contributes to the historic landscape of Mark Street.</p> <p>Heritage Attributes: Two-storey red brick construction; hipped roof; voussoirs; fenestration, offset entrance with transom; verandah with squared decorative columns and decorative woodwork; shutters.</p>

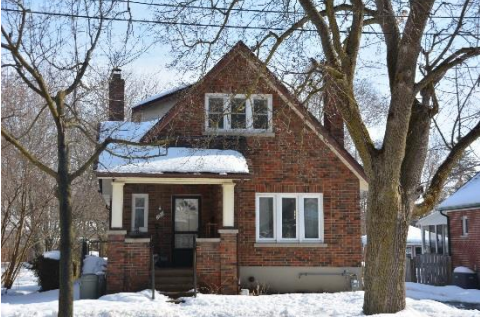
280 Mark Street	<p>280 Mark Street is an example of an Arts and crafts style home constructed in the 1920s or 1930s.</p> <p>Heritage Attributes: One-and-a-half storey brick construction; gable roof; banks of windows; offset entrance including entrance porch, brick piers; square columns and entablature; chimney</p>

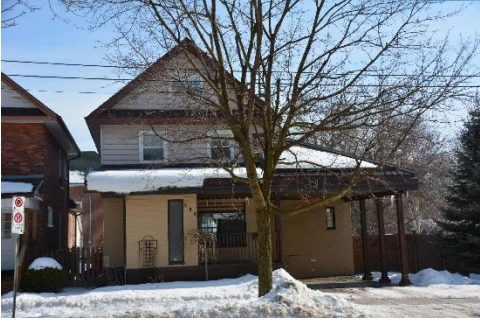
294 Mark Street	<p>While heavily modified, 294 Mark Street is an example of an Edwardian style vernacular building with gable front. It retains its gable and central window which is typical of the style.</p> <p>Heritage Attributes: Two-and-a-half storey construction; gable roof; front gable with central window; fenestration; offset entrance.</p>

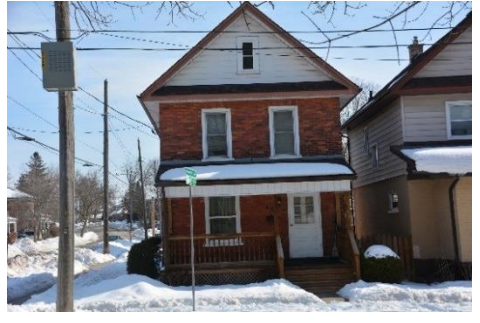
298 Mark Street	<p>298 Mark Street is an example of an Edwardian front gable house. It retains features of the style including a shingled front gable. It was most likely occupied by working class families and reflects the historical character of Mark Street.</p> <p>Heritage Attributes: Two-and-a-half storey red brick construction; gable roof; front gable; shingles; central window; fenestration; verandah; entablature.</p>
