Properties Eligible for Listing on the Heritage Register of the City of Peterborough

The following properties have been identified as having met at least one of the criteria.

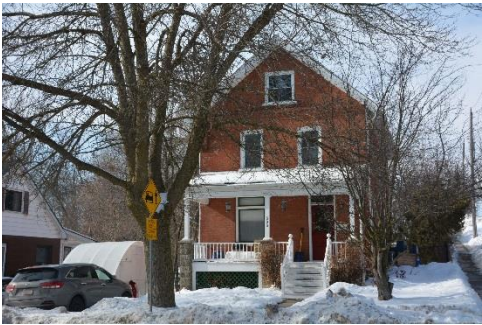
Address	Statement of Significance Heritage Value	Photo
303 Mark Street	<p>303 Mark Street is a good example of gable front construction. Constructed circa 1910, it is a contributing property to the historic landscape of Mark Street.</p> <p>Heritage Attributes: Two-and-a-half storey brick construction; gable roof with central window and decorative brickwork; fenestration; main floor window with transom; offset entrance with transom; verandah with entablature, cut stone piers and square columns.</p>

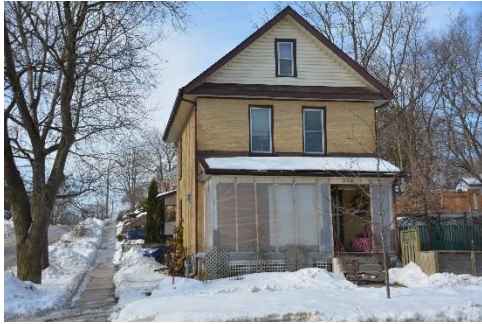
305 Mark Street	<p>Mark Street is an example of an Edwardian front gable house. Constructed in the early twentieth century, it retains features of the style including a shingled front gable. It was most likely occupied by working class families and reflects the historical character of Mark Street.</p> <p>Heritage Attributes: Two-and-a-half storey buff brick construction; gable roof; front gable; shingles; central window; fenestration; verandah.</p>

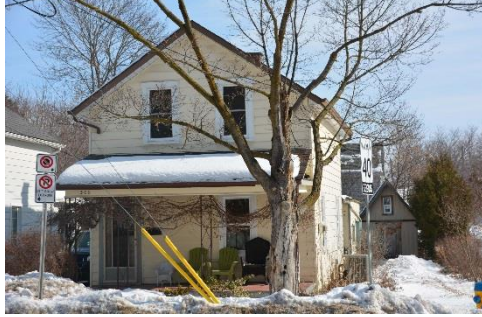
306 Mark Street	<p>306 Mark Street is a good example of Victorian vernacular construction for working class occupants. It is a contributing property to the historic character of Mark Street.</p> <p>Heritage Attributes: One-and-a-half storey construction; gable roof; fenestration; offset entrance with transom; verandah.</p>

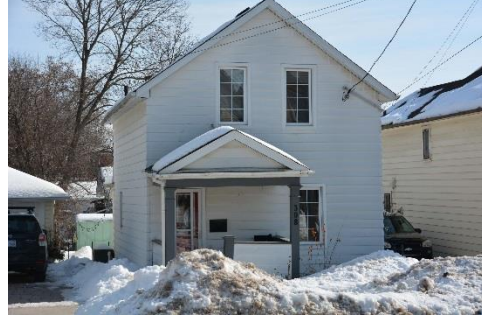
308 Mark Street	<p>308 Mark Street is a good example of a Victorian vernacular gable front home constructed in the early 1900s for working class occupants. It is a contributing property to the historic character of Mark Street.</p> <p>One-and-a-half storey frame construction; gable roof; fenestration; offset entrance with entrance porch and pediment.</p>

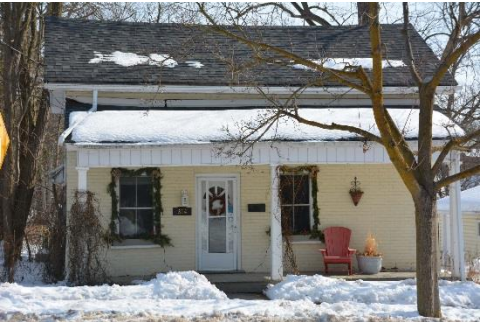
Address	Statement of Significance Heritage Value	Photo
314 Mark Street	<p>One of the earliest dwellings on Mark Street, 314 was constructed before 1875 and is a good example of a vernacular residence in Peterborough/Ashburnham. It is of frame construction and has a low gable roof, central entrance and small windows.</p> <p>Heritage Attributes: One-storey construction; symmetrical front elevation; central entrance; gable roof.</p>

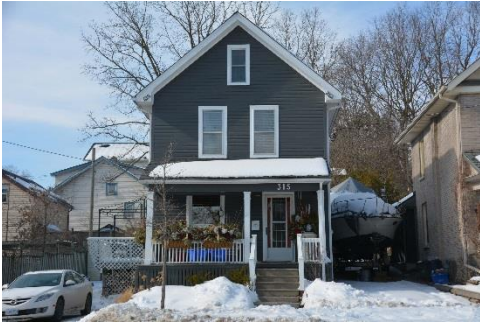
315 Mark Street	<p>Constructed in the early part of the twentieth century, 315 Mark Street is a typical gable front vernacular dwelling. It is a contributing property to the historic landscape of Mark Street.</p> <p>Heritage Attributes: Two-and-a-half storey construction; gable roof; brackets; central gable window; fenestration; picture window with transom; offset entrance; verandah.</p>

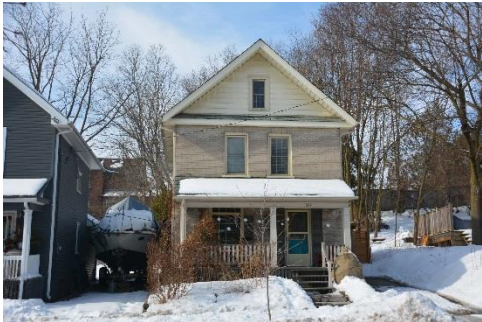
317 Mark Street	<p>Constructed in the early part of the twentieth century, 317 Mark Street is a good example of an Edwardian front gable house, which was quite popular in Peterborough. The property is a contributing feature to the historic residential landscape of Mark Street.</p> <p>Heritage Attributes: Two-and-a-half storey buff brick construction; front gable with central window and moulding; fenestration; entrance; verandah; columns; entablature.</p>

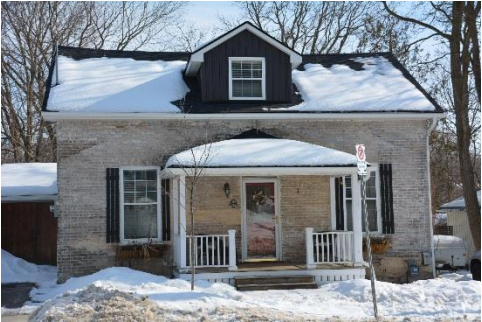
322 Mark Street	<p>A good example of vernacular worker's housing from the mid-nineteenth century. It is a contributing property to the historic landscape of Mark Street.</p> <p>Heritage Attributes: One-and-a-half storey buff brick construction; gable roof with central dormer; symmetrical massing; central entrance with transom; fenestration; voussoirs.</p>

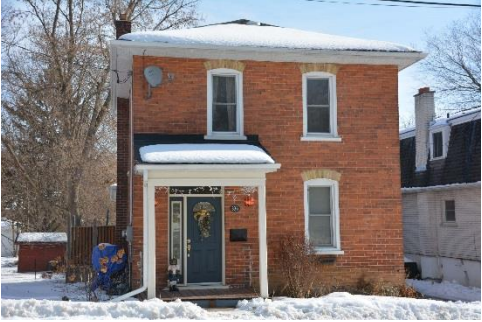
Address	Statement of Significance Heritage Value	Photo
336 Mark Street	<p>336 Mark Street is a good example of a Victorian hipped roof vernacular house. It was constructed in about 1880 and is a contributing property to the historic landscape of Mark Street.</p> <p>Heritage Attributes: Two-storey red brick construction; hipped roof; fenestration including rounded top windows and voussoirs; offset entrance and surround including transom; entrance porch including entablature and columns.</p>

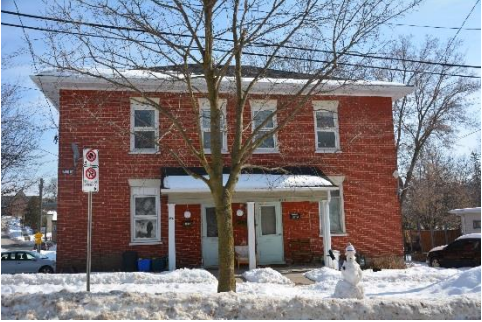
344-346 Mark Street	<p>A good example of early twentieth century multi-residential working class housing, 344-346 Mark Street was constructed around 1875 and is a contributing property to the historic landscape of Mark Street.</p> <p>Heritage Attributes: Two-storey red brick semi-detached construction; hipped roof; buff brick voussoirs; fenestration; offset entrances on the unit entrances; entrance porch.</p>

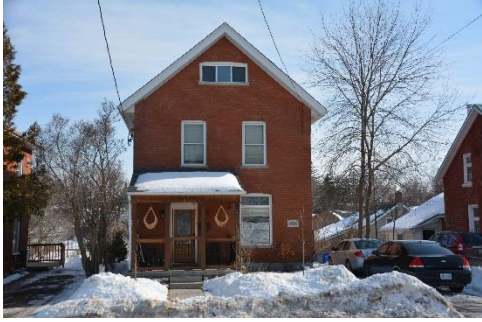
358 Mark Street	<p>358 Mark Street is an example of late nineteenth century vernacular residential design featuring a box cornice.</p> <p>Heritage Attributes: Two-and-a-half storey red brick construction; moulded brick detail at second storey; gable roof; central gable window; main floor window with stained glass transom; fenestration; voussoirs; cut stone sills; offset entrance.</p>

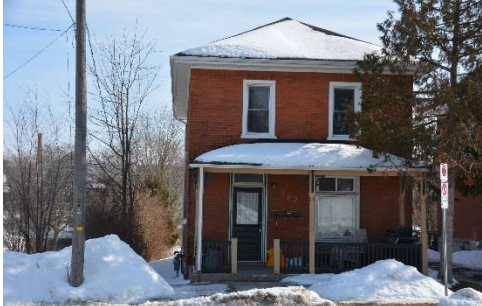
360 Mark Street	<p>360 Mark Street is a good example of Victorian vernacular residential design. It contributes to the historic character of Mark Street.</p> <p>Heritage Attributes: Red brick construction; hipped roof; fenestration; wide eaves; offset entrance with transom; verandah.</p>

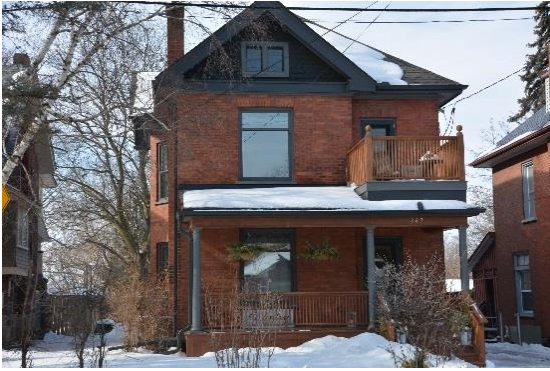
367 Mark Street	<p>Constructed near the turn of the twentieth century, 367 Mark Street is a good example of vernacular housing featuring elements of the Queen Anne style. It incorporates simplified elements of the style including asymmetrical massing, entrance porch and projecting gable. It is a contributing feature to the historic residential landscape of Mark Street.</p> <p>Heritage Attributes: Two-and-a-half storey red brick construction; front gable with central windows, painted shingles and box cornice; fenestration; window with transom; offset entrance; porch.</p>

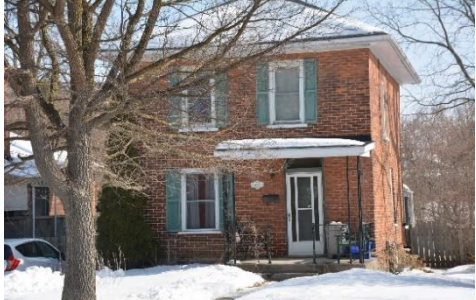
368 Mark Street	<p>Constructed in the 1880s, 368 Mark Street is a contributing feature to the historic residential landscape of Mark Street.</p> <p>Heritage Attributes: Two-storey red brick construction; hipped roof; wide eaves; fenestration; offset entrance with transom and entrance porch.</p>

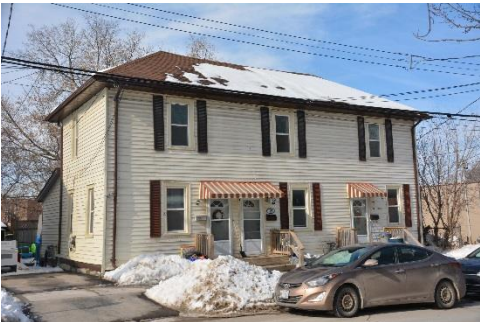
Address	Statement of Significance Heritage Value	Photo
383-387 Mark Street	<p>383-387 Mark Street was constructed prior to 1875 and appears on the 1875 Romaine's Map. It is a good example of working class multi-residential housing with offset entrances for the units and hipped roof.</p> <p>Heritage Attributes: Two-storey frame construction; hipped roof; symmetrical composition; fenestration.</p>

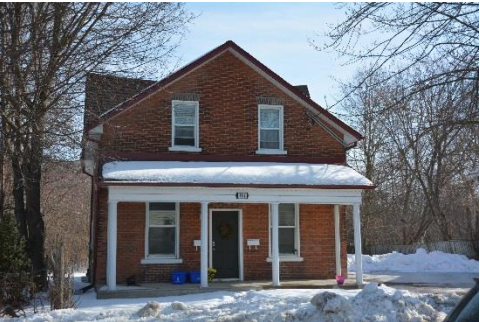
384 Mark Street	<p>384 Mark Street is of frame construction with a brick veneer. Constructed in the 1880s, it is typical of late Victorian worker's housing.</p> <p>Heritage Attributes: Frame construction with brick veneer; gable roof; shallow verandah with entablature featuring decorative wood detailing; central entrance; fenestration; buff brick voussiors.</p>

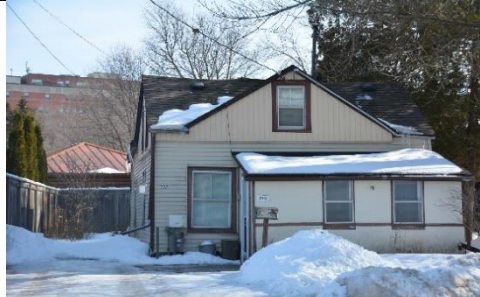
390 Mark Street	<p>390 Mark Street is a one storey structure of frame construction built in about 1885. While heavily modified, it still retains the overall massing of the original structure.</p> <p>Heritage Attributes: One-storey frame construction; gable roof; fenestration.</p>

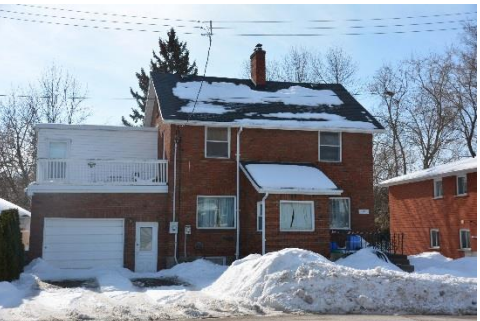
107 Robinson Street	<p>107 Robinson Street is a good example of Edwardian foursquare construction. Also of note is the inclusion of the single bay garage which began to appear on homes constructed in the early part of the twentieth century.</p> <p>Heritage Attributes: Two-storey red brick construction; hipped roof; chimney; fenestration; attached single bay garage.</p>

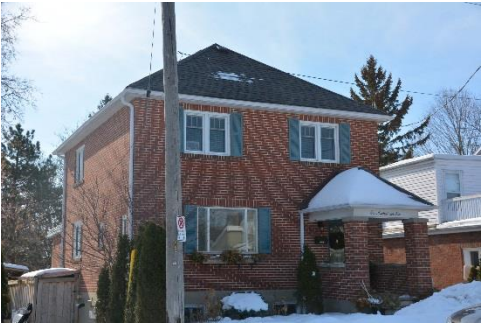
Address	Statement of Significance Heritage Value	Photo
109 Robinson Street	<p>109 Robinson Street is a good example of Edwardian foursquare construction. It features a typical square plan, hipped roof and paired windows on the second storey.</p> <p>Heritage Attributes: Two-storey red brick construction; hipped roof; paired windows; fenestration; offset entrance with entrance porch; brick columns; entablature.</p>

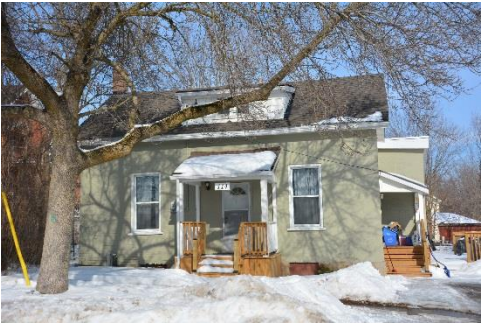
114 Robinson Street	<p>114 Robinson Street appears in the 1875 Romaine's Map on property owned by A. Walker. It is a good example of a vernacular worker's cottage likely constructed in the 1850s. It is a contributing property to the historic character of Robinson Street.</p> <p>Heritage Attributes: One-storey frame construction; central dormer; gable roof; central entrance; entrance porch; fenestration.</p>

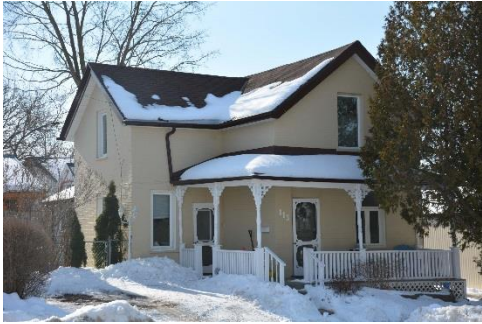
115 Robinson Street	<p>Constructed around 1885, 115 Robinson is a good example of gable roof Victorian vernacular construction, this property contributes to the historic landscape of Robinson Street.</p> <p>Heritage Attributes: Two-storey frame construction; brick cladding; gable roof; fenestration, verandah; decorative woodwork; spindles; columns; offset entrance.</p>

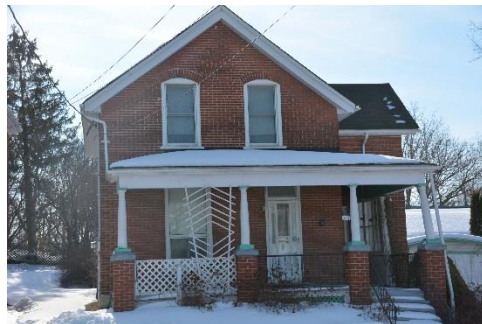
117 Robinson Street	<p>117 Robinson Street is a good example of front gable vernacular construction. The property contributes to the historic landscape of Robinson Street.</p> <p>Heritage Attributes: one-and-a-half storey brick construction; gable roof; rounded windows; fenestration, voussoirs; offset entrance; verandah; brick piers; stone coping; wooden tapered columns; entablature.</p>

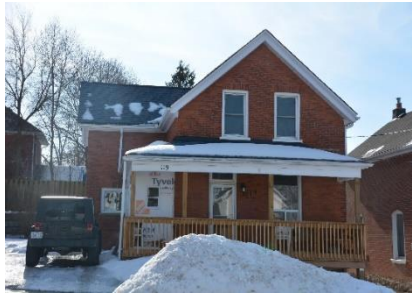
Address	Statement of Significance Heritage Value	Photo
119 Robinson Street	<p>119 Robinson Street is a good example of front gable vernacular construction. The property contributes to the historic landscape of Robinson Street.</p> <p>Heritage Attributes: one-and-a-half storey brick construction; gable roof, voussoirs; fenestration including main floor transoms; offset entrance; verandah; entablature.</p>

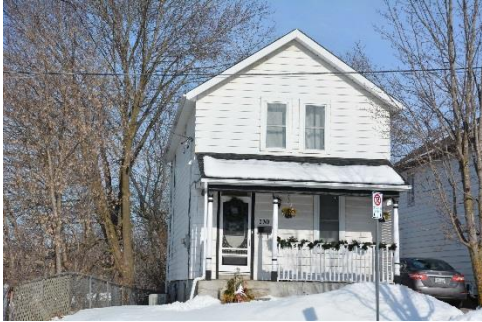
130 Robinson Street	<p>130 Robinson Street is a good example of frame construction gable front Victorian vernacular residence. It was likely constructed for working class occupants. It is a contributing property to the historic landscape of Robinson Street.</p> <p>Heritage Attributes: two-storey frame construction; gable roof; fenestration; offset entrance; verandah; decorative columns and entablature.</p>

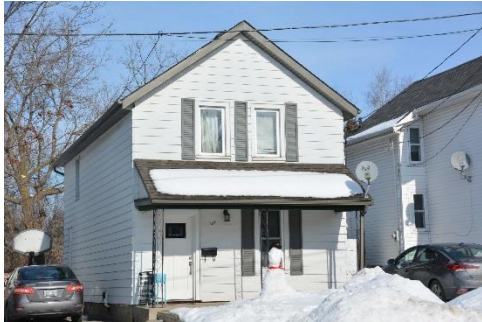
134 Robinson Street	<p>134 Robinson Street is a good example of frame construction gable front Victorian vernacular residence. It was likely constructed for working class occupants. It is a contributing property to the historic landscape of Robinson Street.</p> <p>Heritage Attributes: One-and-a-half storey frame construction; gable roof; fenestration; offset entrance; verandah.</p>

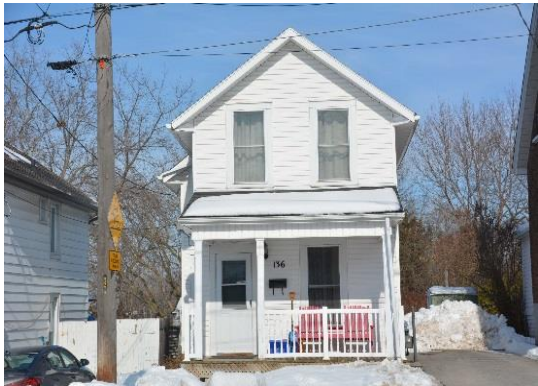
136 Robinson Street	<p>136 Robinson Street is a good example of a gable front Victorian vernacular residence constructed for working class occupants around 1900. It is a contributing property to the historic character of Robinson Street.</p> <p>Heritage Attributes: One-and-a-half storey brick construction; gable roof; decorative brackets; fenestration; offset entrance; verandah.</p>

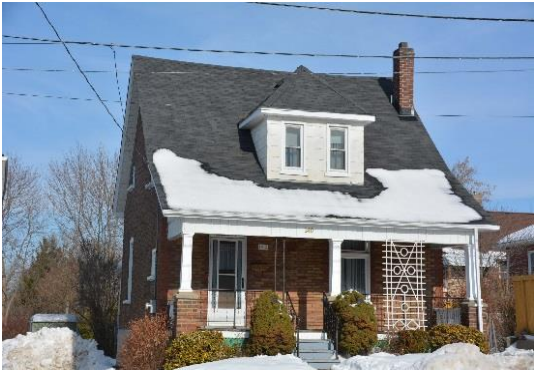
Address	Statement of Significance Heritage Value	Photo
140 Robinson Street	<p>140 Robinson Street was is a good example of a bungalow. Featuring a steep gable roof and central dormer, it retains key elements of the style.</p> <p>Heritage Attributes: One-and-a-half storey red brick construction; gable roof; front dormer with hip roof; fenestration including main floor transoms; offset entrance; verandah; entablature; brick piers with stone coping; square columns; chimney.</p>

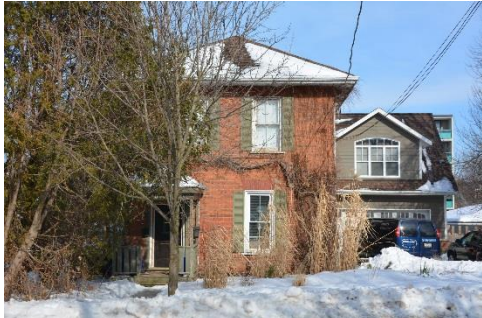
40 Robinson Street	<p>40 Robinson Street is a good example of a hipped roof Victorian vernacular house. It was constructed for working class occupants and is a contributing property to the historic landscape of Robinson Street.</p> <p>Heritage Attributes: Two-storey red brick construction; hipped roof; fenestration; offset entrance; entrance porch; shutters.</p>

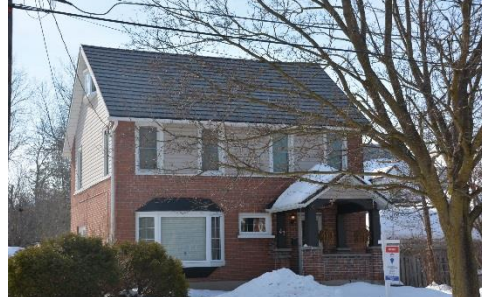
47 Robinson Street	<p>47 Robinson Street was likely constructed in the early part of the twentieth century and is a heavily modified example of a four square style home.</p> <p>Heritage Attributes: Two storey construction; gable roof; offset entrance; entrance porch.</p>

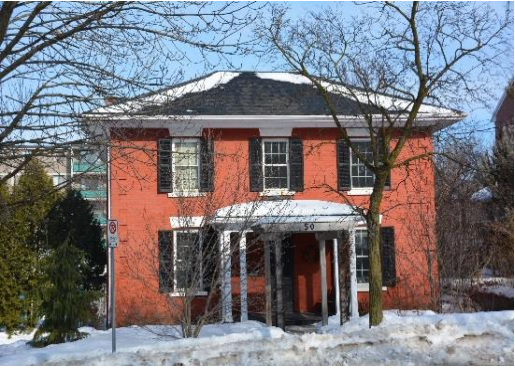
50 Robinson Street	<p>50 Robinson Street, likely constructed in the 1860s, features elements of the Georgian style including symmetrical façade, muted details and a very simple appearance. It is a contributing property to the historic landscape of Robinson Street.</p> <p>Heritage Attributes: Two-storey, three-bay red brick construction; symmetrical massing; hipped roof; sash windows; shutters; voussoirs; fenestration; central entrance with entrance porch; wooden columns; entablature.</p>

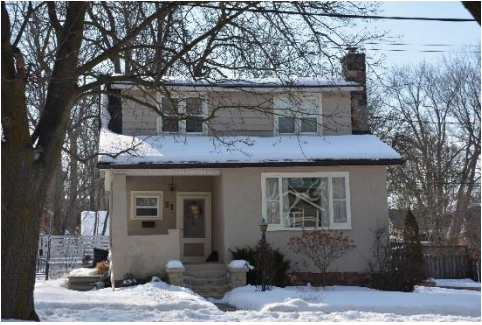
Address	Statement of Significance Heritage Value	Photo
51 Robinson Street	<p>51 Robinson Street is a good example of a 1920s bungalow. It is a contributing property to the historic landscape of Robinson Street.</p> <p>Heritage Attributes: One-and-a-half storey stucco-clad construction; offset front elevation; low pitched gable roof with front wall dormer; fenestration; offset entrance; entrance porch with brick knee walls and stone coping; rusticated stone foundation; stone chimney.</p>

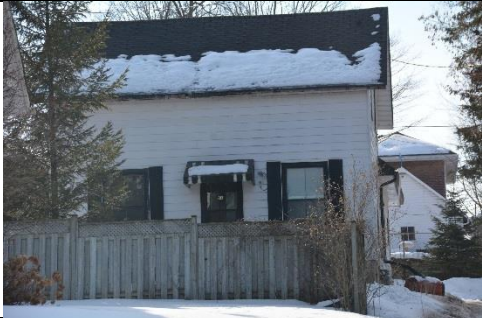
61 Robinson Street	<p>61 Robinson Street is an example of an early worker's cottage constructed on land originally belonging to L. Mowry. It is set back quite far from the street and was constructed prior to 1875.</p> <p>Heritage Attributes: One-storey frame construction; gable roof; fenestration; symmetrical construction.</p>

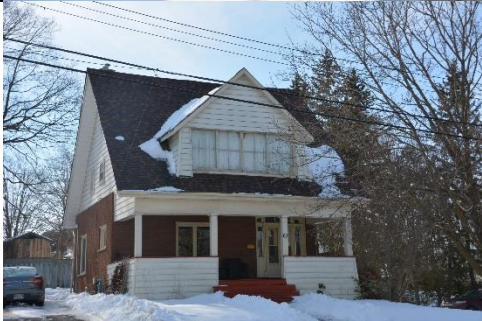
63 Robinson Street	<p>63 Robinson is an Arts & Craft style bungalow. It features a steeply pitched gable roof and central dormer with a bank of four windows.</p> <p>Heritage Attributes: One-and-a-half storey construction; gable roof; front dormer with bank of four windows; offset entrance; piers; fenestration; integrated verandah; entablature.</p>

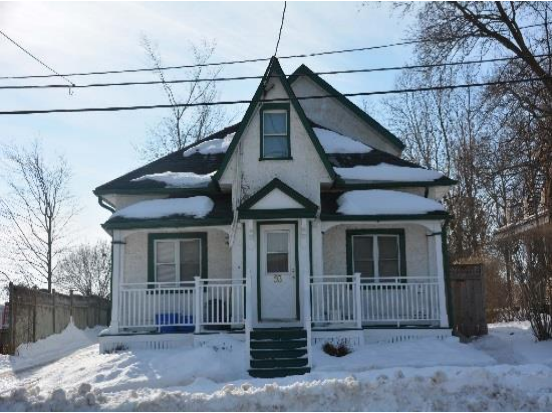
93 Robinson Street	<p>93 Robinson Street appears on the 1875 Romaine's Map and is a good example of vernacular housing in Peterborough with some features of various styles popular through the decades and seen in neighbouring properties including Gothic Revival details such as its central front facing gable with central window.</p> <p>Heritage Attributes: One-and-a-half storey construction; rough cast cladding; hipped roof with steeply pitched front gable and central window; symmetrical front elevation; verandah; central entrance with pediment and decorative brackets.</p>
