City of
Peterborough

Subject: **Report IPSTR18-022
Summerhill Drive / Rosehill Drive Traffic Operational Review**

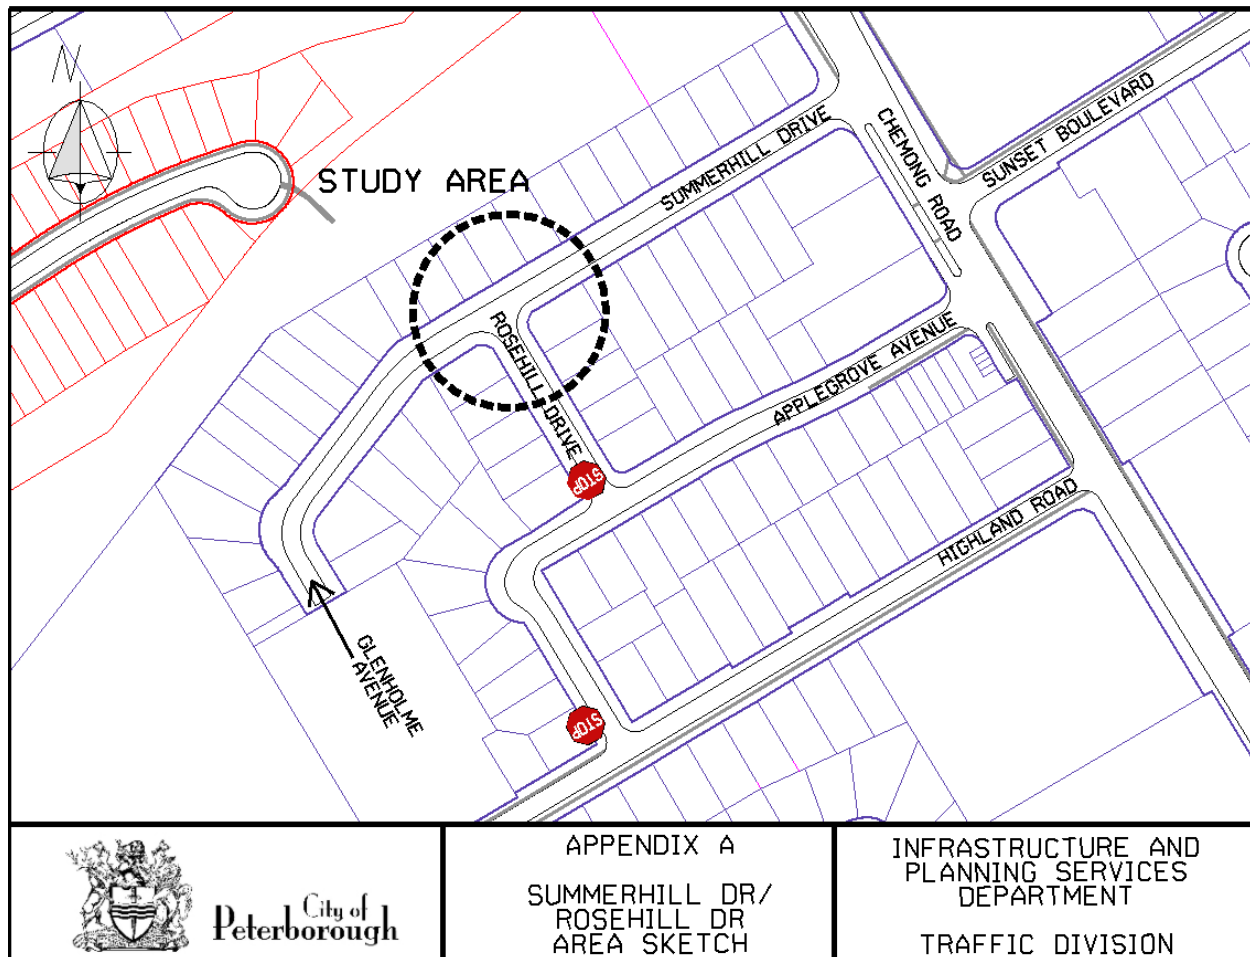
Appendix A - Summerhill Drive / Rosehill Drive Area Sketch

Summerhill Drive is a two-lane local road running east-west from Chemong Road to Glenholme Avenue. Rosehill Drive is a short (80 m) two-lane local road running north-south from Summerhill Drive to Applegrove Avenue (see Appendix A). There are no sidewalks on either road, and 3 hour on-street parking is permitted on both Summerhill Drive and Rosehill Drive. Rosehill Drive has a stop sign in the southbound direction at the intersection with Applegrove Avenue. Both roads serve a residential neighbourhood and have a speed limit of 50 km/h.

The intersection of Summerhill Drive and Rosehill Drive is a T-intersection. There is currently no stop or yield control at the intersection and drivers are expected to observe the **Highway Traffic Act** right-hand rule when entering the intersection such that when two vehicles enter an uncontrolled intersection at the same time, the driver on the left shall yield the right-of-way to the driver on the right.

That Stop Control be implemented on Rosehill Drive at the intersection of Summerhill Drive and Rosehill Drive.
