BUILDING CONDITION
ASSESSMENT REPORT

City Of Peterborough
The DelaFosse Library

Aug. 13th, 2021

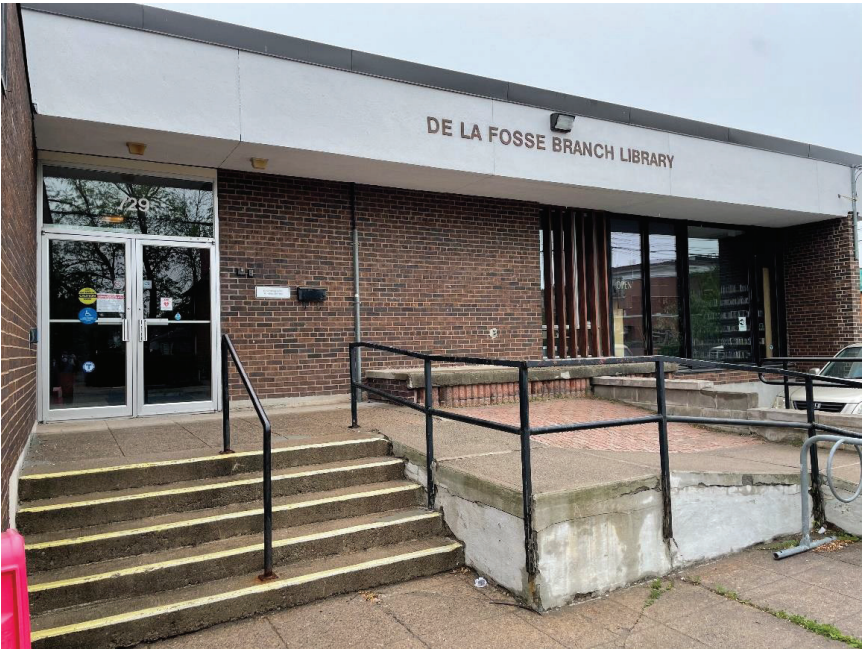
Photo #1 – Library Main Entrance

The existing building structure in its present state is a one-storey building with full basement and has a footprint of about 136'-7" x 50'-0". (Photo #1) The building structure is a combination of concrete, masonry, and steel construction.

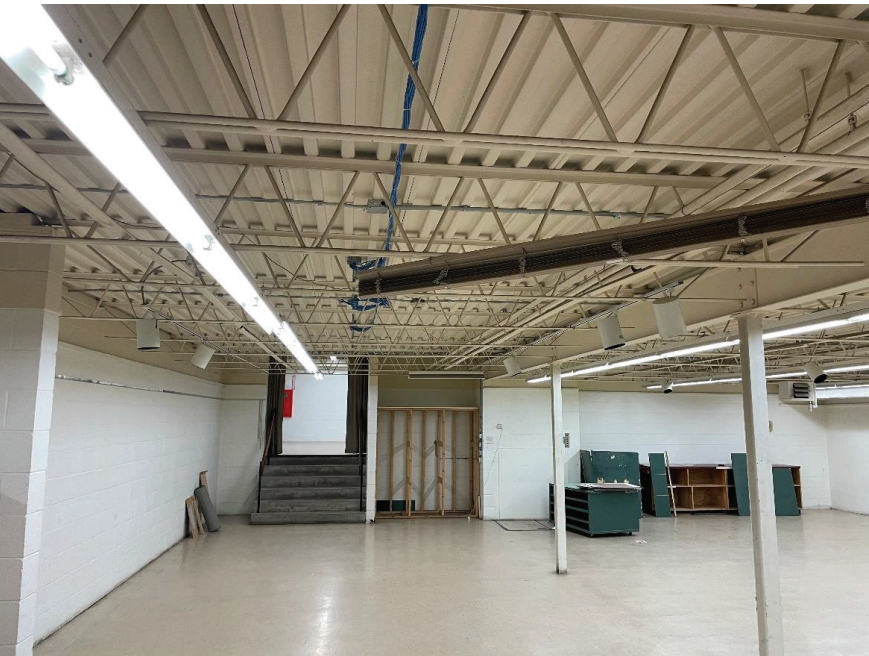
Photo #2 – Existing Basement

Exterior perimeter basement walls consist of 12" thick reinforced concrete walls supported on concrete strip footings. Interior basement walls consist of 8" or 10" block supported on concrete strip footings. Basement floor on western side of the building stack area is about 3'-6 1/4" higher than the main lower basement area. There is a concrete stair connecting the two levels. There is also a lift located at the central portion of the structure which serves lower basement level and main ground floor level. Lift shaft walls consist of block wall construction. (Photo #2)

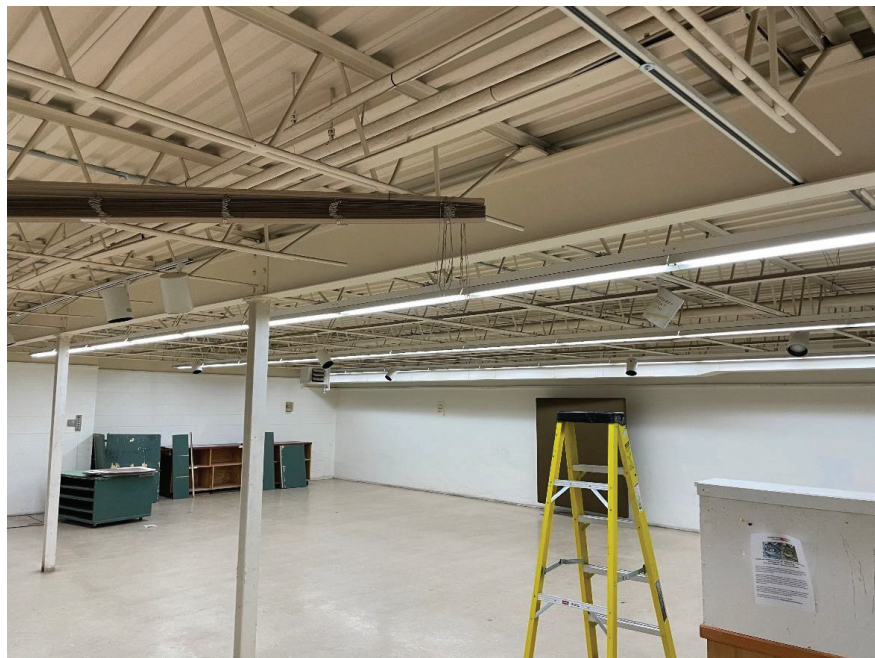
Photo #10 – Existing ground floor framing

“Existing structural drawings indicate a superimposed design dead load of 35 pounds per square foot (psf) and design live load of 60 psf for the ground floor. Ground floor structure appears to be in reasonably good condition although library staff has noted some vibration in the floor in the Adult library area which currently is where the book stacks are located.” (DK)

The building was designed as a library and as noted above, the structure was designed to meet 60 pounds per square foot. The current building code carries that figure for reading rooms and study rooms, but book stack areas are now mandated to meet 150 pounds per square foot.

“...the existing ground floor structure does not have sufficient capacity to safely support the required loading in stack areas.” (DK)

The ground floor structural framing at both library areas consists of 2.0" concrete slab on 1.5" deep steel deck supported on steel open web steel joists at approximately 4'-8" o/c maximum. (Photo #10). At the Boys & Girls library area the floor joists are spanning in east-west direction and are supported on interior block masonry walls. At the Adult library area joists are spanning in north-south direction and are supported on concrete or block masonry walls at one end and on interior row of steel beams at the other end in the centre of the building. Steel beams are supported on steel columns and footings.

“As a temporary measure, until remedial action is complete, we recommend that existing loading at the stack area be reduced immediately within the allowance of 60 psf which the floor is currently designed for.” (DK)

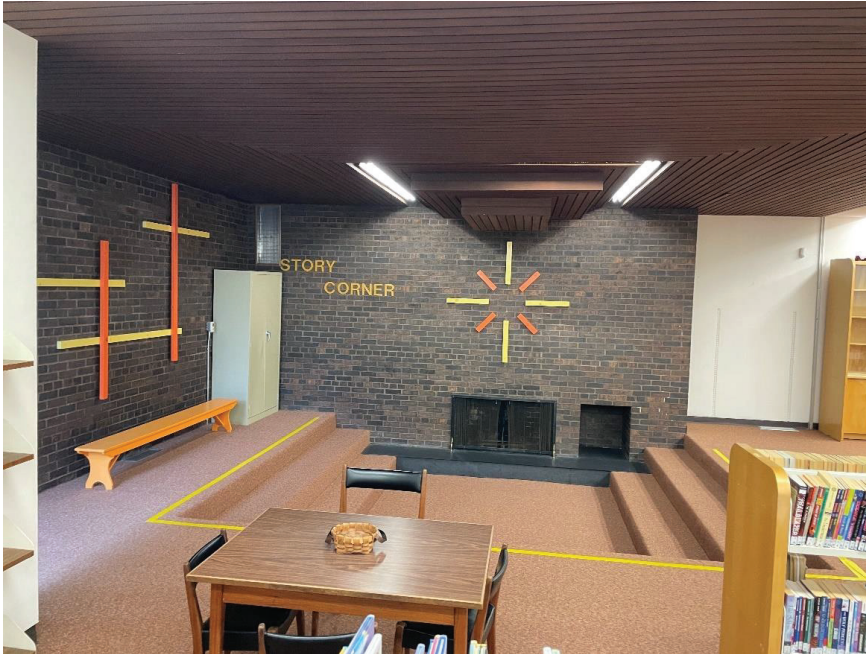
Photo #11 – Sunken lecture pit

Ground floor consists of two main sections, the Adult library and the Boys & Girls library. The Adult library is at the same level as the main entrance. The Boys & Girls library is at a higher level and is accessible by as set of steel stairs and an interior ramp on west side (Photo #9). The Boys & Girls library is currently used as reading room. At the north-west corner (Story Corner) there is sunken pit which consists of reinforce concrete construction (Photo #11).

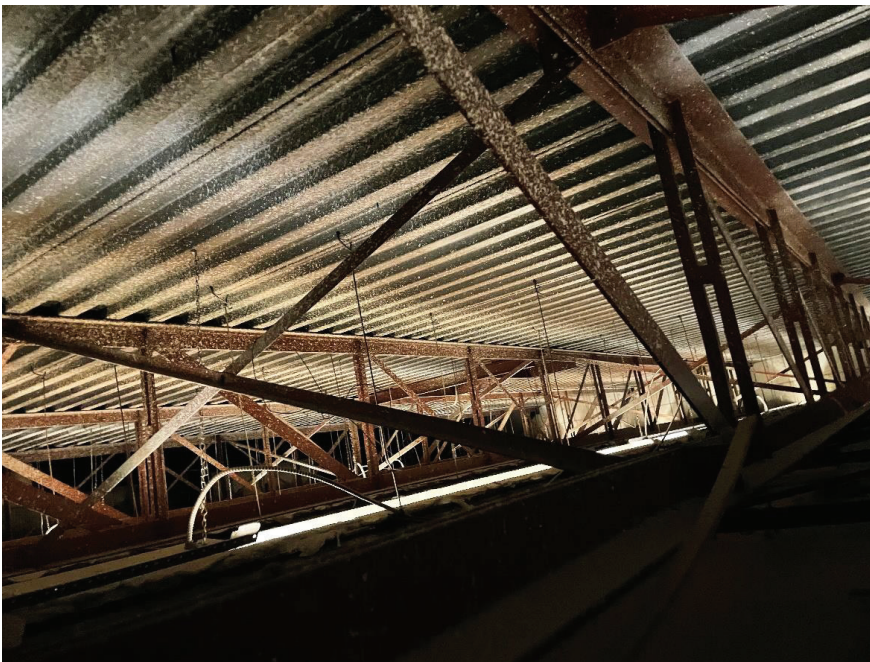
Photo #12 – Roof framing

Based on review of existing structural drawings, roof framing consists of 1.5" steel deck supported on 30" deep long span open web steel joists spaced at 6'-6" o/c. Gauge of steel deck is not specified on the existing drawings available. Joists are spanning in east-west direction and supported on exterior block walls. Roof farming had finishes and was only visible in some limited areas. (Photo # 12)
