107 Park Street North

HERITAGE IMPACT ASSESSMENT REPORT

September 4, 2025

Project # 23120

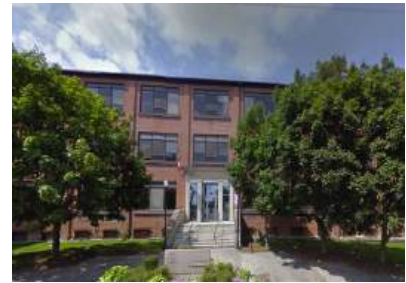
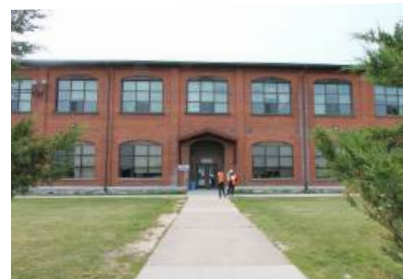
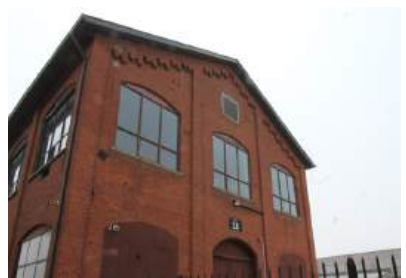
49. Building 2 East Elevation (Google, 2018)

50. Building 2A East Elevation (ERA, 2023)

51. Building 2 North Elevation (ERA, 2023)

Masonry: Clean areas of efflorescence and repoint the stone base. Remove any pipes, wires, or fixtures affixed directly to the brick to protect the masonry fabric.

Window Openings: Where possible, reopen window openings

on the courtyard side adjacent to Building 2 and in the projecting courtyard section. Window sills may need replacement based on their condition under the existing metal flashing.

Windows: Assess and replace windows throughout to match the building’s historical style and improve overall performance.

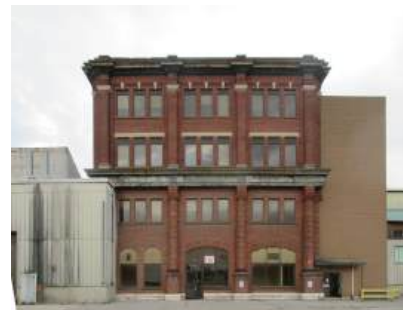
58. East Elevation Building 8A
(Source: ERA, 2023)

The following conservation activities are recommended to conserve the cultural heritage value of Building 8A:

- Demolish the stairs and walkway on north elevation to expose the original heritage facade
- Remove paint from brick on north, west and south elevations
- Demolish concrete masonry unit window infill on north and south elevations
- Infill superfluous openings on west elevation
- Provide new windows and exterior doors throughout the building
- Infill lower cornice at demolished stair on the north elevation
- Repair parapet and cornices on each elevation
- Build new exit stair and fire escape on west elevation of building and maintain barrier-free exit requirements
- Maintain and retrofit existing elevator
- Repair and/or replace roofing
- Repair damaged floor structure below area of leaking roof
- Repair at connections to adjacent/attached buildings which are proposed for removal, following deconstruction
- Mothball the building until a future use is identified

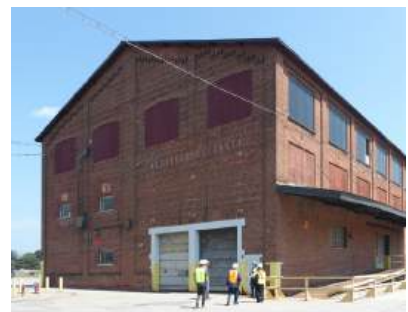
Building 30 contains Edwardian industrial elements including round-headed windows, decorative brick corbels and a gabled clerestory roof. It fronts onto Park Street, and is attached directly to Building 2, constructed as an addition in 1924. It has a secondary entrance onto Park Street. It has two loading bays and additional door openings that face Albert Street which are not accessible to the public. Many of its original openings have been bricked in or boarded up over time. In some cases, bricked-in windows have had smaller modern windows inserted. To restore its cultural heritage attributes, it is proposed that these openings be returned to their original state through removing the various material infills, where possible. The original windowsills have been removed over time in many areas and

61. North East corner of Building 30 (Source: ERA, 2024)

should be replaced. The remaining original windows should be refurbished where possible, and openings that are bricked in, without original windows, or infilled with unsympathetic modern replacements, should be fitted with new windows matching the originals. It is proposed that the exterior doors be replaced with more appropriate alternatives, and the overhead doors be refurbished or replaced with glazing.

The following conservation activities are recommended to conserve the cultural heritage value of Building 30:

- Undertake general masonry cleaning and some sympathetic replacement of damaged units, especially near grade
- Refurbish remaining original windows and replace all other windows with new to match original
- Unbrick infilled windows openings and replace removed sills
- Replace existing exterior doors and overhead doors with more sympathetic doors.
- Repair roof leak at west end
- Repair eaves at northwest corner
- Replace wood decking and membrane
- Mothball the building until a future use is identified

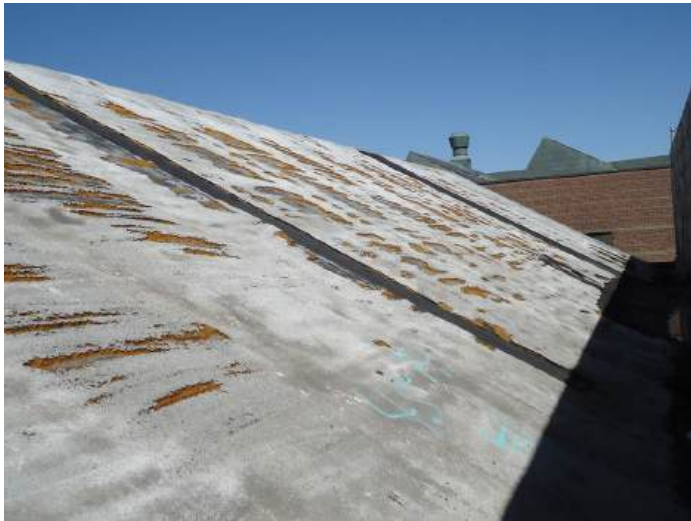
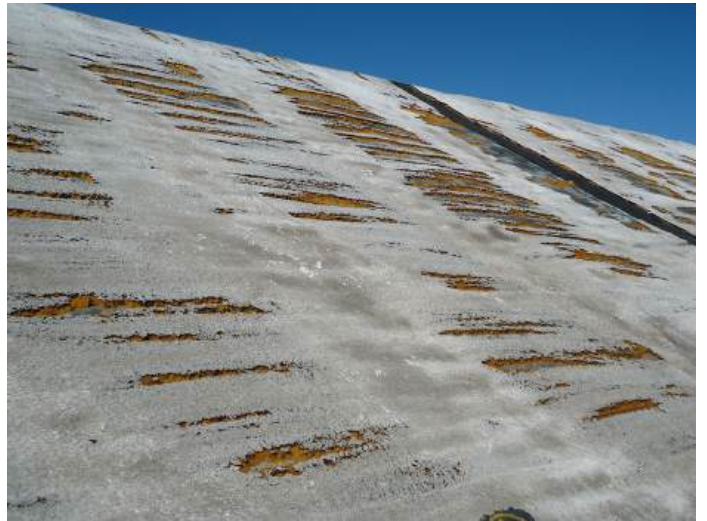
- The roofing appears to be sprayed insulation with a reflective coating on many of the core buildings. The coating and insulation are deteriorated and broken down, allowing moisture infiltration into many of the buildings (Photos 001 and 002). There was ponding apparent at most of the monitor truss

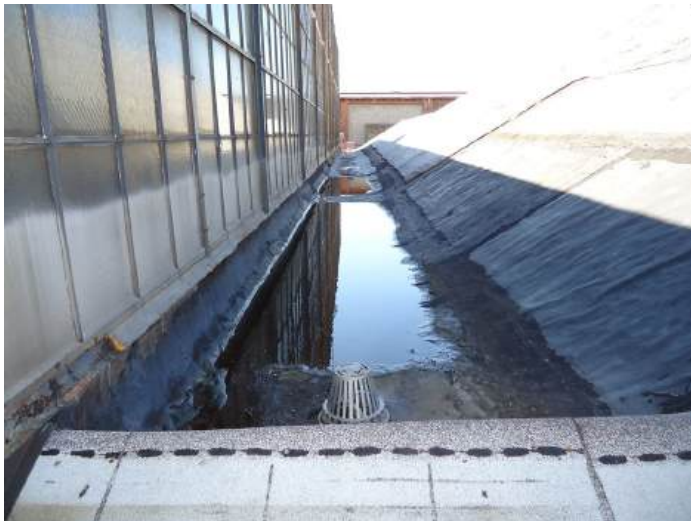
Photo 003

valleys during previous reviews (Photo 003); it was reported by GEV and observed during our visit that there is continued moisture infiltration through the valleys in localized areas at the monitor trusses. A clear indication of water infiltration was apparent from deck staining, puddles on the ground, and tarping around electrical equipment exposed to roof leaks (Photos 004 and 005). GEV has attempted to complete yearly maintenance on the roofs in an effort to maintain them. However, a complete roof replacement program is required due to the age of the roof and decking system. This condition was initially observed in 2015 and continues to be monitored with administrative access controls implemented to suit on-going assessment observations. The full roof replacement of decking and roofing requires significant capital funding and phasing due to the extensive scope of work, likely requiring complete roofing and decking replacement in localized areas.

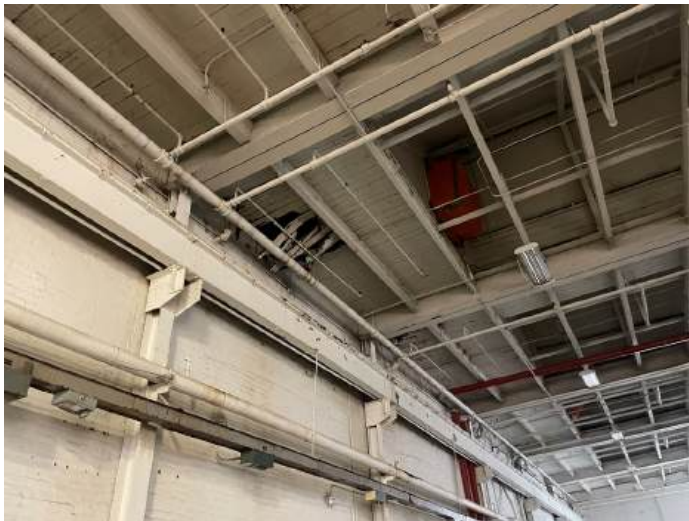
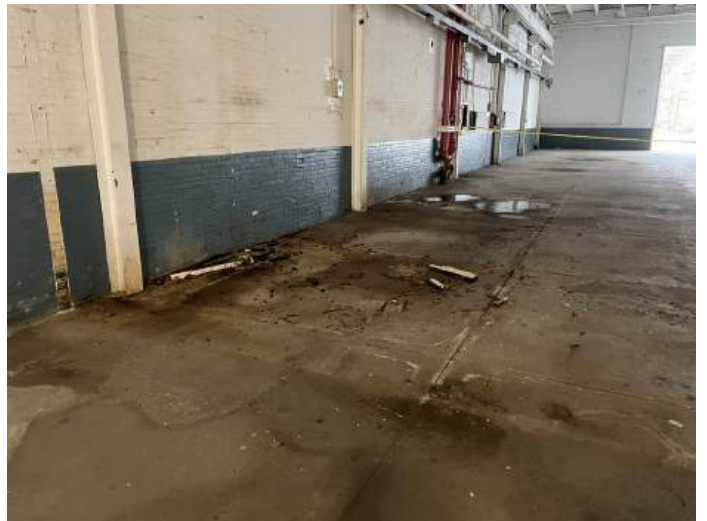
- During the follow-up site visit inside Building 14, there was an apparent failure in the roof membrane and decking, which appeared to have fully collapsed at a localized area. The roof deck had locally collapsed, and there was extensive water staining on the floor where water had infiltrated through the open roof membrane and into the plant (Photos 011 and 012).

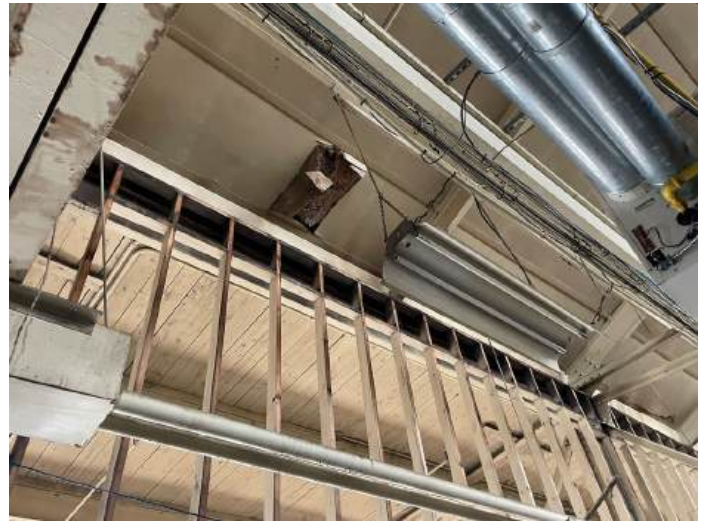
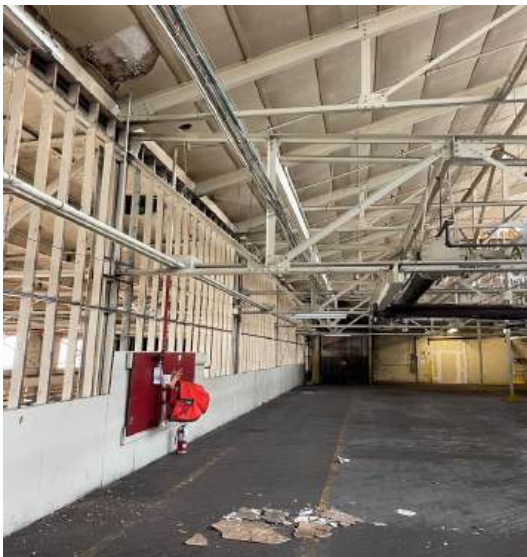
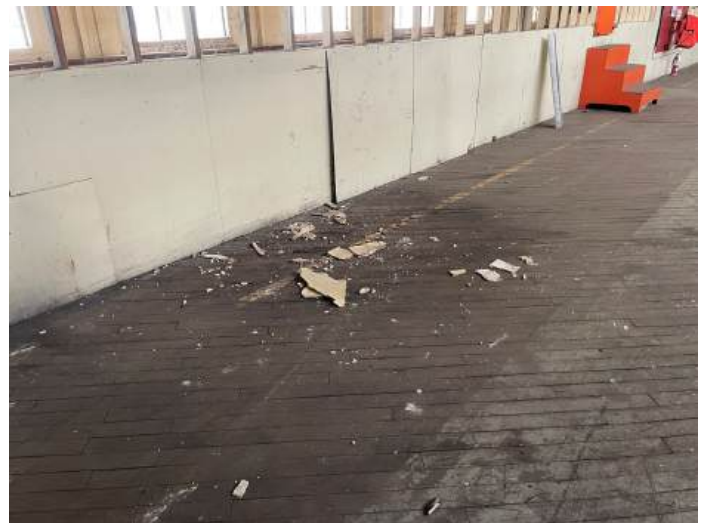
- Building 12 could not be accessed below the lightweight gypsum concrete deck because the deck has been classified as a collapse area and is considered unsafe for occupancy. This roof deck was previously identified as a concern during the 2015 and 2022 reviews. The conditions have not changed, with evidence of new debris on the ground where the light-weight gypsum roof decking was located. The light-weight gypsum concrete decking was also observed from the mezzanine of Building 34, where apparent new fallen sections of the gypsum material were observed on the floor (Photos 013, 014, 015, and 016). This roof deck requires a complete replacement with a new structural decking system.

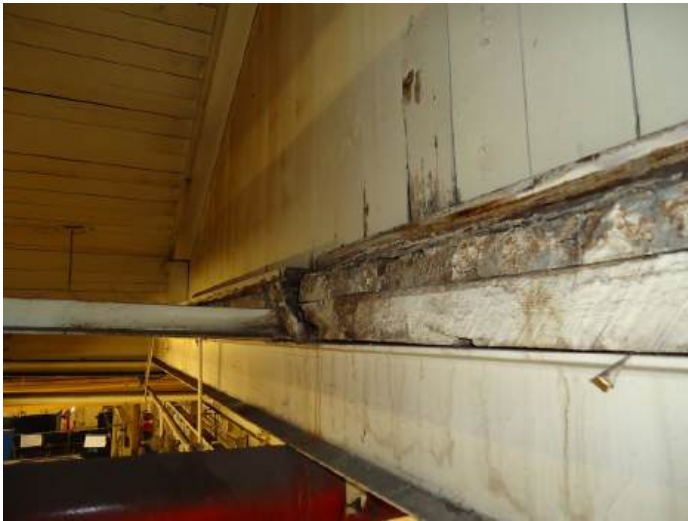
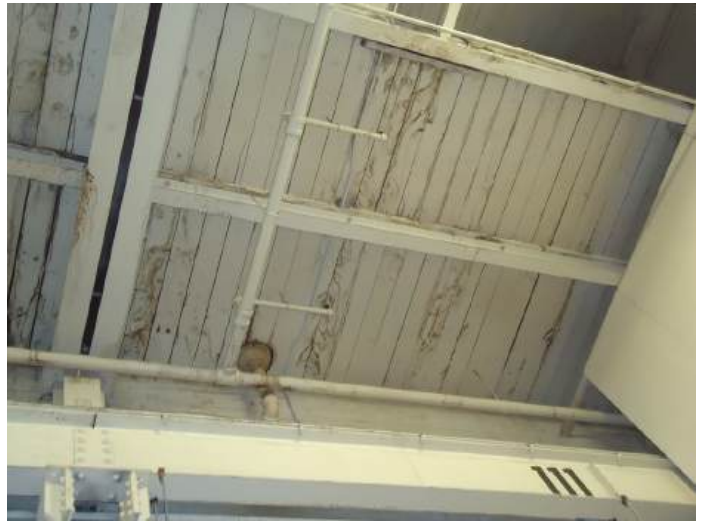
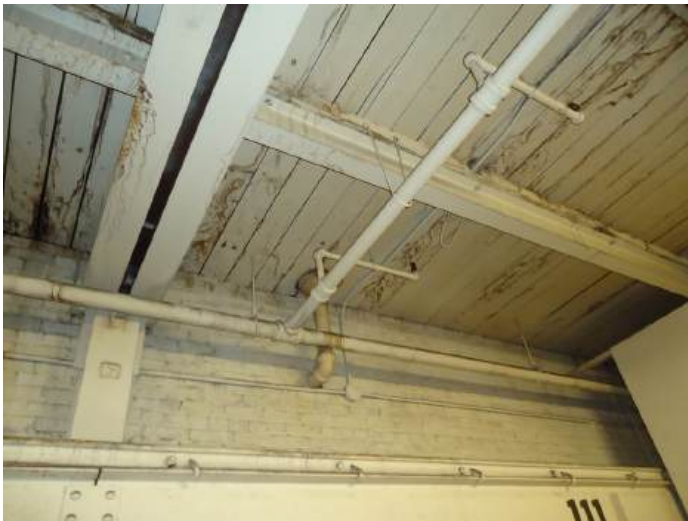
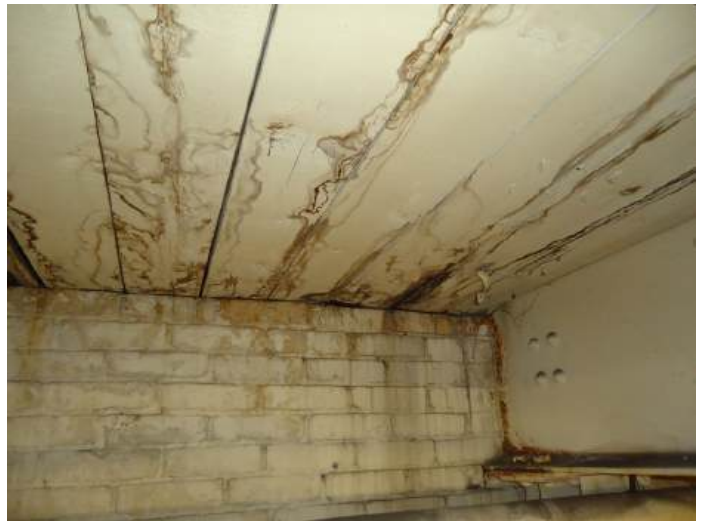
- We observed staining and deterioration on the underside of the wood decking throughout the facility (Photos 017, 018, 019, and 020). Localized areas where the decking has deteriorated will require restoration or complete replacement with new. The wood staining was so severe on the mezzanine wood floor areas that it had fully warped and buckled in areas, creating a trip and fall hazard (Photos 021, 022).

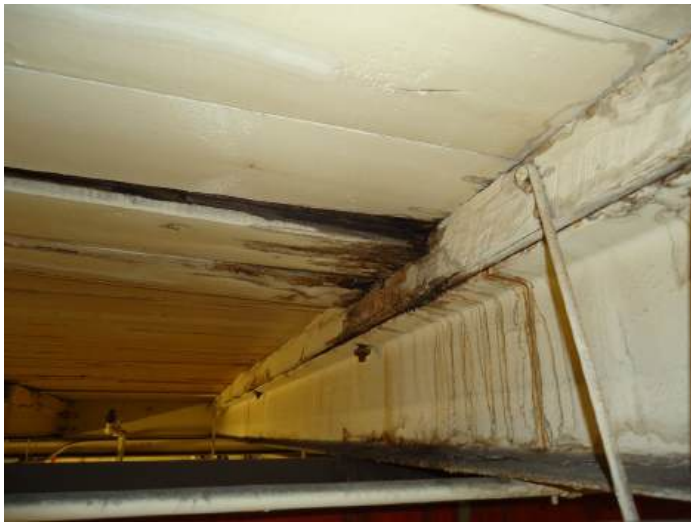
Photo 023

- During the previous close-up review (2015 roofing assessment completed for overhead lifts), there was deterioration observed on some of the supporting structural framing where prolonged exposure to moisture had been occurring. The steel will require further review and likely reinforcing depending on the severity of the deterioration (Photo 023). This condition is consistent in various locations throughout the plant.

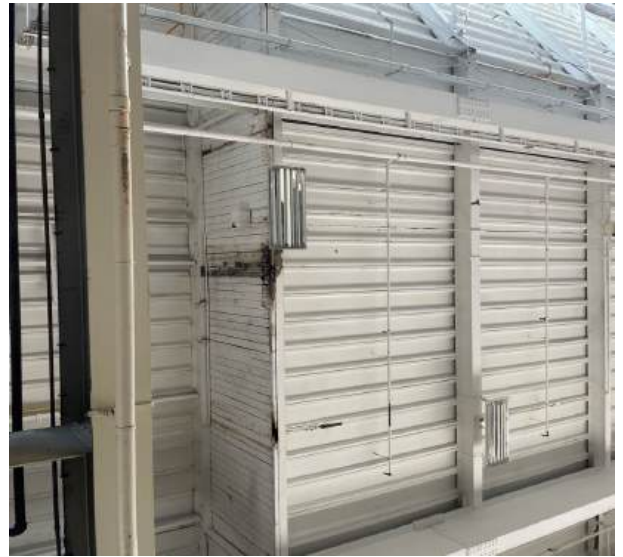
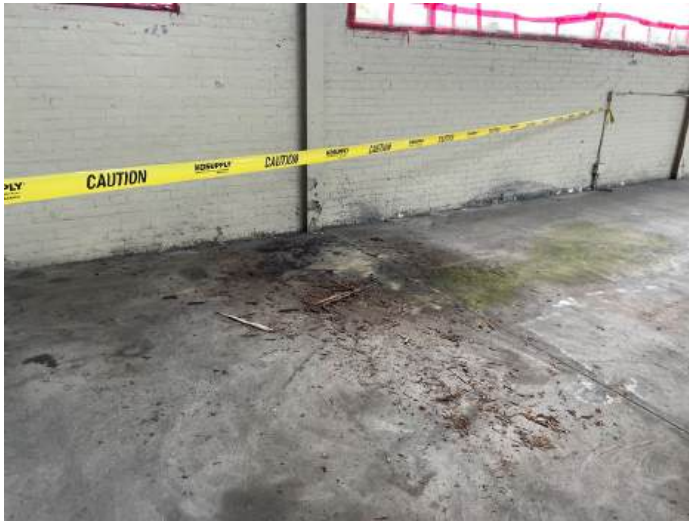
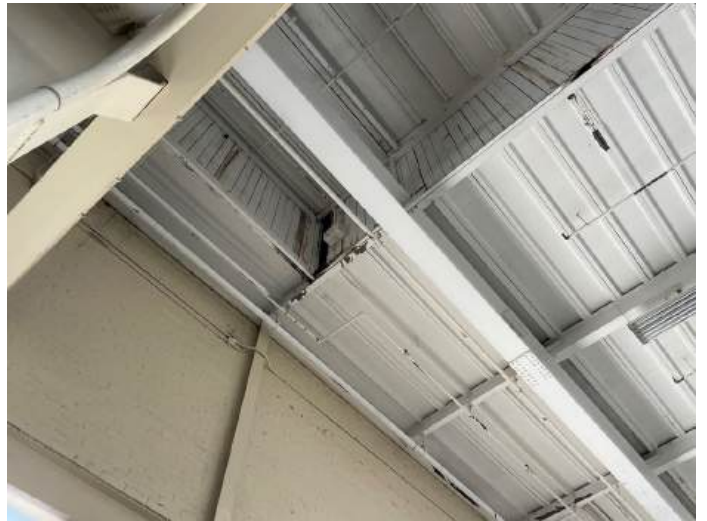
- There are vertical wood cladding panels on the ends of the monitor trusses that are deteriorating and failing at localized areas throughout the plant. The deteriorated wood plank paneling was observed on the floor in many of the areas throughout the plant (Photos 024, 025, and 026).

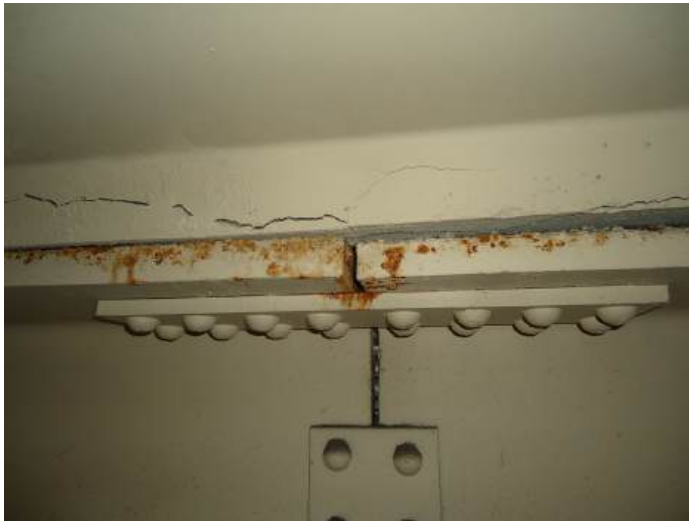
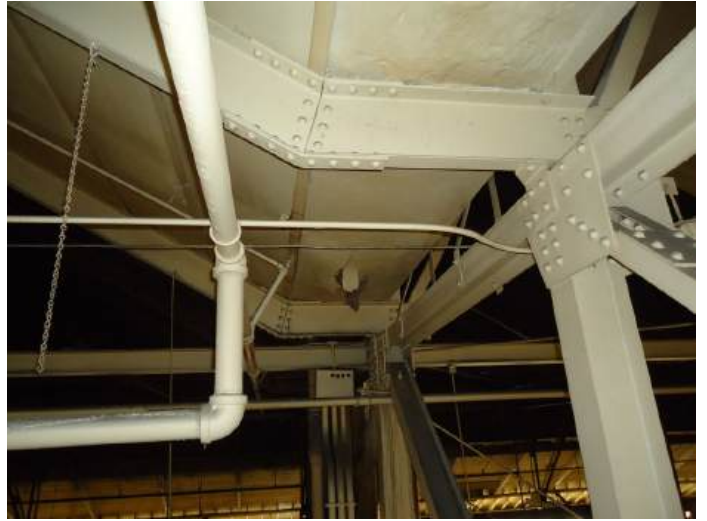
- The structural steel superstructure of many of the buildings is original and consists of light-grade structural steel with riveted connections. Localized close-up visual review connections of the steel should be reviewed where past moisture exposure has occurred to confirm the condition of the riveted connections. We observed areas of scaling/deterioration from a distance on several beams where prolonged roof leaks appear to be occurring (Photos 028, 029, and 030). These conditions have remained generally similar to what was observed in the 2022 review.

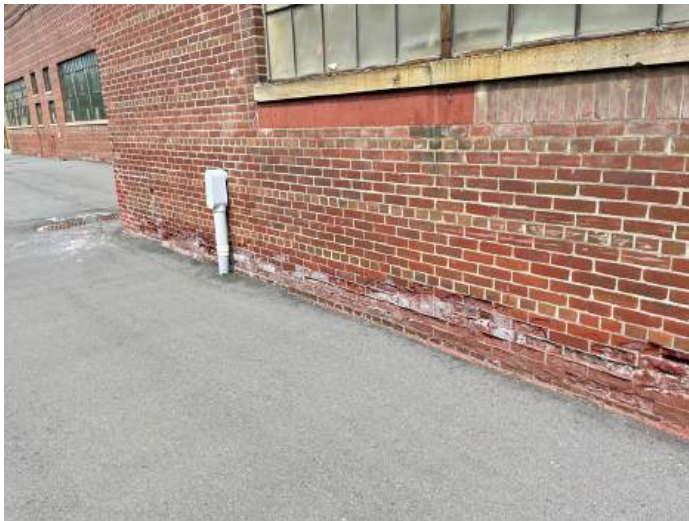
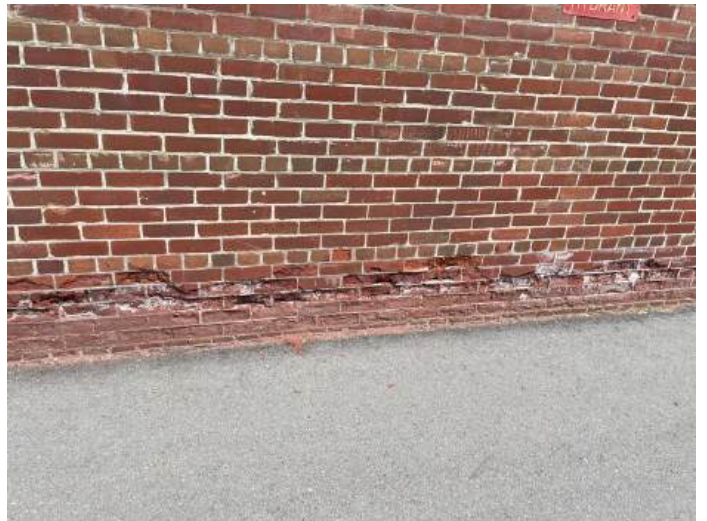
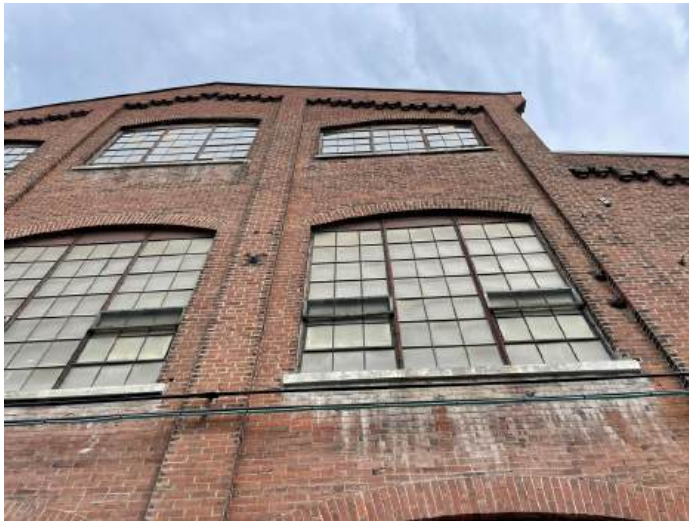
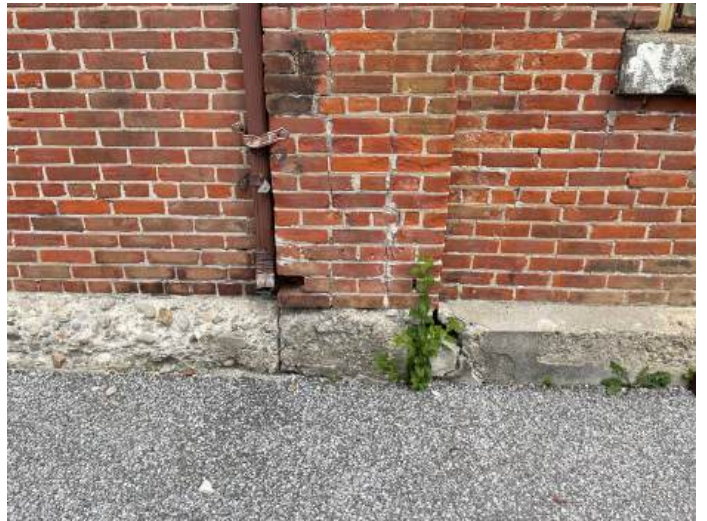
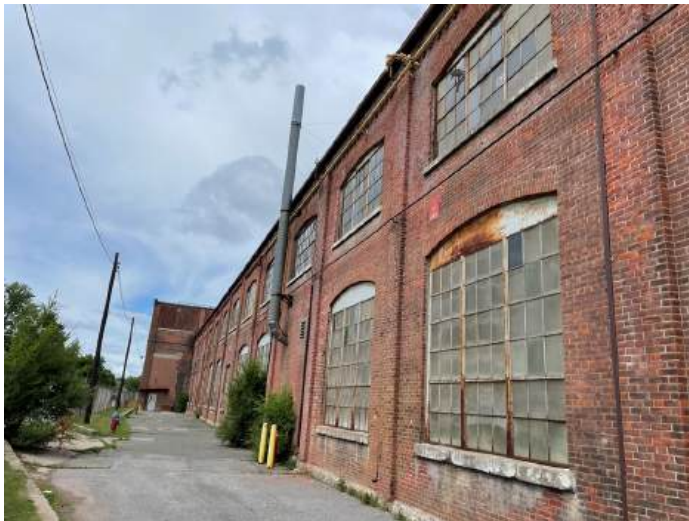
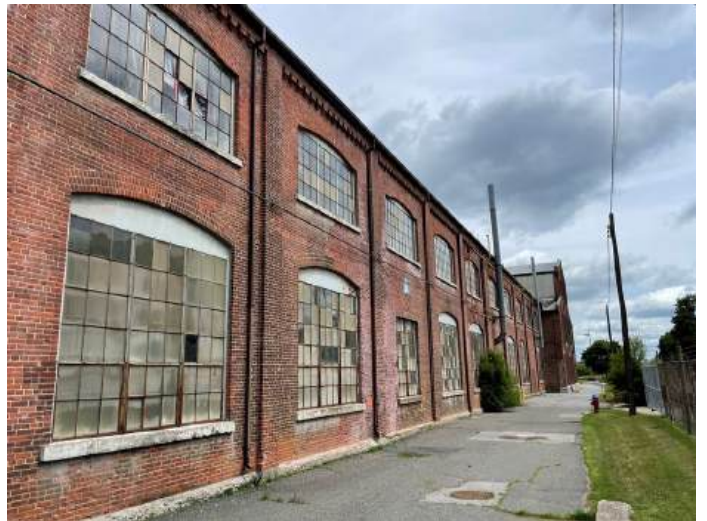
- o Deteriorated (cracked or open mortar joints), especially at the roof lines, around windows, doors, and foundation walls (Photos 031, 032, 033, 034, 035, and 036).

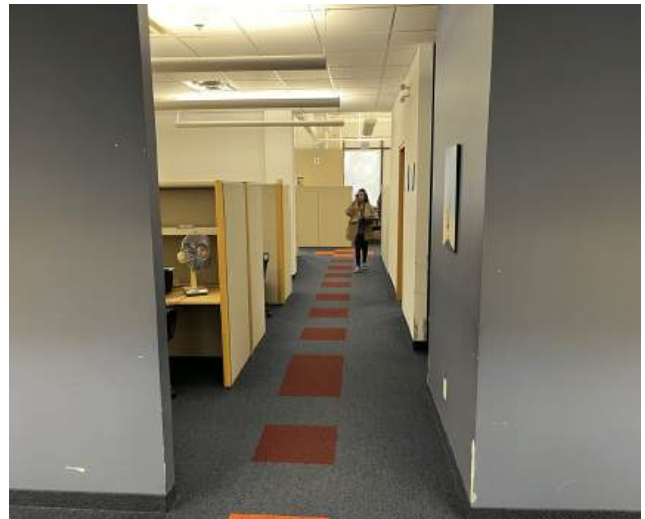
Photo 057

Building 2A is a two (2) storey office/administration building located at the north end of the three buildings. Building 2A generally consists of 26,776 square feet of gross floor area. The building's ground floor is currently being partially used for facility administration and security work. However, the second floor and mezzanine, along with parts of the ground floor, are unoccupied. The unoccupied sections of the building generally have had finishes removed and are in a shell condition, exposing the original heavy timber and wood framed superstructure (Photo 057).

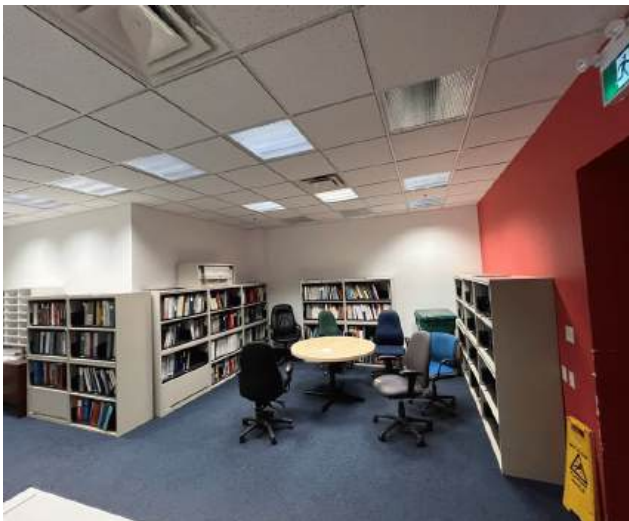
Photo 058

Building 2 is a three (3) storey office/administration building with a full basement and is located between Building 2A and Building 30. Building 2 in general consists of a gross floor area of 39,690 square feet and 13,230 square feet of basement area. The building is currently occupied by GEV staff on the ground, 2nd floor, and 3rd floors, and the basement is used as a storage space. (Photos 058, 059)

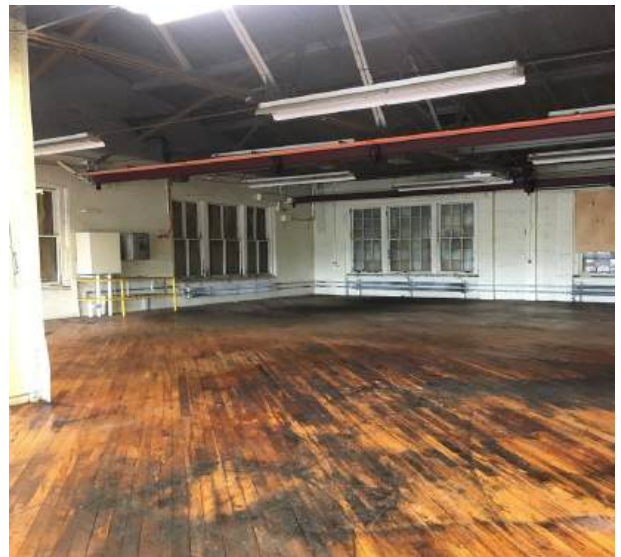
Photo 059

Building 30 is a three (3) storey office/industrial building with a full basement and is located on the south side of Building 2. Building 30 generally consists of 62,339 square feet of gross floor area and 24,871 square feet of basement area. The building is currently not occupied and has been stripped to the building envelope and structural shell (Photos 059, and 060).

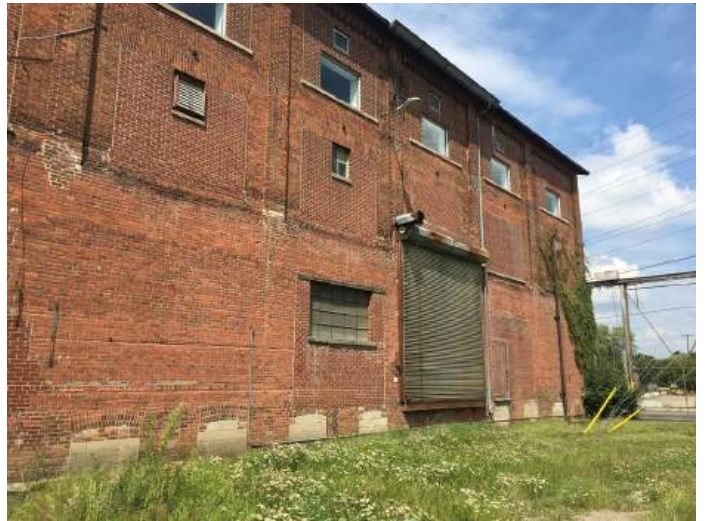
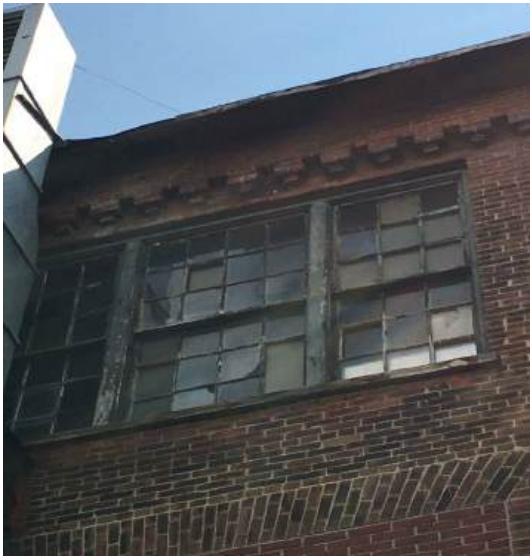
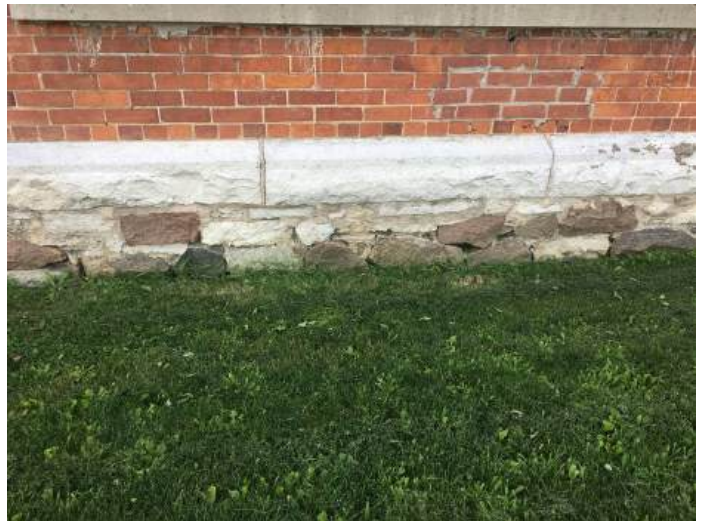
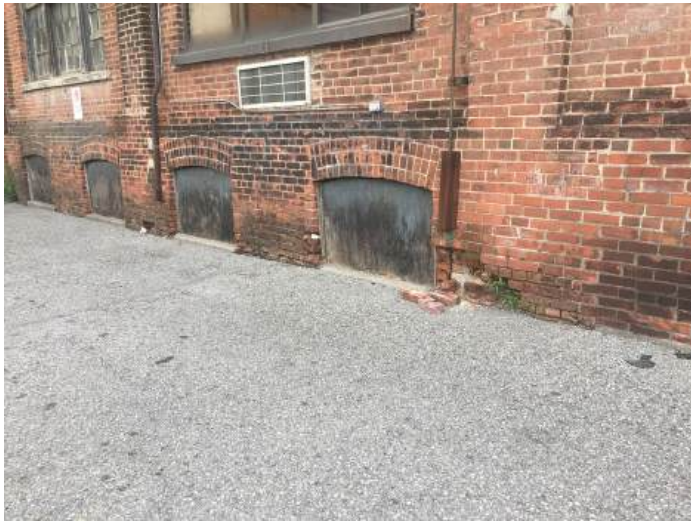
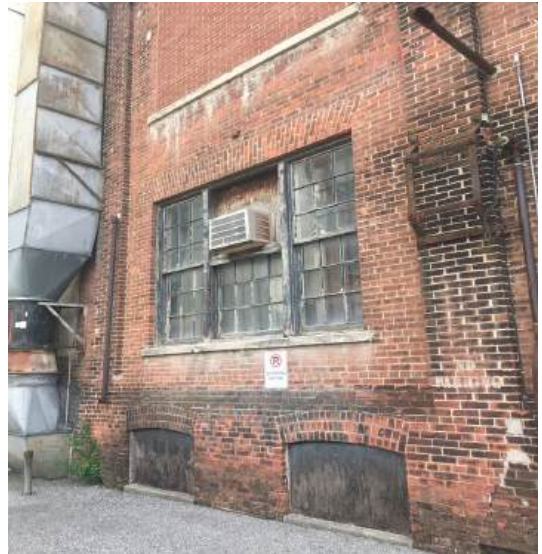
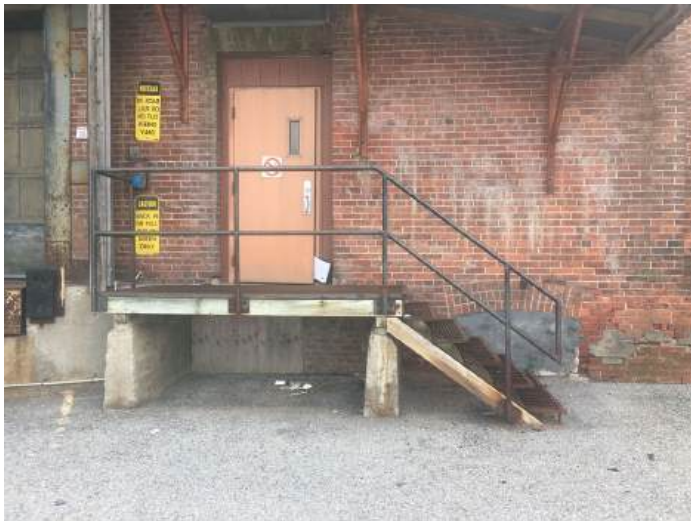
- The roof of Building 30 is in poor condition and is actively leaking (Photos 061, 062, and 063).
- The exterior brick façade will require repointing and localized restoration (Photos 064, 065, and 066).
- Abandoned loading docks that are in poor condition at Building 30 and at-grade approaches will need to be re-purposed or removed (Photos 067 and 068).
- If window and glazing units are replaced, structural lintels and sills / jambs at existing openings will need to be reviewed and reinforced (Photos 069, 070, and 071).
