**CONDITION REPORT**

**Object:** Metal Sculpture  
**Owner:** Art Gallery of Peterborough  
**Location:** 250 Crescent Street, Peterborough ON

**Title:** 'Three Part Groundscreen'  
**Artist:** Peter Kolisnyk  
**Date of Object:** 1986

**Examination Date:** August 2011

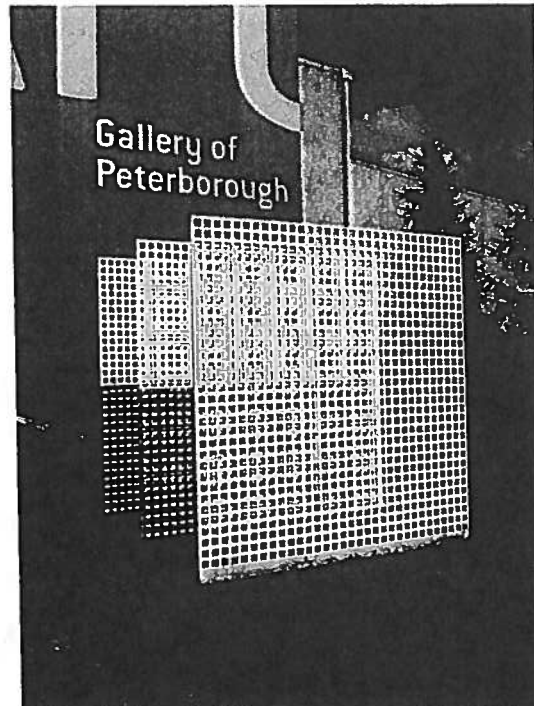
**Current mount or storage method:** Steel is buried underground approximately 2.0 in. 'I' beam is anchored to concrete. Panels are on approximate 48" centers.
