Peterborough

То:	Members of the Committee of the Whole
From:	W.H. Jackson, Director of Utility Services
Meeting Date:	November 30, 2015
Subject:	Report USTR15-016 Request for Pedestrian Signal on Armour Road at Whitaker Street

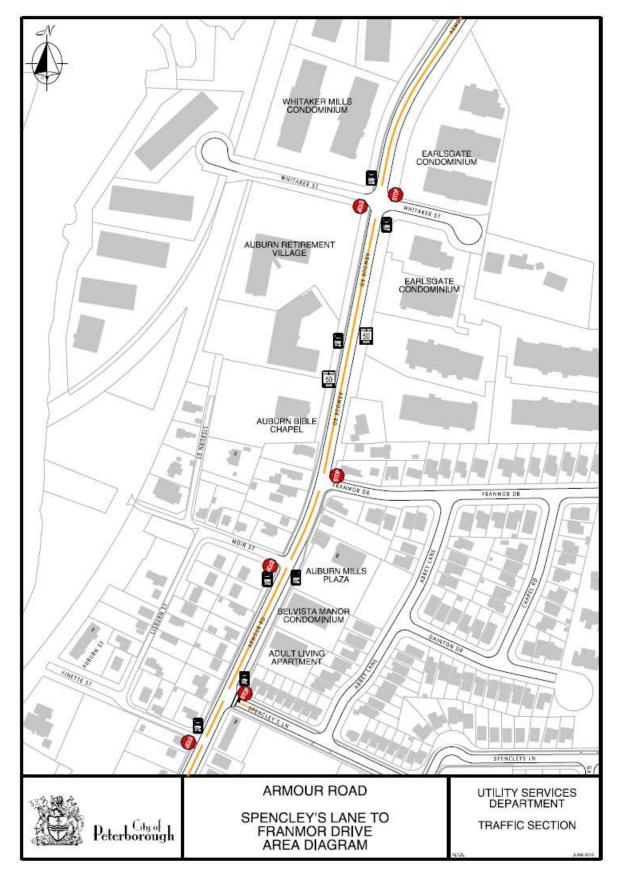
ARMOUR ROAD AT WHITAKER STREET NUMBER OF PEDESTRIANS / HOUR (EAU) WARRANTED 95 -75-NOT WARRANTED 55 35-15 15 30 45 60 120 90 CROSSING OPPERTUNITIES / HOUR UTILITY SERVICES INTERSECTION PEDESTRIAN SIGNAL WARRANT DEPARTMENT TRAFFIC SECTION (IPS) eterborough SEPTEMBER 201

- Appendix A: Armour Road / Whitaker Street, Area Diagram
- Appendix B: Intersection Pedestrian Signal Warrant, Armour Road / Whitaker Street
- Appendix C: Spencley's Lane Franmor Drive, Area Diagram
- Appendix D: Spencley's Lane Franmor Drive, Study Details, Gap Study, Pedestrian counts and Intersection Pedestrian Warrant
- Appendix E: Combined Intersection Pedestrian Signal Warrant, Armour Road / Spencley's Lane to Franmor Drive (Peak Pedestrian Time 3:00 P.M. to 4:00 P.M.)

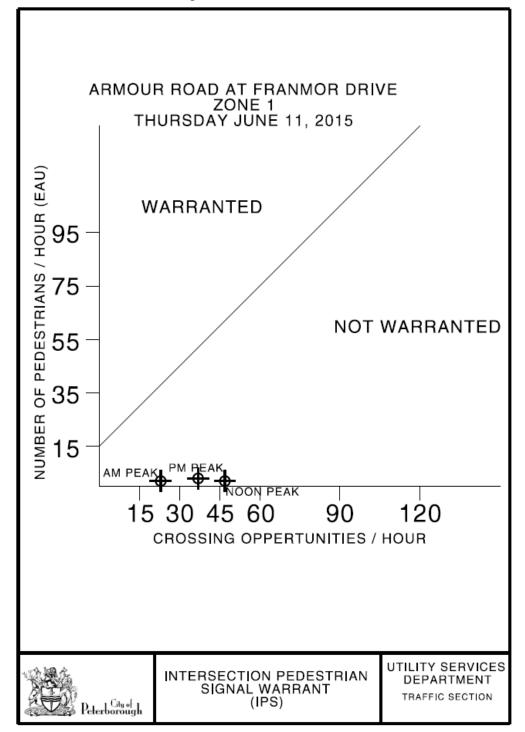
Intersection Pedestrian Signal Warrant, Armour Road / Franmor Drive

The pedestrian count and gap study data collected was analyzed using the City of Peterborough Intersection Pedestrian Signal Warrant below, which compares the availability of safe crossing opportunities to the adjusted crossing demand to determine if pedestrians need traffic control measures to find enough safe gaps in traffic to cross the road. The results show a small number of pedestrians crossing Armour Road at each location and there are large number gaps in traffic to safely cross the road. The minimum technical criteria required for the installation of an Intersection Pedestrian Signal on Armour Road at Spencley's Lane, Moir Street and Franmor Drive was not met.
