## **Properties Eligible for Listing on the Heritage Register of the City of Peterborough**

Under Regulation 9/06 of the Ontario Heritage Act, a property is significant for its cultural heritage value or interest and is eligible for designation if it has physical, historical, associative or contextual value and meets any one of the nine criteria set out below:

The following properties have been identified as having met at least one of the criteria.

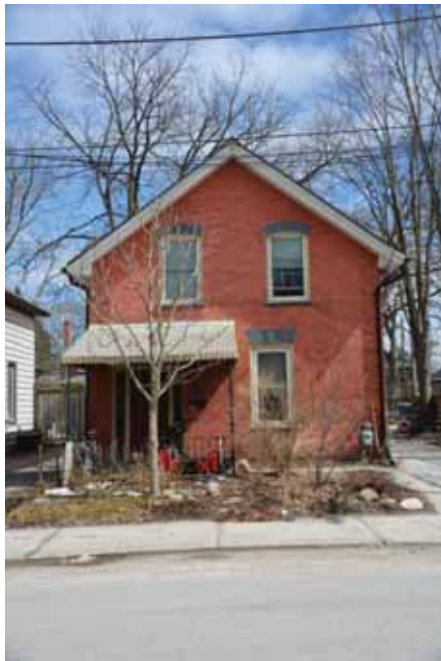
### **571 Harvey Street**

571 Harvey Street was constructed prior to 1875 and is illustrated on the Bird's Eye View map of Peterborough from that year. It is a one-storey frame house which originally belonged to a widow, Mrs. William Finley. It is a good example of worker's housing from this period. It is a contributing property to the cultural landscape of the historic Dickson Mills neighbourhood.

**Heritage attributes:** One-storey frame construction; gable roof; sash windows; central entrance.

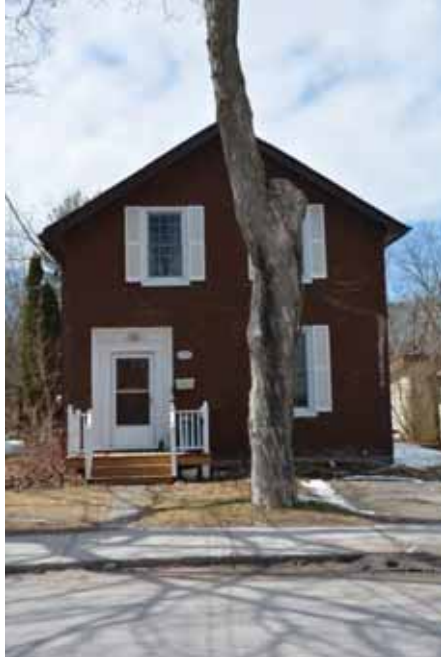
### **576 Harvey Street**

576 Harvey Street was constructed around 1870 and is a good example of a Victorian vernacular gable front house. This solid brick house is a typical worker's residence from this period and has a number of unique decorative elements including rusticated brick quoins and raised keystones in the voussoirs. It is a contributing property to the cultural landscape of the historic Dickson Mills neighbourhood.

**Heritage attributes:** One-and-a-half story brick construction; gable roof; sash windows; fenestration; voussoirs with raised keystones; rusticated quoins; offset entrance.

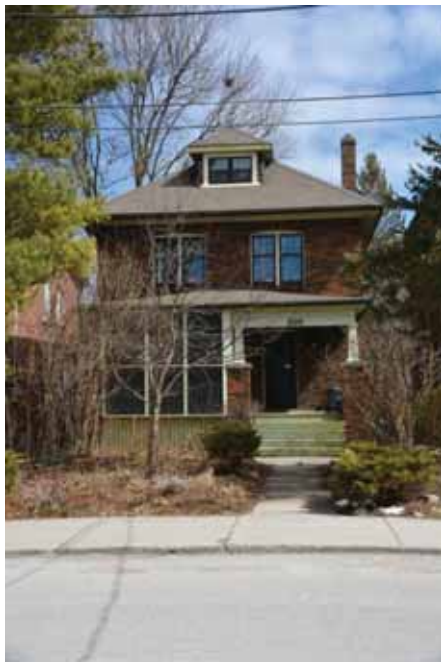
### **588 Harvey Street**

588 Harvey Street is a good example of an Edwardian gable front house. Constructed in 1916, it was originally occupied by David Yarnold, an upholsterer at J.D. Craig's furniture store. It retains a number of important elements of the Edwardian gable front type, including its singled gable, tripartite window and verandah. It is a contributing property to the historic landscape of the Dickson Mills area.

**Heritage attributes:** Two-and-a-half storey red brick construction; gable roof; chimney; shingles gable; tripartite window with decorative surround; fenestration; sash windows; offset entrance; shingled side bay; verandah; entablature; square columns; stone piers.

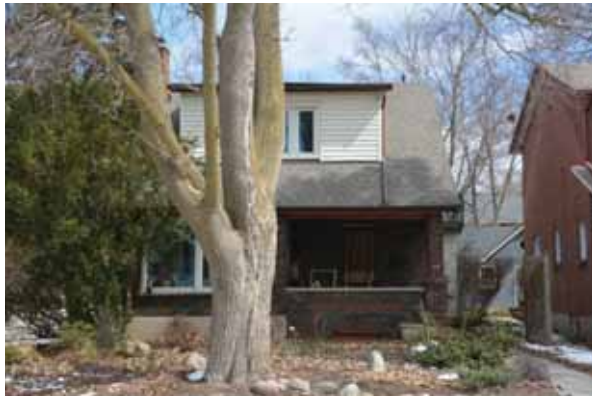
### **597 Harvey Street**

**Heritage attributes:** Two-storey construction; red brick cladding; hipped roof; granite foundation; symmetrical massing; central entrances; rounded windows; fenestration; chimneys.

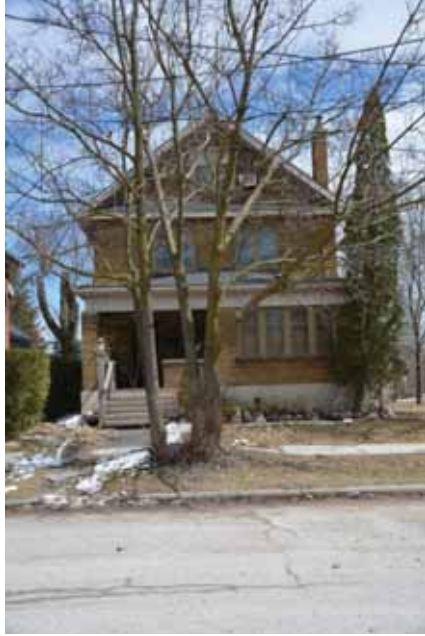
### **726 Elcombe Crescent**

726 Elcombe Crescent is a good example of a hipped roof vernacular Victorian residence. Likely constructed around the turn of the twentieth century, it replaced an older house on this site. It has the characteristic and massing and layout of this house type. It is a contributing property to the historic character of Elcombe Crescent.

**Heritage attributes:** Two-storey red brick construction; hipped roof; fenestration; offset entrance with transom; window with transom; verandah; entablature; square columns; stone piers.

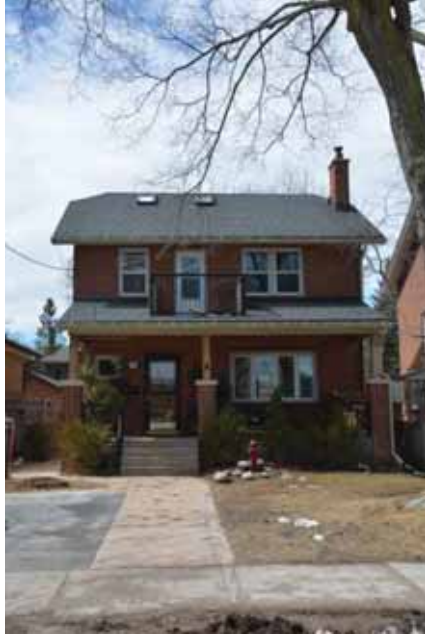
### **592 Waterford Street**

592 Water Street is a good example of a Dutch Colonial Revival house with the characteristic gambrel roof of this style. The house was constructed in 1936 to replace an older building owned by the Dickson Mills Company and occupied by Leo Copp, the County school inspector. The property forms part of an intact historic streetscape between London and Dublin Street comprised almost entirely of Classical and Colonial Revival homes constructed between 1926 and 1937.

**Heritage attributes:** One-and-a-half-storey red brick construction; gambrel roof; chimney; corner bay; dormers; fenestration; L-shaped plan; asymmetrical massing; corner entrance; portico.

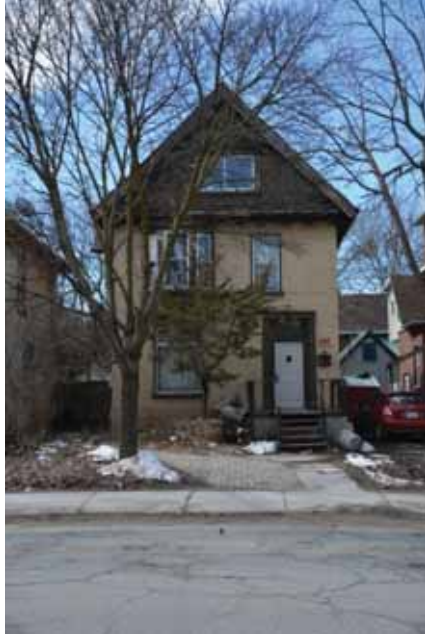
### **583 Water Street**

583 Water Street is a good example of a Georgian style house in Peterborough. It is believed to have been owned by Dr. George Burnham and moved to this location after 1875 and is of frame construction, clad in brick. It retains the typical three bay arrangement of the Georgian style with a central doorway and symmetrical massing.

**Heritage attributes:** Two-storey frame construction; buff brick cladding; hipped roof; chimneys; symmetrical massing; central entrance with transom and sidelights; entrance porch; square columns; entablature; fenestration.

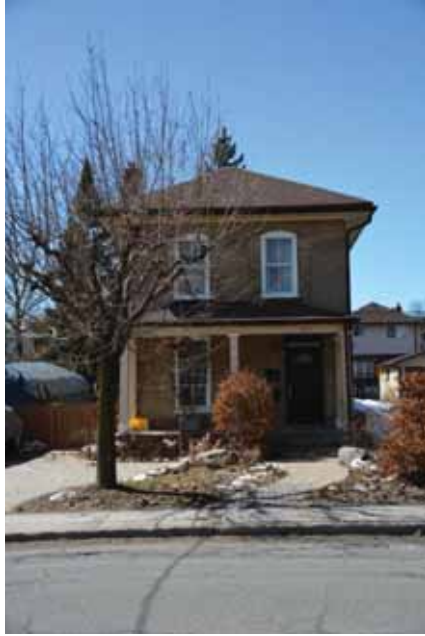
### **663 Water Street**

663 Water Street was constructed in the late 1880s and is a good example of a Victorian vernacular hipped roof residential building. The house retains many of its original features, but its verandah was replaced in the 1920s with an excellent example of a Rustic style entrance porch with rubble stone piers knee walls. . It is a contributing property to the historic landscape of this section of Water Street which forms an intact landscape of turn of the century worker's housing.

**Heritage attributes:** Two-storey frame construction; buff brick cladding; hipped roof; rounded upper storey windows; fenestration; entrance with transom; rubble stone foundation; entrance porch; rubble stone piers and knee walls with coping; front door.

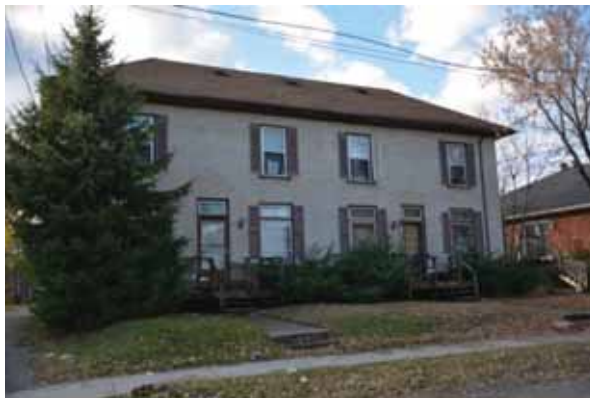
### **183 Bethune Street**

183 Bethune Street was constructed in 1883 for George Loudon, a moulder at the Hamilton Foundry. It is a frame building clad in brick and was reported on in the *Peterborough Examiner* on November 8, 1883. It is a good example of gable front worker's housing from the late nineteenth century and is a contributing property to the historic landscape of Bethune Street.

**Heritage attributes:** One-and-a-half storey construction; buff brick cladding; gable roof; chimney; fenestration; offset entrance with transom

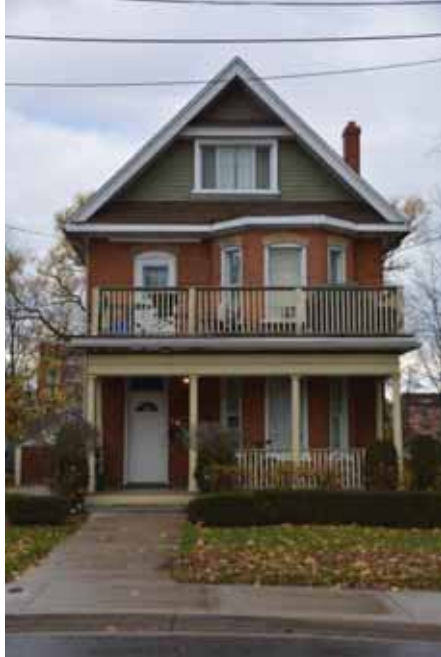
### **181 Dalhousie Street**

181 Dalhousie Street was constructed around 1888 and was occupied by William White, a carpenter at Hamilton's Foundry. It is a good example of late Victorian vernacular design, featuring two bays and a hipped roof; it is of frame construction and clad in brick. It is also a good example of worker's housing from the late nineteenth century and has important connections to Peterborough's industrial heritage through its occupants.

**Heritage attributes:** Two-storey red brick construction; hipped roof; fenestration; offset entrance; entrance porch.

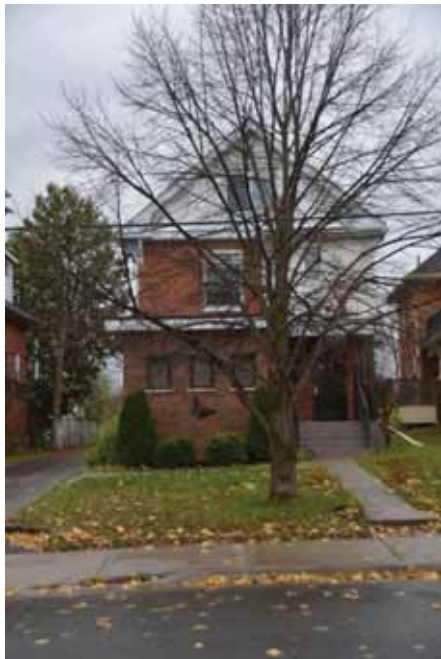
### **185 Dalhousie Street**

**Heritage attributes:** Two-storey buff brick construction; hipped roof; fenestration; voussoirs with decorative keystones; offset entrance; porch; pediment; entablature; square columns; concrete piers; stone foundation.

Late Victorian two story hip roof house built around 1899.

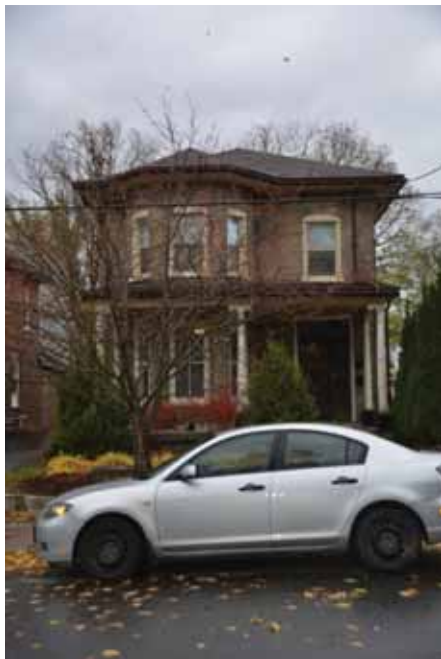
### **202 Dalhousie Street**

202 Dalhousie Street is a good example of a vernacular Victorian residence with Italianate details including the wide eaves and rusticated quoins. It was constructed in 1889 for R.S. Davidson, of McKee and Davidson Hardware. It is a contributing property to the overall landscape of historic Dalhousie Street.

**Heritage attributes:** Two-storey red brick construction; hipped roof; wide eaves; chimney; two-storey bay; rusticated quoins; fenestration; rounded windows; voussoirs; offset entrance with transom and sidelights.

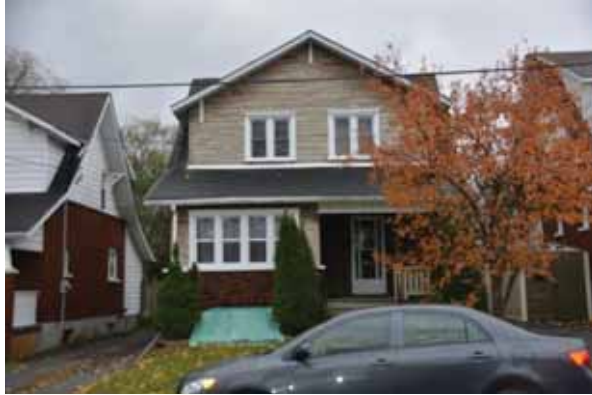
### **212-214 Dalhousie Street**

214 Dalhousie Street was constructed prior to 1888 and is a good example of a late Victorian vernacular house. It was originally occupied by Robert Logan, a blacksmith at the Hamilton foundry. It retains its verandah with decorative woodwork which is characteristic of this style of house. It is a contributing property to the historic landscape of Dalhousie Street.

**Heritage attributes:** One-and-a-half storey buff brick construction; gable roof; fenestration; offset entrance with transom; verandah; decorative woodwork; square columns.

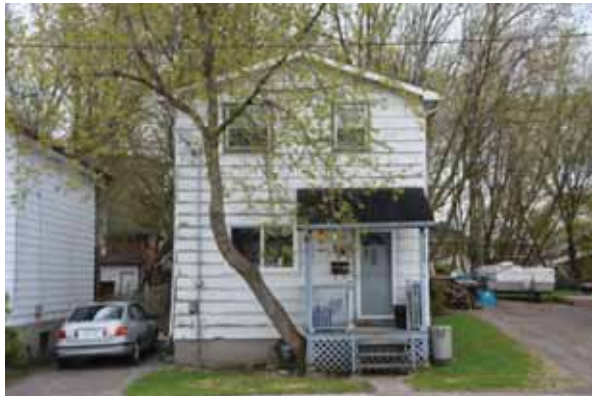
### **193 Rink Street**

193 Rink Street was constructed around 1929 and is a good example of a vernacular gable front house. It was occupied by John McFarlane, an employee at the Hamilton Foundry, and reflects the demographic development of this area as a working class neighbourhood. It is a contributing property to the historic landscape of this area of the city.

**Heritage attributes:** One-and-a-half storey construction; gable roof; fenestration; offset entrance; entrance porch.

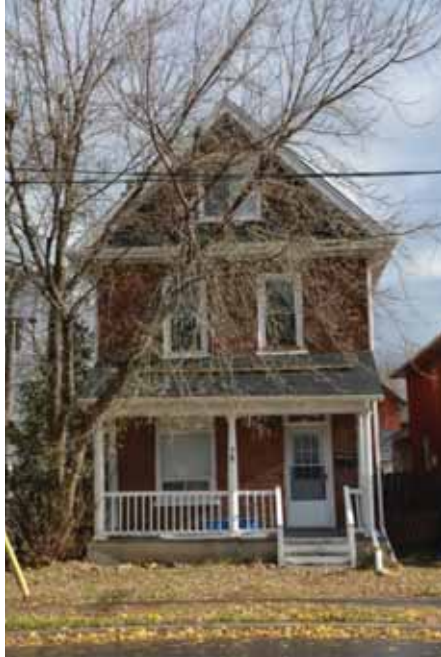
### **76 Aylmer Street N**

Built in 1880, 76 Aylmer Street N provides an interesting example of Victorian vernacular home construction. It features accents such as decorative key stone above front windows. It also includes a high stone foundation. It is a contributing property to the historic character of Aylmer Street N.

**Heritage attributes:** One-and-a-half storey red brick construction; gable roof; window surrounds with key stones; fenestration; entrance porch; pediment; entablature; square columns; brick piers; high stone foundation; offset entrance.
