City of  
**Peterborough**

**Subject:** Report IPSTR18-012  
Hunter Street East / Armour Road Traffic Operational Review

A report to present the findings of the Hunter Street East / Armour Road Traffic Operational Review.

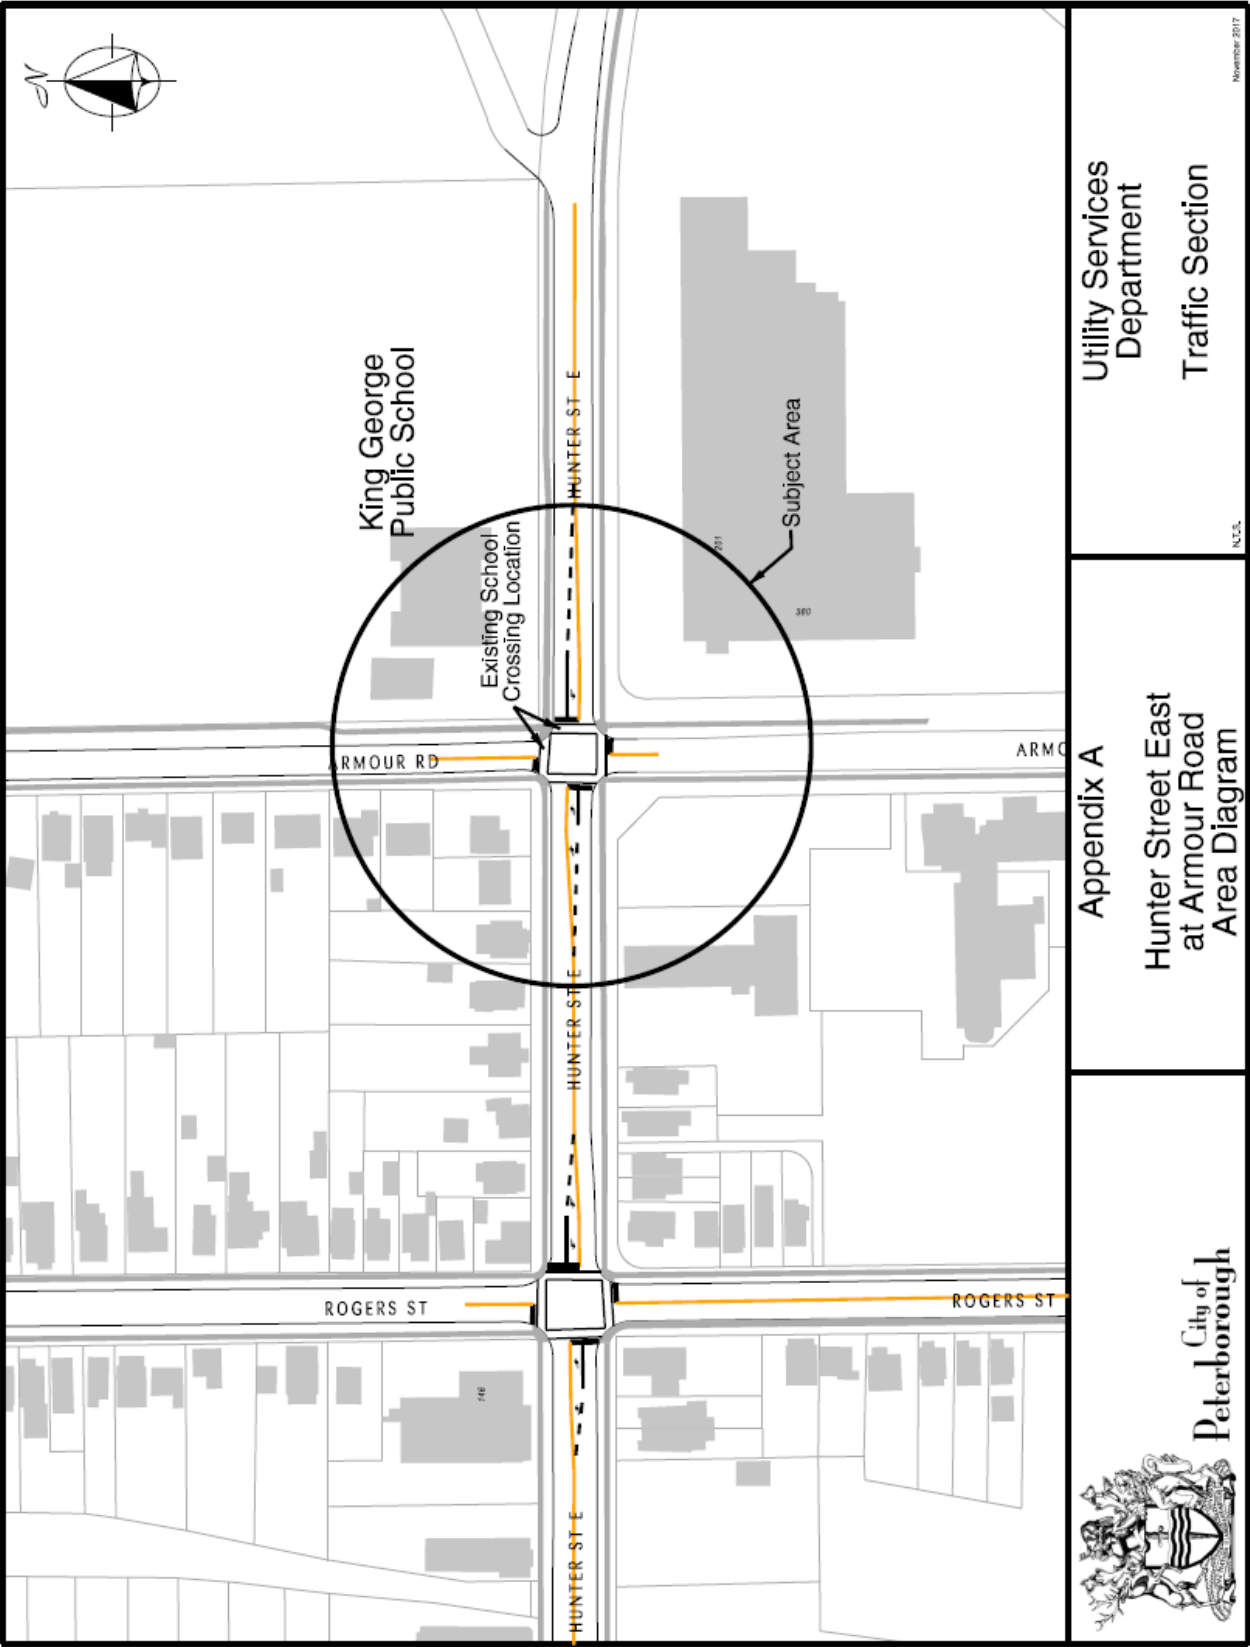
Appendix A: Hunter Street East / Armour Road Area Diagram

Across from King George Public School, the Skyline Westclox Building, located on the southeast corner of the intersection, houses a mixture of professional, commercial, and residential units. A sketch of the subject area is shown in Appendix A.
